Baffle Box with Media Filtration Installation,
Effectiveness Evaluation, and Associated Education for
the Lake Jesup Watershed

Contract S0497

Final Report

City of Casselberry

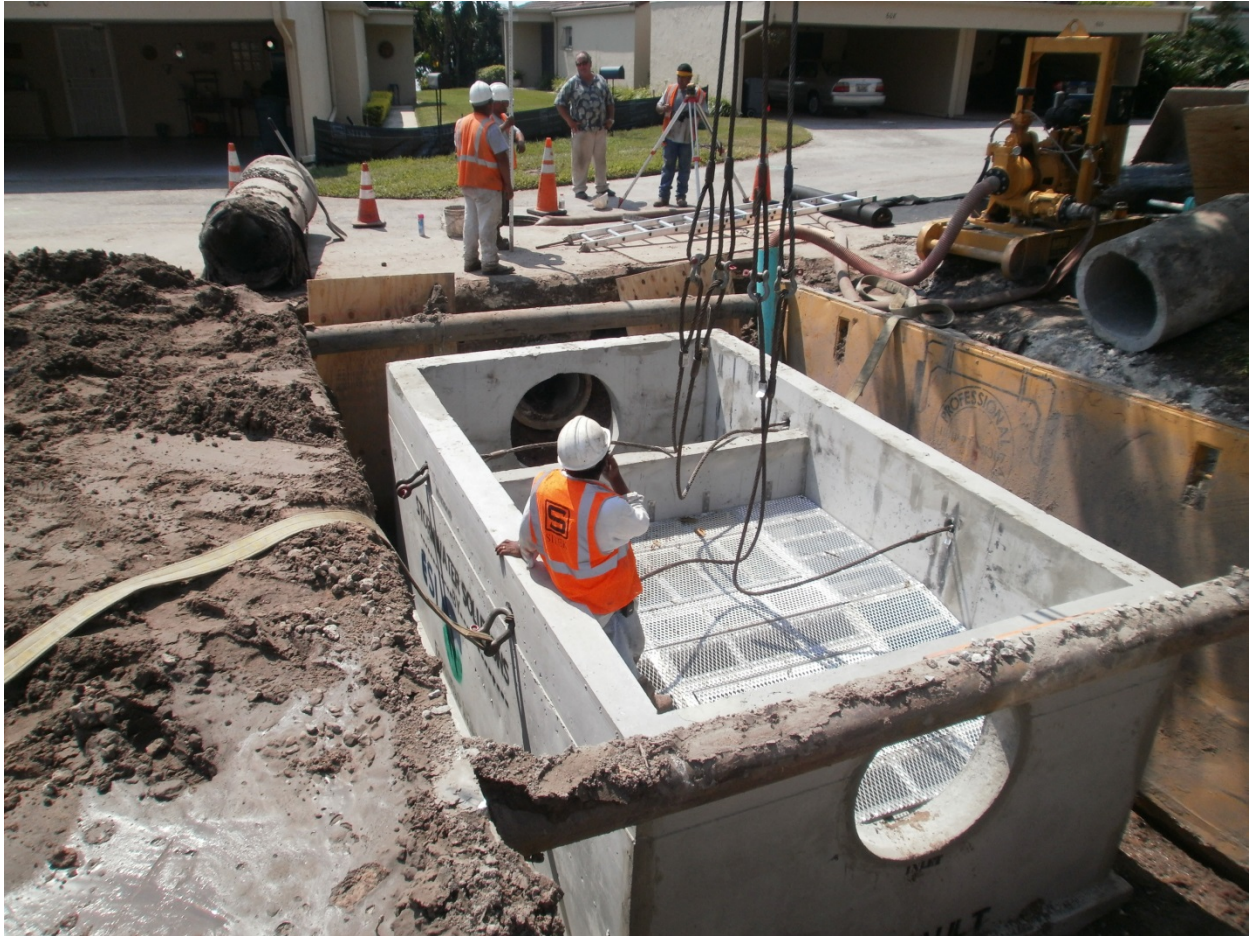
Installation of one of the smaller baffle boxes at the Sausalito Condos on Lake Howell. This box treats a 24" storm pipe – the upstream side is in the foreground (Lake Howell is just beyond the buildings in the photo.) The leaf screen can be seen on the upstream side of the box.

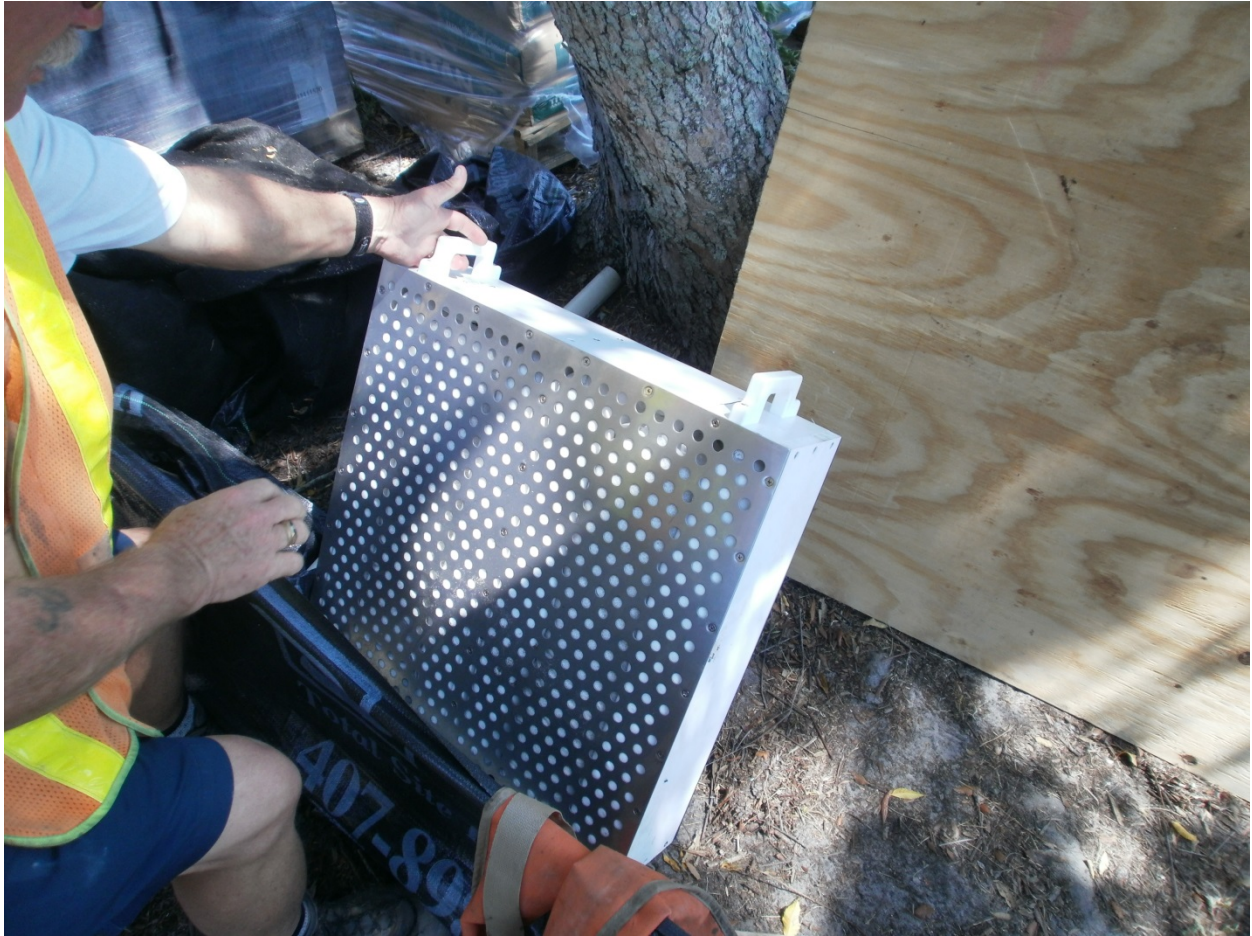
Cassette media filter prior to installation in one of the baffle boxes at Sausalito Condos on Lake Howell. These filters typically require annual replacement.

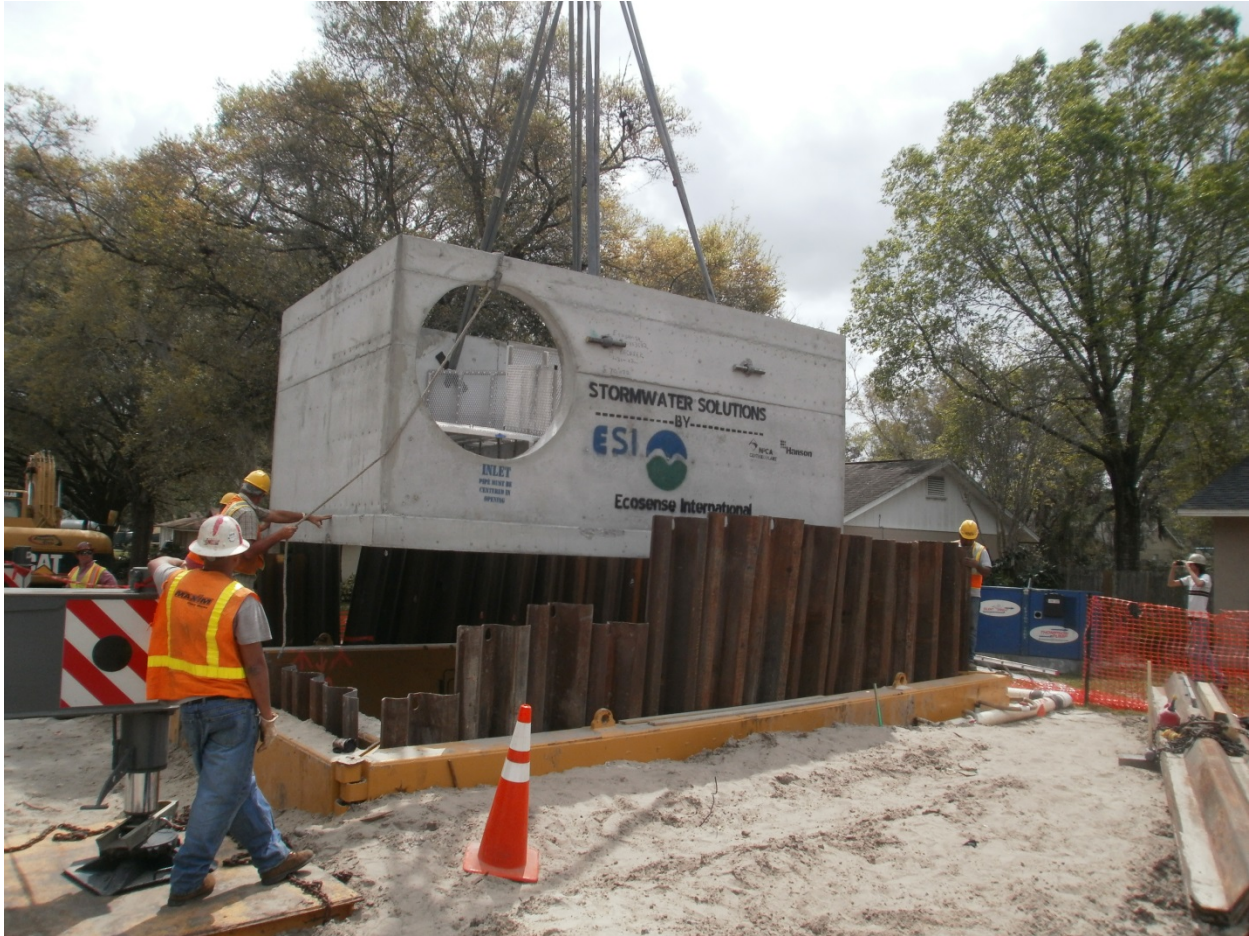
Lowering of one of the larger baffle boxes via crane on Osceola Trail at Gee Creek. Note the temporary sheet pile installation around the excavated area. The large opening in the side of the box is where the 42" upstream pipe was set (see next photo). Gee Creek (receiving water) is behind the homes to the right in the photo.

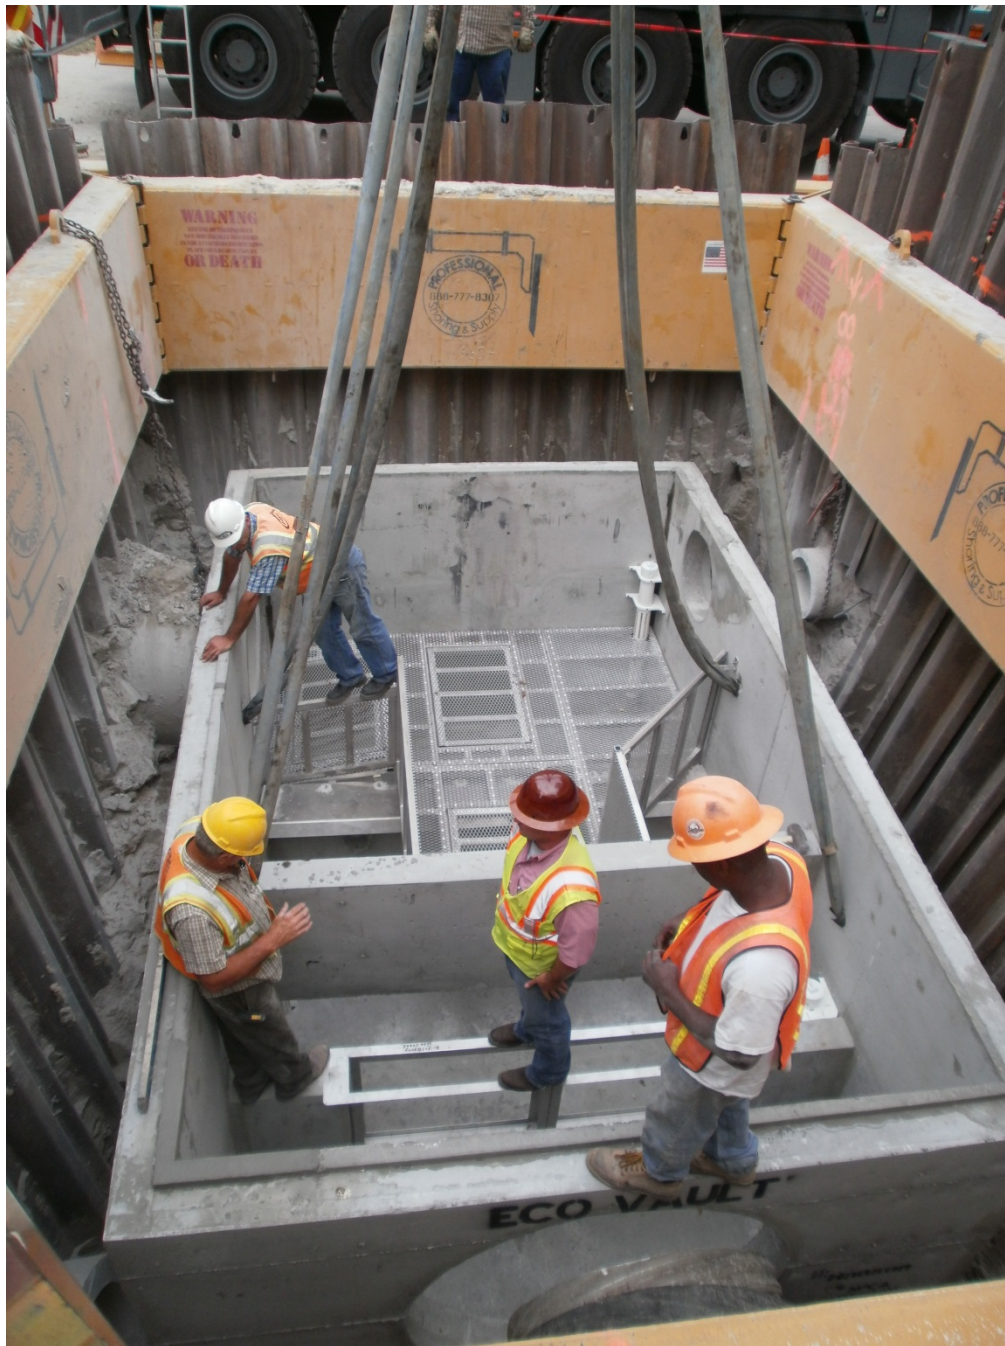
Placement of the baffle box on Osceola Trail at Gee Creek. Due to existing pipe geometry, this box was configured in a “T” fashion, receiving flows from a 42” pipe (upper left) and 15” pipe (upper right) with outflow to a 42” pipe (foreground) that discharges to Gee Creek. The leaf screen can be seen in the background. A PVC tube where VaultOx® is placed is visible in the upper right corner of the box. The metal frame in the foreground is where the cassette media filters are placed (this box requires two cassettes).

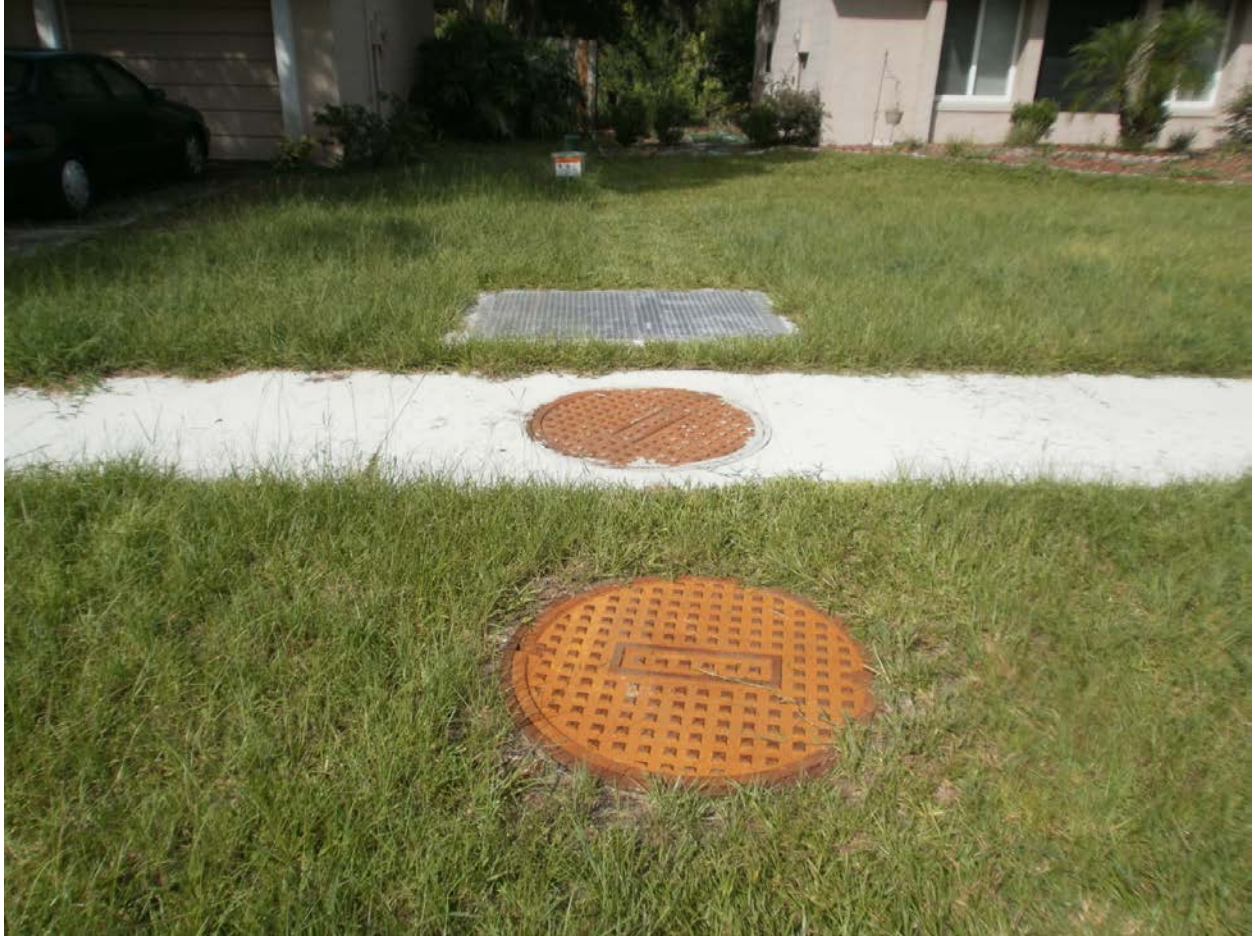
Baffle box on Osceola Trail at Gee Creek after full restoration. Gee Creek is behind the homes in the background. The manholes and hatches are used to access the baffle box for maintenance, including cleanouts and filter replacement.

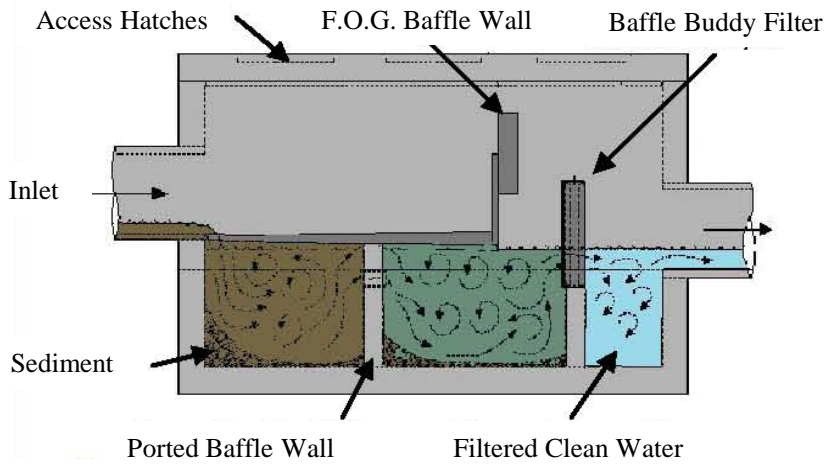
a. Schematic flow patterns in the EcoVault® unit

Photographs of the ESI EcoVault® baffle box system are given on Figure 2-1. As indicated on Figure 2-1a, the EcoVault® contains three separate internal chambers separated by concrete walls. As water enters the EcoVault® unit, the flow spreads out over a series of hinged screen aluminum hatches. The runoff passes downward through the screens (illustrated on Figure 2-1b) which filter out larger debris, leaves, and vegetation, while allowing smaller particles (such as sand and grit) to settle into the internal chambers. The elevation of the screens is designed to be higher than the outflow invert elevation so that the collected solid material is stored out of the water between storm events. Storage of the collected vegetation and debris under dry conditions minimizes leaching of nutrients from the vegetation which is substantially accelerated when the vegetation is maintained in a saturated environment. The EcoVault® baffle box is cleaned by first vacuuming the solids from the top of the screens. The screens then open up (as illustrated on Figure 2-1c) to allow access to the lower chambers to remove accumulated solids.

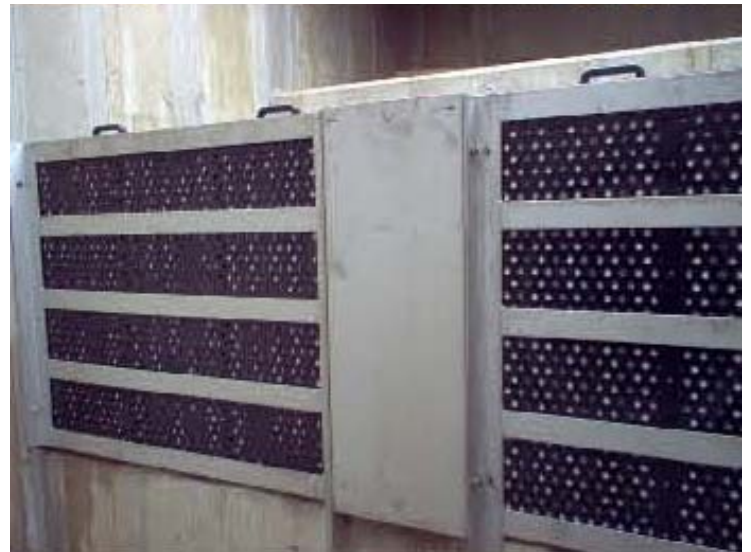
d. "Baffle Buddy" Outlet filter

One of the unique features of the ESI EcoVault® baffle box is the inclusion of an outlet filter system located on the downstream side of the baffle box unit. Water which exits the baffle box must first pass through the outlet filter system (illustrated on Figure 2-1d). ESI refers to the filter as the “Baffle Buddy filter” which contains a patented surfactant-modified alumino silicate which, according to ESI, absorbs cations and anions such as phosphates, ammonia, dissolved heavy metals, hydrocarbons, fecal bacteria, and a variety of organic compounds. Product literature for the EcoVault® baffle box system is included in Appendix A.1.

In addition to solids retention on the internal screens and in the sump area, the EcoVault® units also contain a “Baffle Buddy” outlet filter system (see Figure 2-1d) which contains a patented surfactant-modified aluminosilicate which absorbs cations and anions, such as phosphates, ammonia, dissolved metals, hydrocarbons, fecal bacteria, and a variety of organic compounds. Because of this additional removal process, the total mass of solids entering the EcoVault® units cannot simply be calculated as the discharge mass plus the mass of sump solids as was used for the CDS and Suntree baffle box units. Mass removal in the outlet filter system must also be considered. Therefore, the equation used for estimation of input and output mass loadings are summarized below:

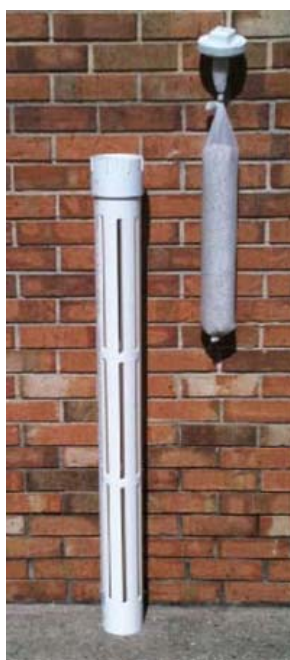
a. Vault-Ox® insert

In addition to the outflow filter system, the Lake Hodge and Gee Creek EcoVault® baffle boxes also contained Vault-Ox® inserts, which are also manufactured by ESI. Photographs of the ESI Vault-Ox® inserts are given on Figure 2-2. The Vault-Ox® insert consists of water-permeable mesh which contains a proprietary blend of two active ingredients, one of which is calcium peroxide. As the calcium peroxide dissolves, hydrogen peroxide is produced which is a strong oxidizer designed to maintain oxidized conditions within the baffle box between storm events. According to ESI, the addition of a Vault-Ox® cartridge to a baffle box is intended to improve dissolved oxygen, immobilize phosphorus, elevate and buffer pH, absorb nitrogen, enhance aerobic activity, promote oxidation of organics, lower COD/BOD, and absorb heavy metals.

The Vault-Ox® insert is placed into a protective holder (Figure 2-2b) which provides protection for the mesh insert. ESI refers to Vault-Ox® as “static stormwater remediation chemistry”, since it is designed primarily to maintain oxidized conditions within baffle boxes between storm events. Product literature information for Vault-Ox® is given in Appendix A.2. The Vault-Ox® inserts are stand-alone products which can be used in many types of baffle boxes and small detention devices.

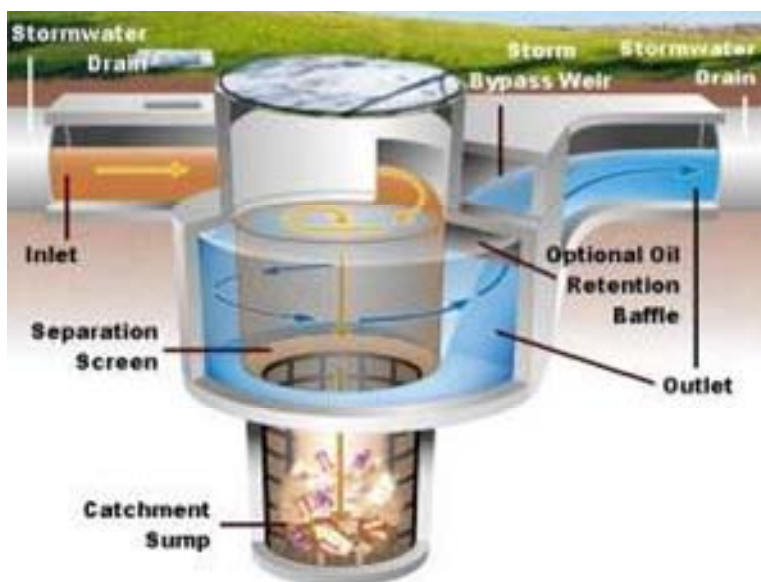
Figure 2-3.

A schematic of a typical Contech CDS unit is given on Figure 2-3, and product literature for Contech CDS units is given in Appendix A.3. According to Contech, the design of the CDS unit provides virtually full retention for captured pollutants, even during extremely high flow conditions through the unit. However, due to the vertical construction of the CDS unit, installation of CDS units typically requires deeper excavations than would be required for a typical baffle box unit.

Under operational conditions, the inflow is directed into a curved conduit which creates a swirling action on the inside of the unit in the separation cylinder. The swirling action inside the cylinder creates centrifugal forces on larger solids, causing them to pass through the internal screen and settle into the bottom sump area. In addition, the swirling action within the separation chamber acts to continually shear debris off the screen to keep it clean. Floating debris and trash is collected and stored in the center portion of the unit, with larger particles of sand and grit accumulating into the bottom of the sump. Cleaning operations consist of vacuum removal of the accumulated material within the central sump portions of the unit and sump.

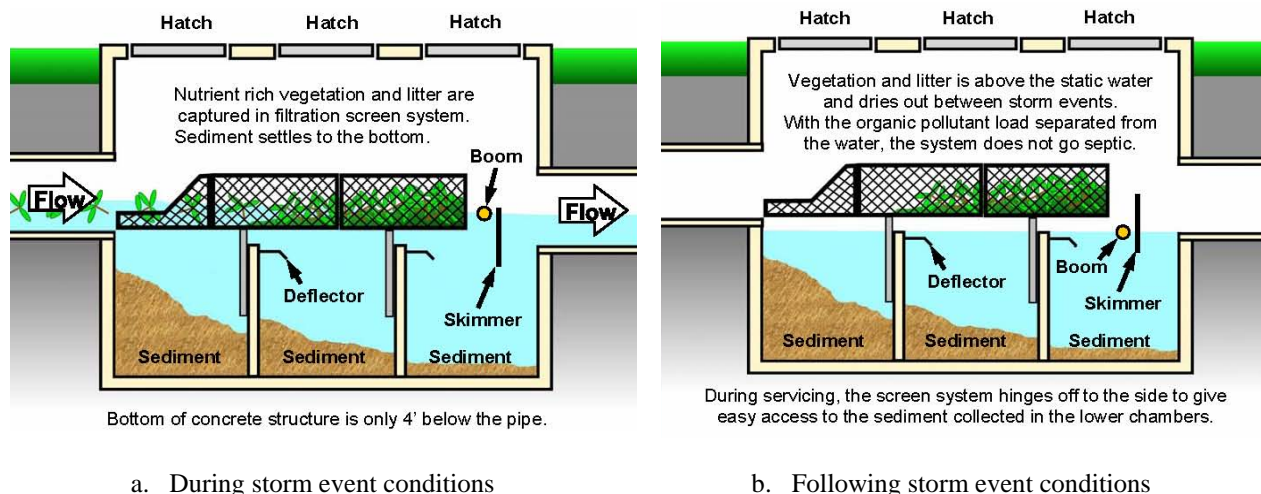
Figure 2-4. Schematic of the Suntree 2nd Generation Nutrient Separating Baffle Box.

A somewhat unique feature of the Suntree 2nd generation baffle box is the deflector shields provided on the internal walls of the basic baffle box structure. These deflectors minimize opportunity for development of turbulent and circular flow regimes adjacent to the baffle wall which could potentially mobilize collected sediments. The latest version of the nutrient separating baffle box contains deflector shields on both sides of the internal chambers. The Suntree system also contains a floating boom, referred to as the Storm Boom, designed to collect and adsorb hydrocarbons floating on the water surface in front of the outflow skimmer. The Suntree nutrient separating baffle box structures are available in a variety of sizes to accommodate pipe diameters ranging from 4-72 inches. A schematic of the Suntree unit is given on Figure 2-4, and product literature for the Suntree 2nd Generation Nutrient Separating Baffle Box System is given in Appendix A.4.

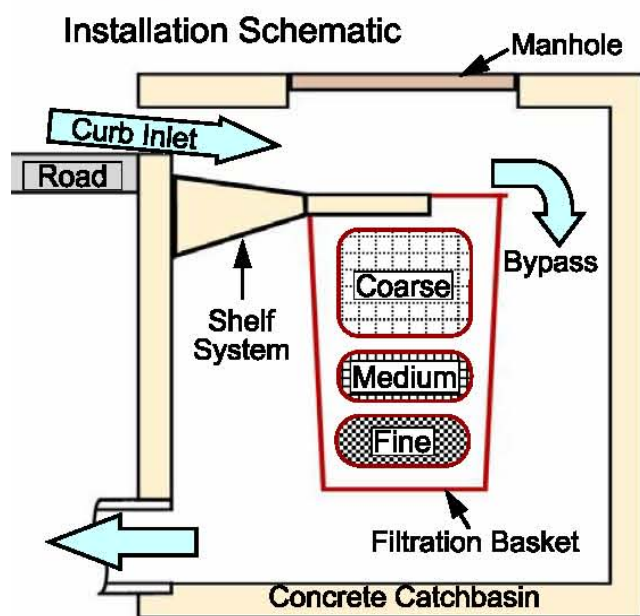
a. Schematic of the Suntree high-capacity curb inlet basket

In addition to the baffle box and CDS structures, monitoring was also conducted at three curb inlet basket sites which were located in the general vicinity of the San Pablo CDS and baffle box units. The installed high-capacity curb inlet baskets were manufactured by Suntree Technologies in Cocoa, Florida. A schematic of the Suntree high-capacity curb inlet basket is given on Figure 2-5. The unit consists of a wire mesh basket which is suspended near the center of a storm inlet using a shelf support system (Figure 2-5a). The shelf support also serves to direct the runoff inflow into the filtration basket where the water passes through the mesh openings, trapping suspended solids, vegetation, litter, and debris inside the basket. Inflows which exceed the intake capacity of the filtration basket bypass the unit and travel downstream through the stormsewer system. A photograph of a filtration basket filled with collected solids is given on Figure 2-5b. Product information concerning the Suntree high-capacity curb inlet basket is given in Appendix A.5.

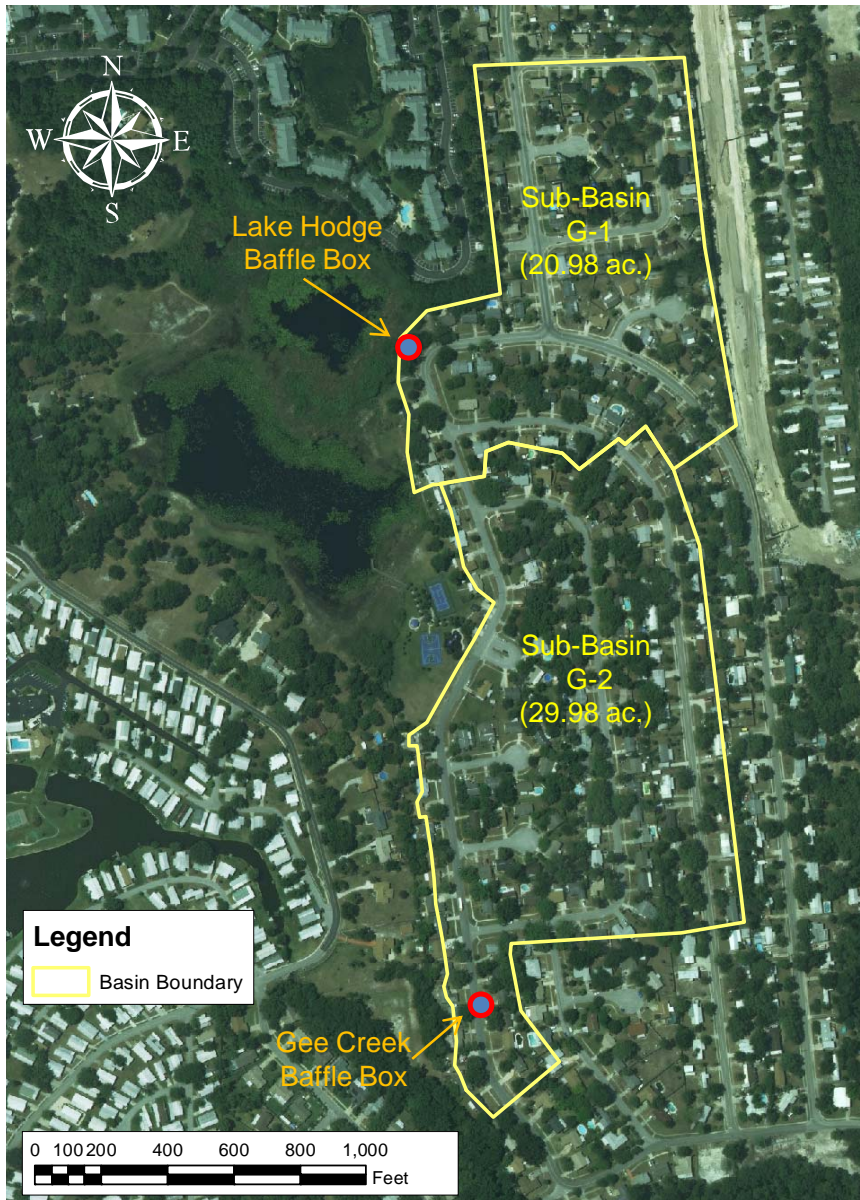
Figure 2-7.
Contributing
Watersheds for the
Osceola Trail Sites.

Contributing watershed areas for the Lake Hodge and Gee Creek baffle box systems are illustrated on Figure 2-7. The Lake Hodge baffle box receives inflow from the sub-basin designated as G-1 which consists of approximately 20.98 acres of single-family residential homes. The Gee Creek baffle box unit receives inflows from the sub-basin identified as G-2 which consists of approximately 29.98 acres of single-family residential homes.

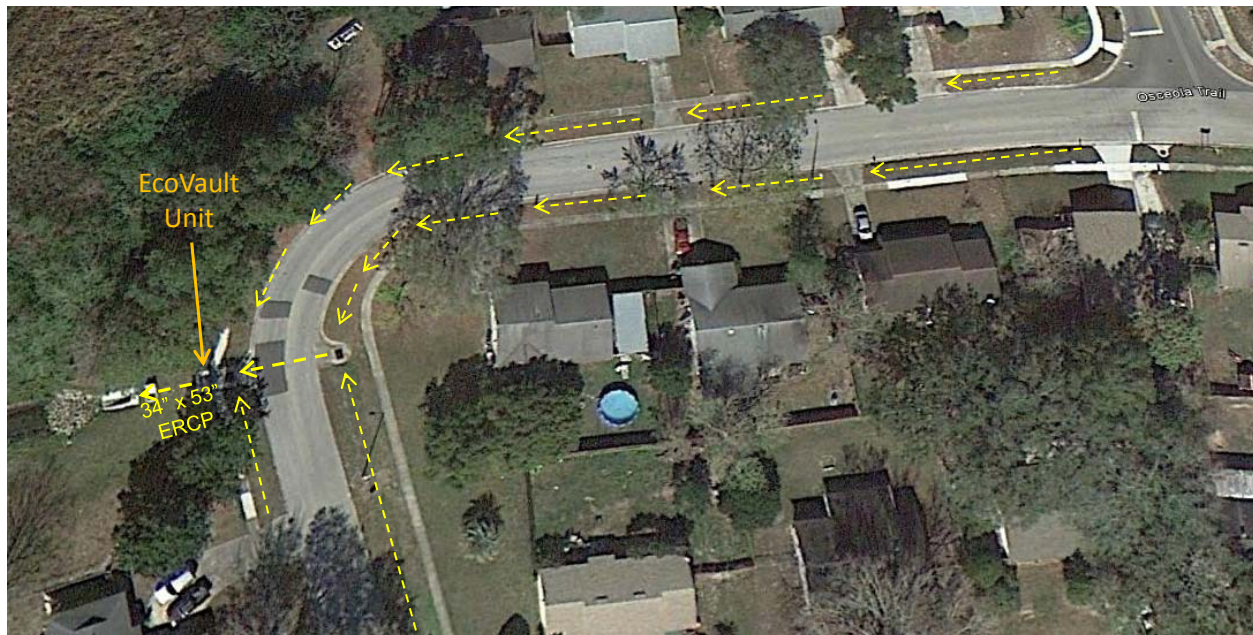
Figure 2-8. Drainage Patterns in the Vicinity of the Lake Hodge Baffle Box Site.

An overview of drainage patterns in the vicinity of the Lake Hodge baffle box site is given on Figure 2-8. In general, drainage within the sub-basin travels by a combination of roadside swales and curb and gutter systems before converging into the combined inflow for the EcoVault® unit.

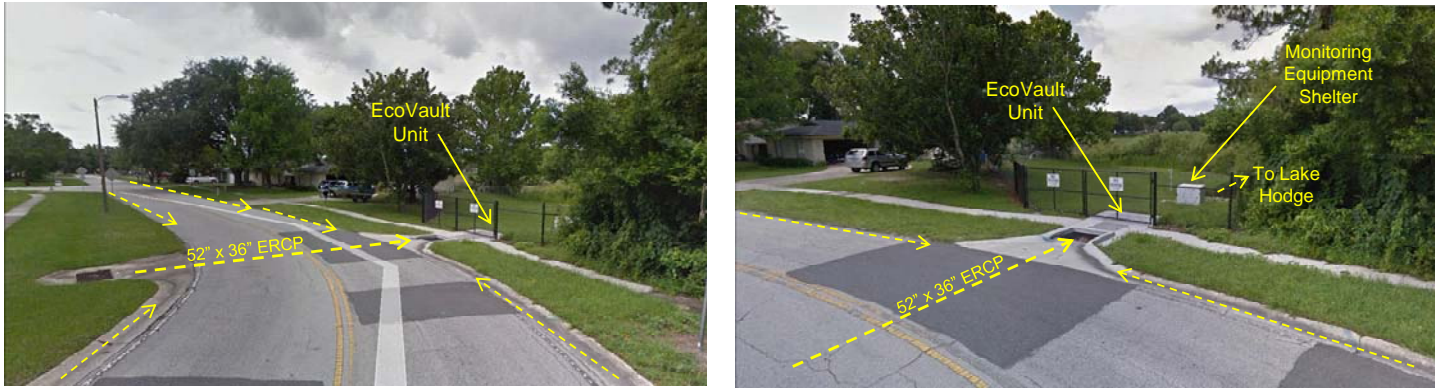
Figure 2-9. Photographs of the Lake Hodge Baffle Box Inflow.

Photographs of the Lake Hodge baffle box inflow are given on Figure 2-9. Runoff is collected on the east side of the roadway in a grate inlet and conveyed beneath Osceola Trail through a 52-inch x 36-inch ERCP. This RCP combines with surface inflows from the west and north sides of Osceola Trail to form the inflow into the EcoVault® unit.

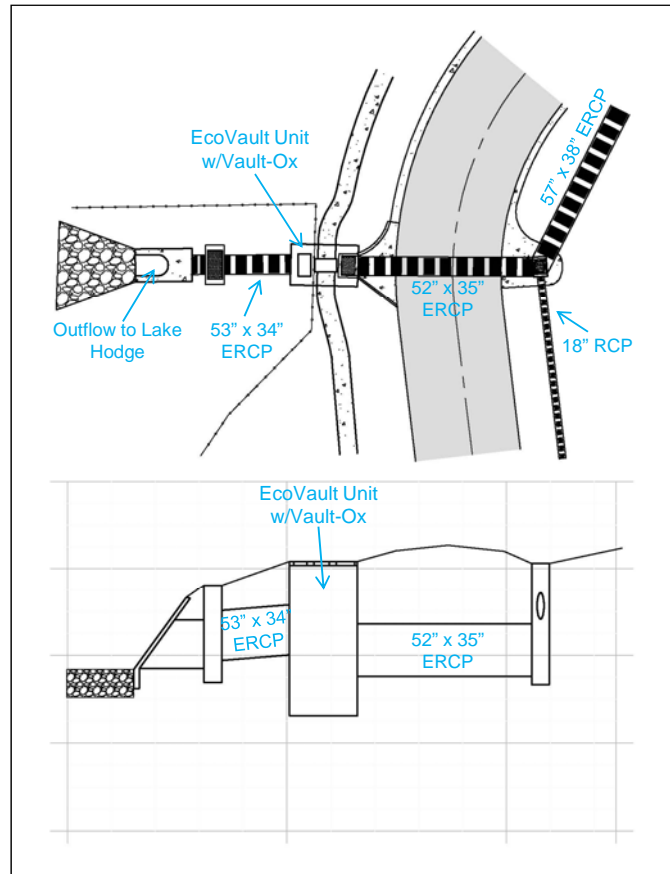
Plan and cross-section views of the Lake Hodge EcoVault® baffle box are illustrated on Figure 2-10. The inflow into the baffle box consists of a 52-inch x 36-inch ERCP, with the discharge from the structure consisting of a 34-inch x 53-inch ERCP. The EcoVault® unit installed at this site is similar to the model illustrated on Figure 2-1 which incorporates the outlet filter. In addition, a Vault-Ox® insert was also installed at this site. Construction drawings for the Lake Hodge EcoVault® site are included in Appendix B.1.

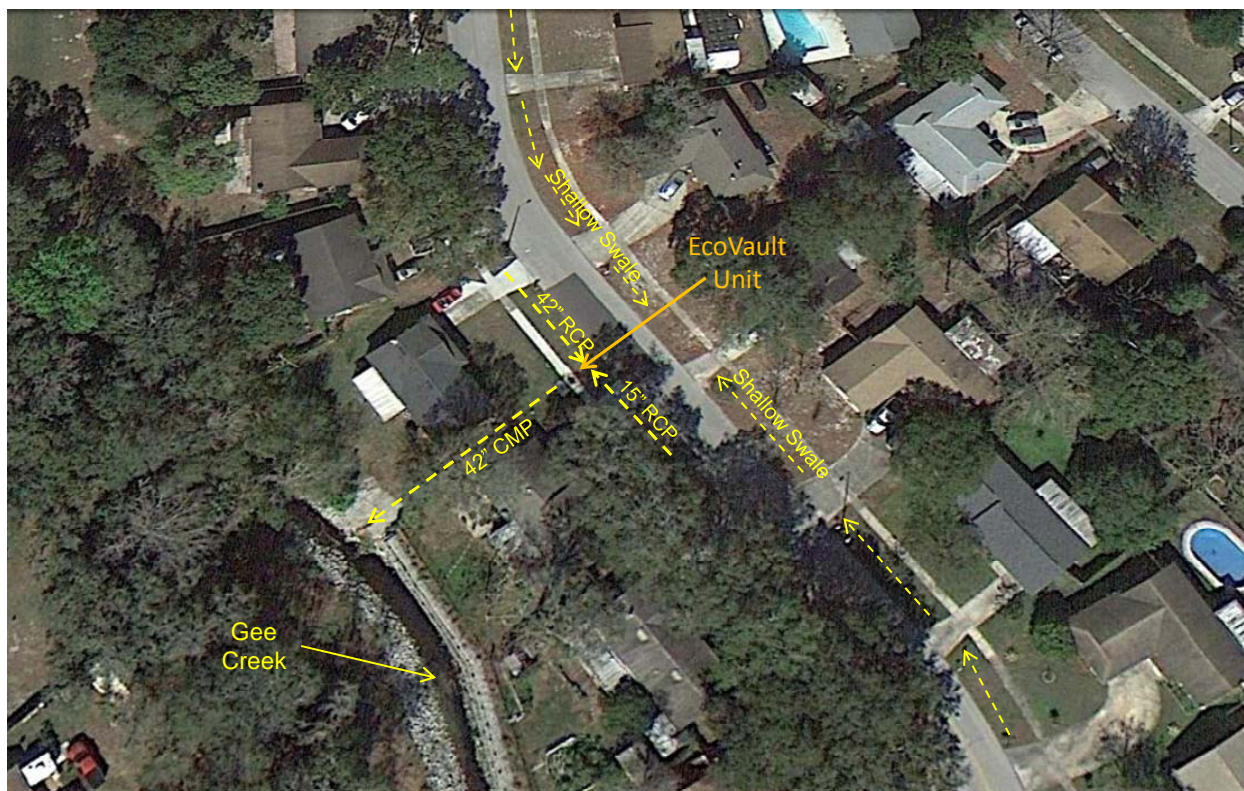
Figure 2-11. Drainage Patterns in the Vicinity of the Gee Creek Baffle Box Site.

Drainage patterns in the vicinity of the Gee Creek baffle box site are illustrated on Figure 2-11. The drainage system within the watershed discharging to the baffle box site consists almost exclusively of shallow vegetated roadside swales which lead to periodic grate inlets within the swales. Due to the highly permeable soils within the basin, a large portion of the generated runoff infiltrates into the onsite soils and swales, resulting in a relatively low runoff potential for this sub-basin area.

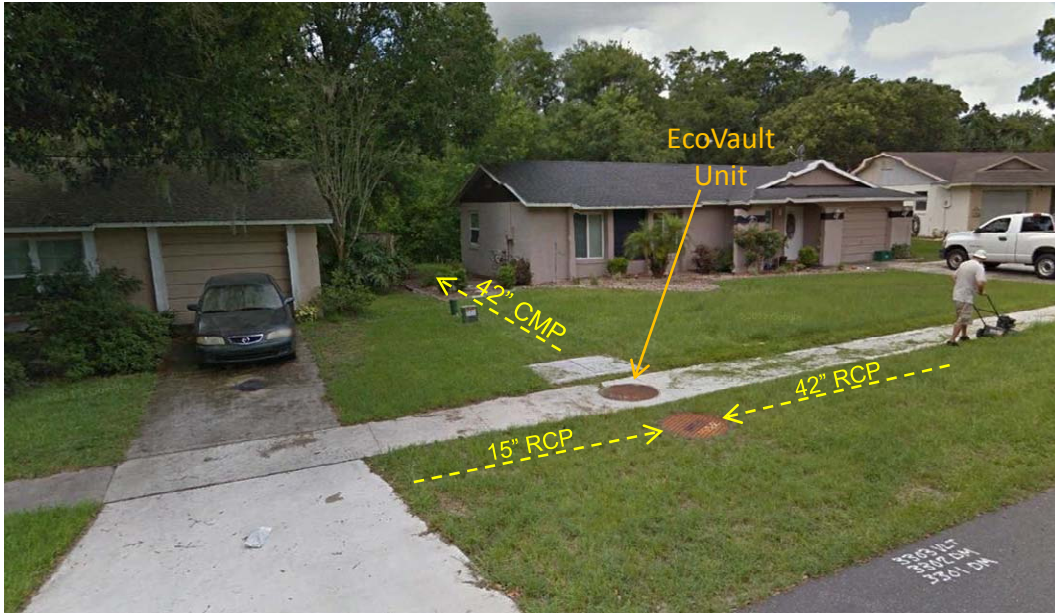
Figure 2-12. Photograph of the Exterior of the Gee Creek EcoVault® Unit.

A photograph of the Gee Creek baffle box site is given on Figure 2-12. A 42-inch RCP and a 15-inch RCP converge into a manhole located in the roadside swale area. The combined flows are then introduced into the EcoVault® baffle box through a 42-inch RCP. After treatment within the EcoVault® system, water discharges from the unit through a 42-inch CMP into Gee Creek. Plan and cross-section views of the Gee Creek EcoVault® baffle box are illustrated on Figure 2-13. The EcoVault® unit installed at this site is similar to the model illustrated on Figure 2-1 which incorporates the outlet filter. In addition, a Vault-Ox® insert was also installed at this site. Construction drawings for the Gee Creek EcoVault® system are included in Appendix B.1.

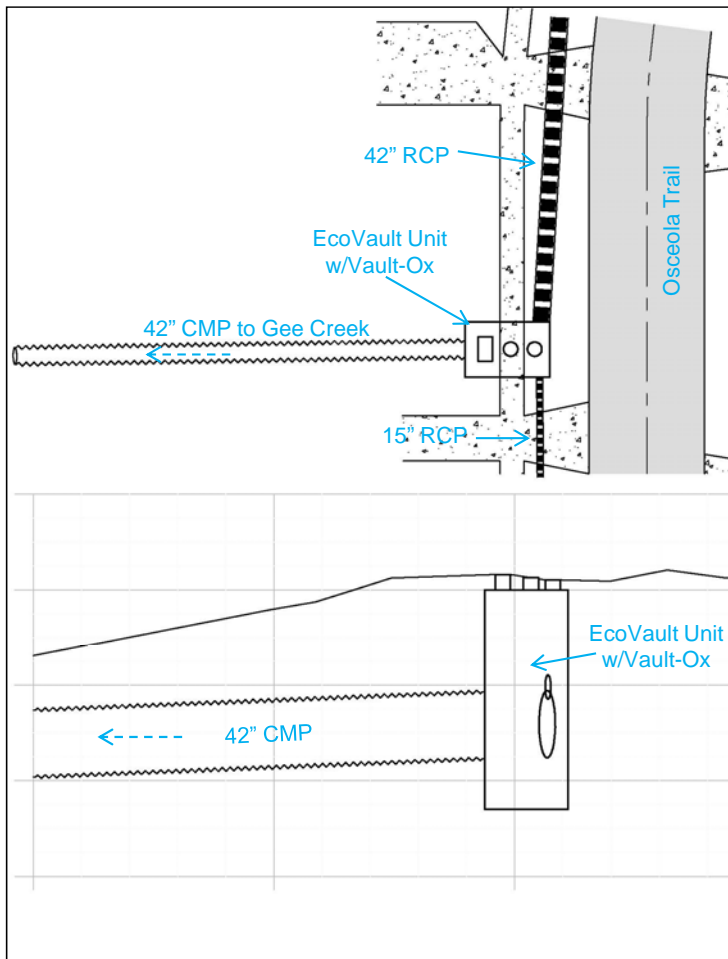
Figure 2-13.

Plan and Cross-Section Views of the Gee Creek EcoVault® Baffle Box.

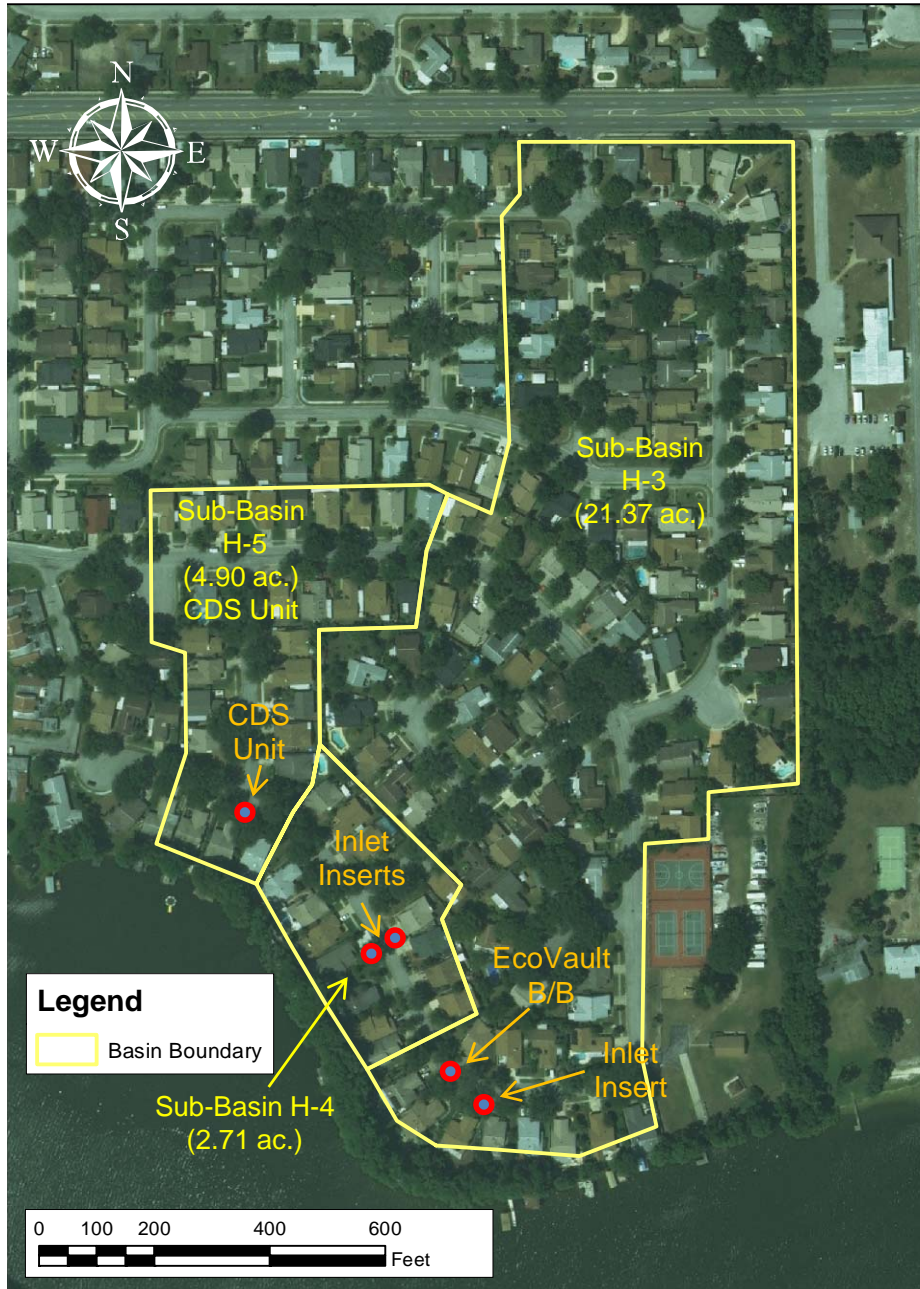
Contributing watershed areas for the San Pablo Avenue GPS units are illustrated on Figure 2-15. The San Pablo EcoVault® site receives runoff from the sub-basin designated as H-3 which consists of approximately 21.37 acres of single-family residential homes. Approximately 19.37 acres of sub-basin H-3 discharge to the EcoVault® unit, with 2.0 acres discharging to the 680 San Pablo inlet filter basket. The 668/669 San Pablo Suntree curb inlet baskets receive inflow from the sub-basin designated as H-4 which consists of approximately 2.71 acres of single-family residential homes. The Contech CDS unit receives runoff from the sub-basin designated as H-5 which consists of approximately 4.90 acres of single-family residential homes.

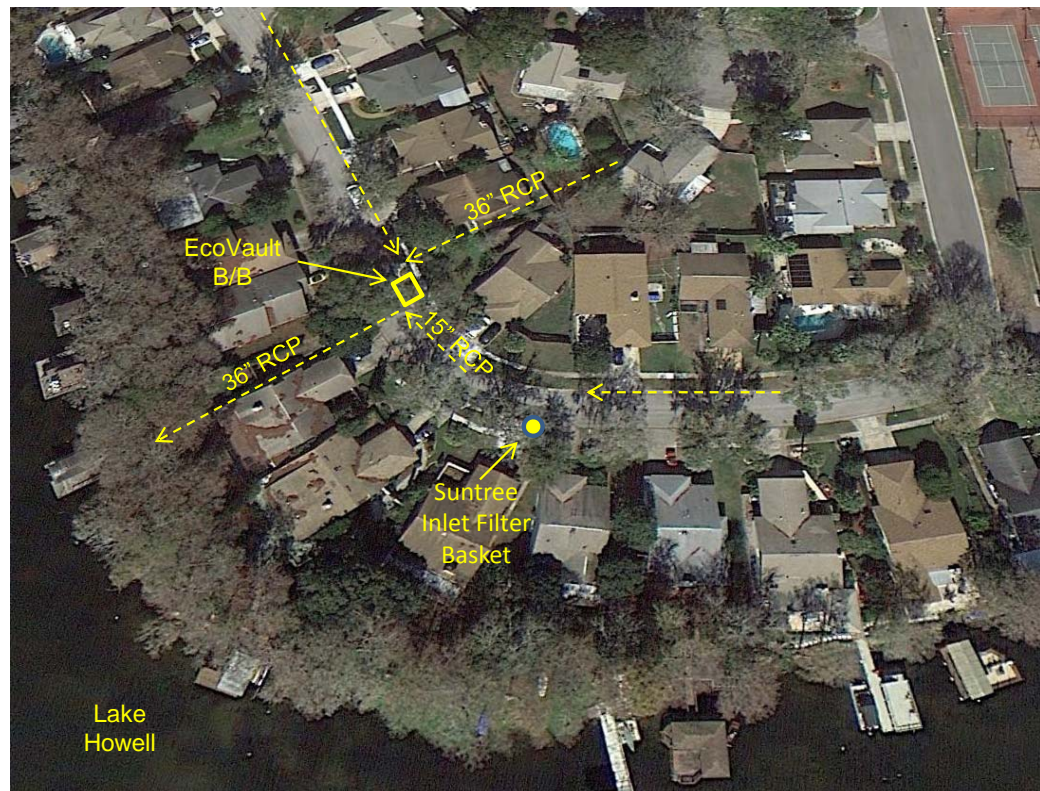
Figure 2-16.
Drainage
Patterns at the
San Pablo
Baffle Box
Site.

An overview of drainage patterns in the vicinity of the sub-basin H-3 EcoVault® baffle box site is given on Figure 2-16. In general, drainage within the sub-basin travels by a combination of curb and gutter systems and underground stormsewers which conveys the runoff into the EcoVault® unit. Approximately 19.37 acres of sub-basin H-3 discharge to the EcoVault® unit. The remaining 2 acres is treated by the inlet filter basket at 680 San Pablo and discharges into the downstream side of the EcoVault® unit through the 15-inch RCP.

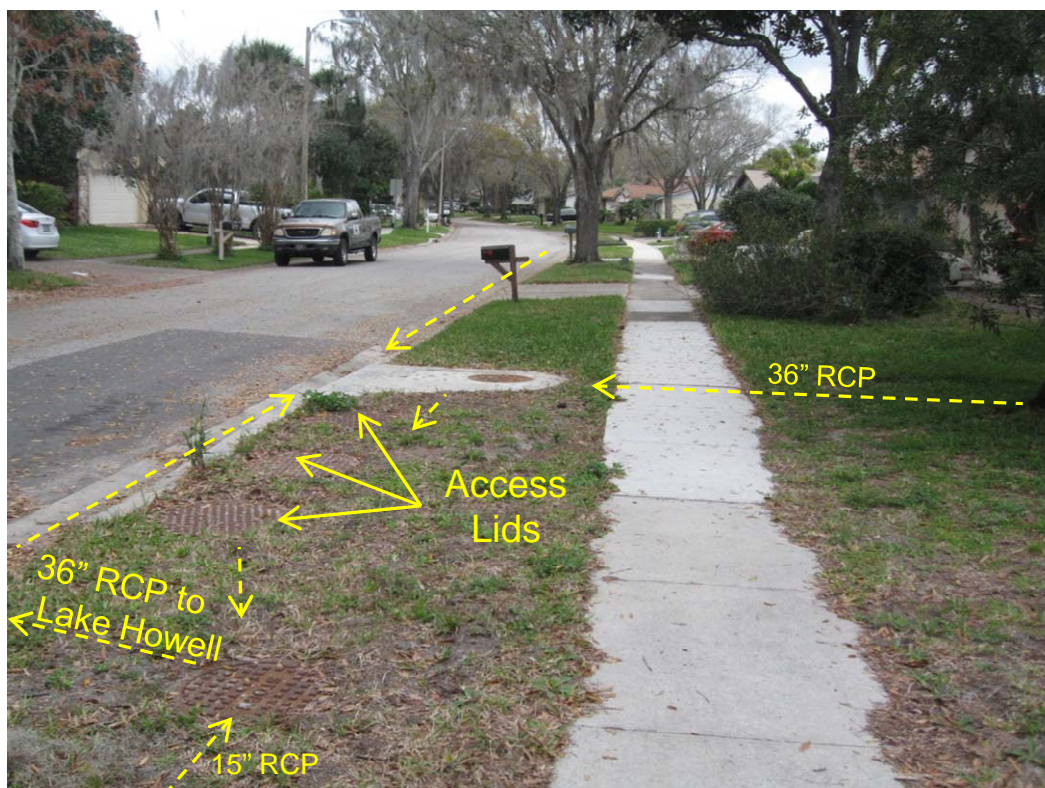
Figure 2-17. Photograph of the San Pablo Baffle Box Site.

A photograph of the exterior of the San Pablo EcoVault® site is given on Figure 2-17. The unit was constructed entirely within the existing right-of-way. Access into the unit is obtained through one of three manholes located in the grassed portion of the right-of-way.

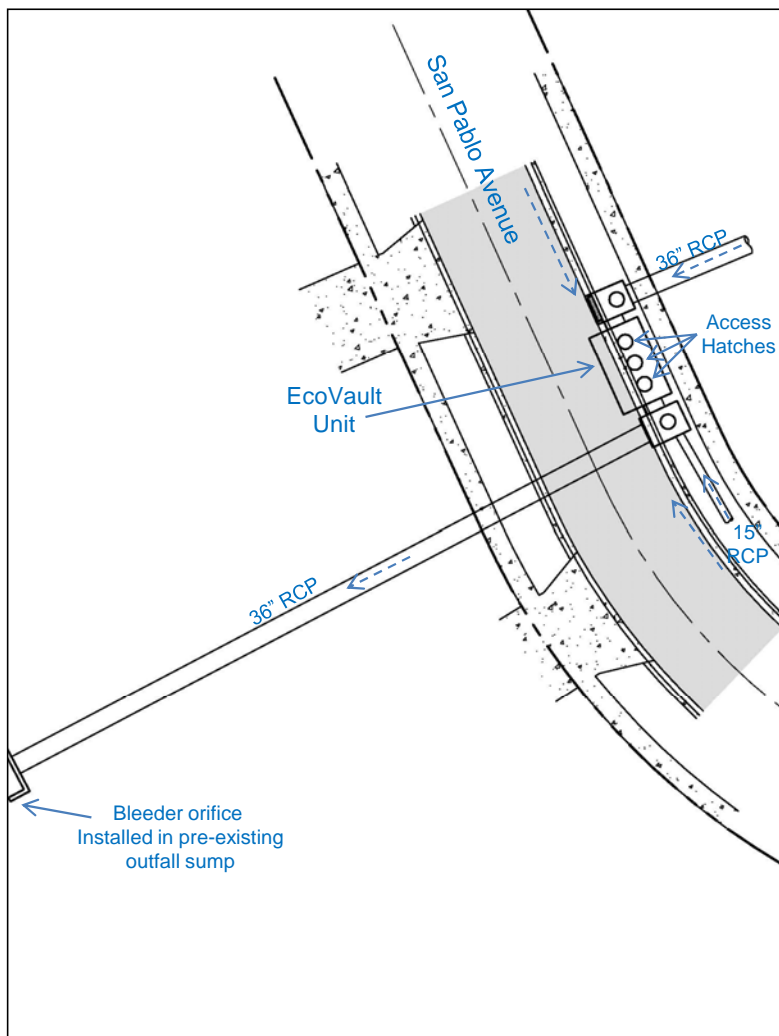
Plan and cross-section views of the San Pablo EcoVault® baffle box are illustrated on Figure 2-18. Inflow into the baffle box originates from a 36-inch RCP as well as local street runoff which discharges into the curb inlet structure and combines with the 36-inch RCP inflow. The combined flows pass through the EcoVault® unit, discharges into a manhole, and combines with the 15-inch CP treated by the Suntree inlet filter. The combined flows then discharge through a 36-inch RCP to Lake Howell. As part of this project, a bleeder orifice was installed in a pre-existing outfall sump to control the static water table elevation. This orifice was prone to clogging and is responsible for surcharged conditions frequently observed in the EcoVault® unit. The EcoVault® unit installed at this site is similar to the EcoVault® units installed at the Lake Hodge and Gee Creek sites with the exception that the San Pablo EcoVault® did not contain a Vault-Ox® insert. Construction drawings for the San Pablo EcoVault® site are provided in Appendix B.2.

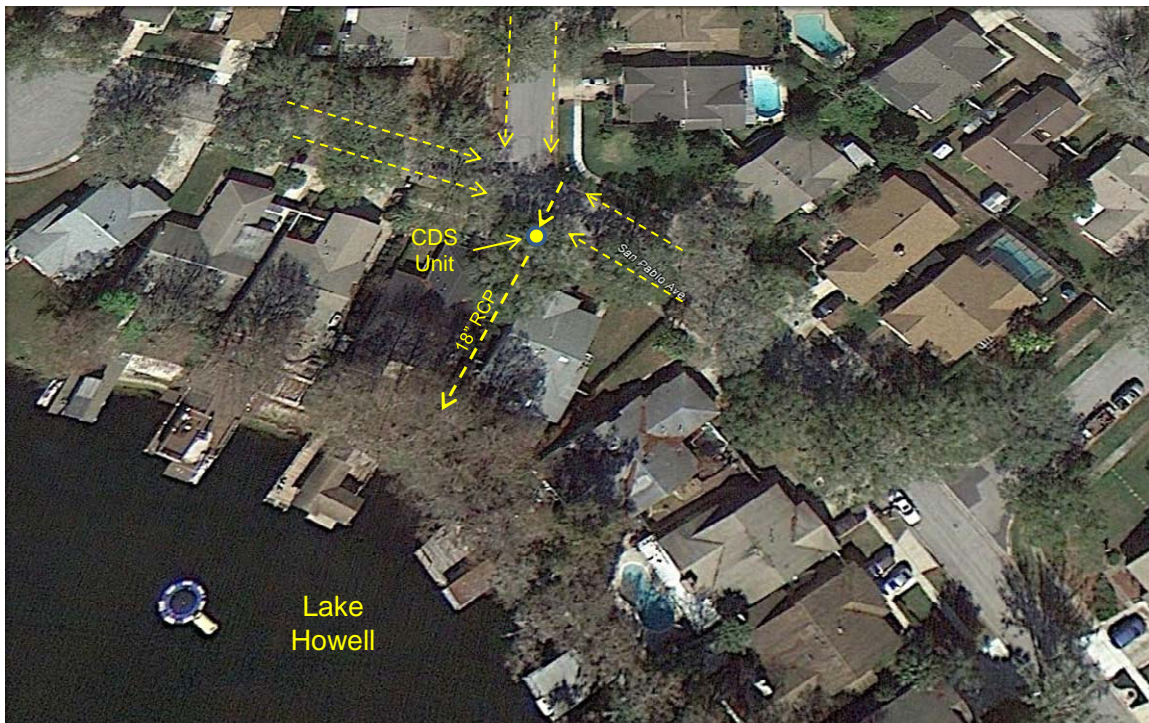
Figure 2-19. Drainage Patterns at the San Pablo CDS Unit Site.

Drainage patterns in the vicinity of the San Pablo CDS unit are illustrated on Figure 2-19. The drainage system within sub-basin H-5 consists almost exclusively of roadside curb and gutters with underground stormsewer systems. Runoff is collected within sub-basin H-5 and conveyed to the location of the CDS unit on San Pablo Avenue. Due to the highly permeable soils within the sub-basin, a large portion of the generated runoff infiltrates into the onsite soils, resulting on a relatively low runoff potential for the sub-basin area.
