Baffle Box with Media Filtration Installation,
Effectiveness Evaluation, and Associated Education for
the Lake Jesup Watershed

Contract S0497

Final Report

City of Casselberry

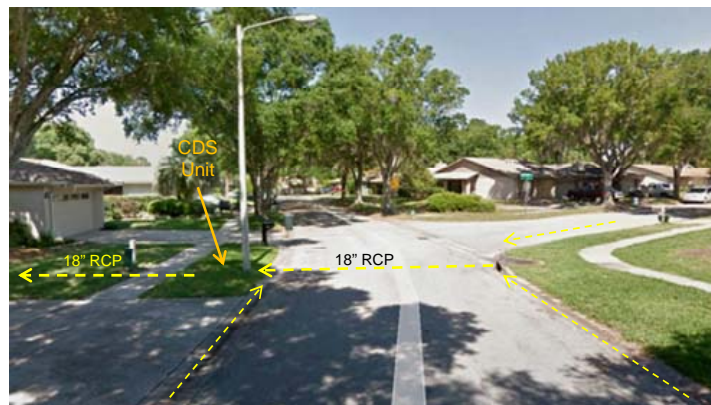
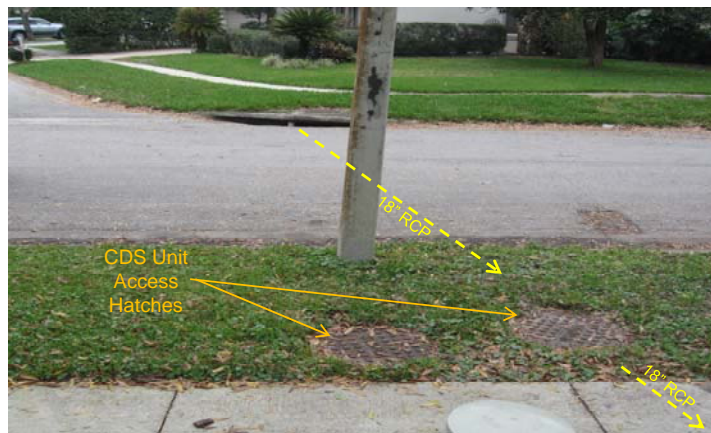
A photograph of the San Pablo CDS site is given on Figure 2-20. Runoff enters the CDS unit through an 18-inch RCP which conveys drainage from northern portions of sub-basin H-5. The discharge from the CDS unit to Lake Howell also consists of an 18-inch RCP. Access into the CDS unit is obtained through two separate manhole covers which are removed for clean-out operations. Plan and cross-section views of the San Pablo CDS unit are given on Figure 2-21. Construction drawings for the San Pablo CDS site are included in Appendix B.3.

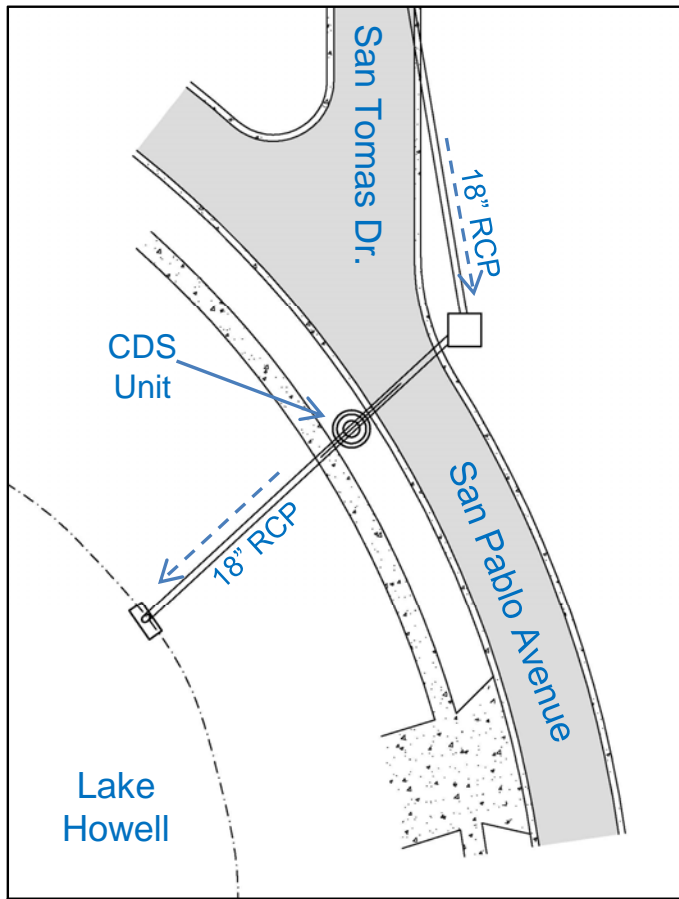
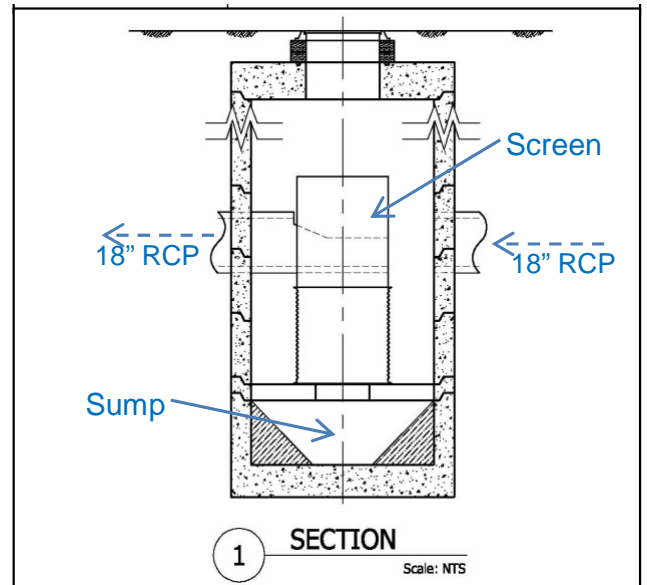
Figure 2-21.

Plan and Cross-section Views
of the San Pablo CDS Unit.

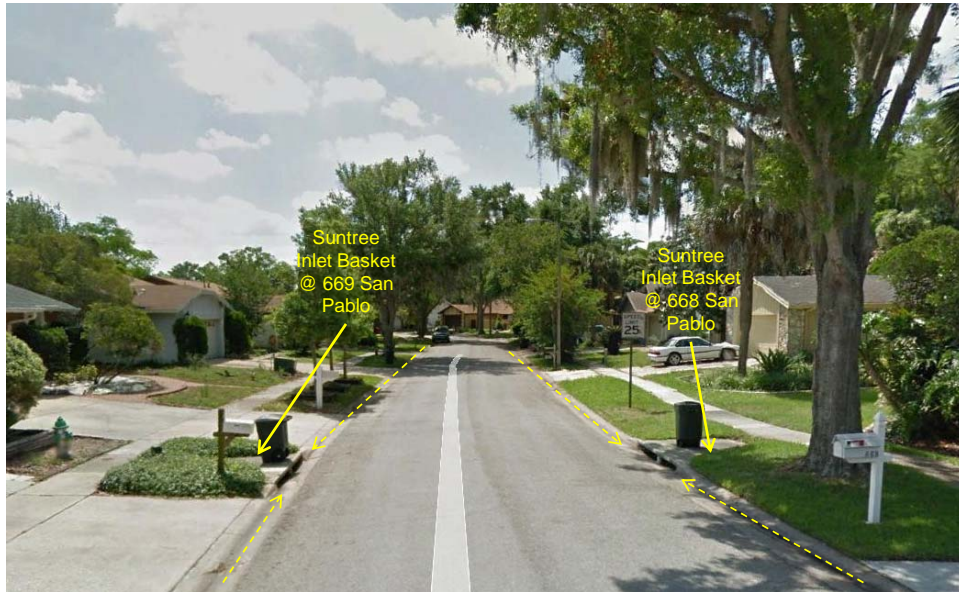
Figure 2-22. Photograph of the San Pablo Suntree Inlet Basket Site.

Three Suntree inlet baskets were installed along San Pablo Avenue, with two installed in sub-basin H-4 and one installed in sub-basin H-3 (see Section 2.2.2.2). An overview of drainage patterns in the vicinity of the San Pablo Suntree inlet basket sites in sub-basin H-4 is given on Figure 2-22. Runoff is conveyed to each of the inlet basket inserts by overland flow through the existing curb and gutter system. The runoff is collected in curb inlets located on the north and south sides of San Pablo Avenue, with separate inlet baskets located in each of the two structures. Photographs of the inlet basket units are given on Figure 2-23. Construction drawings for the Suntree inlet baskets are given in Appendix B.2.

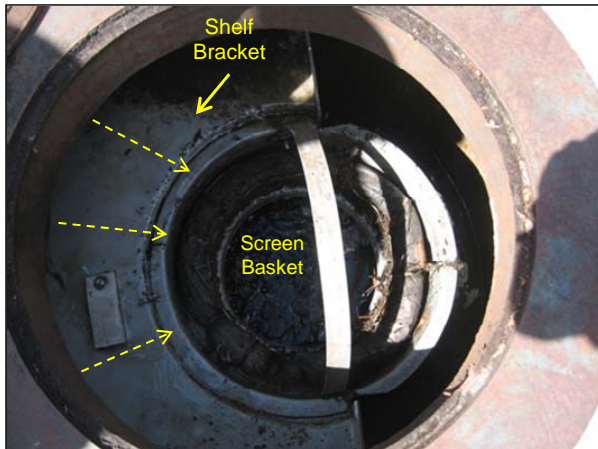
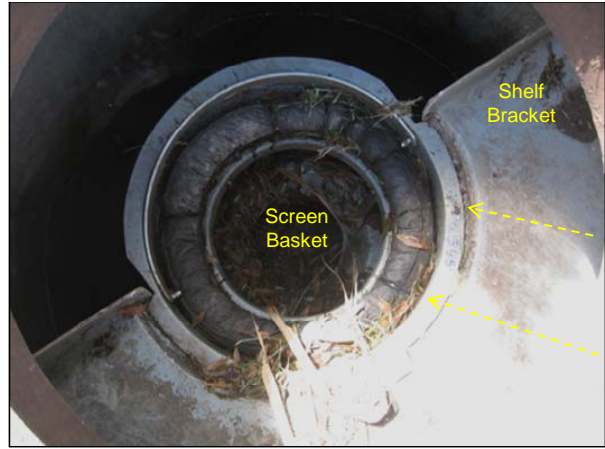
a. Interior of the 668 San Pablo inlet basket

b. Interior of the 669 San Pablo inlet basket

Figure 2-23. Photographs of the San Pablo Inlet Basket Units.

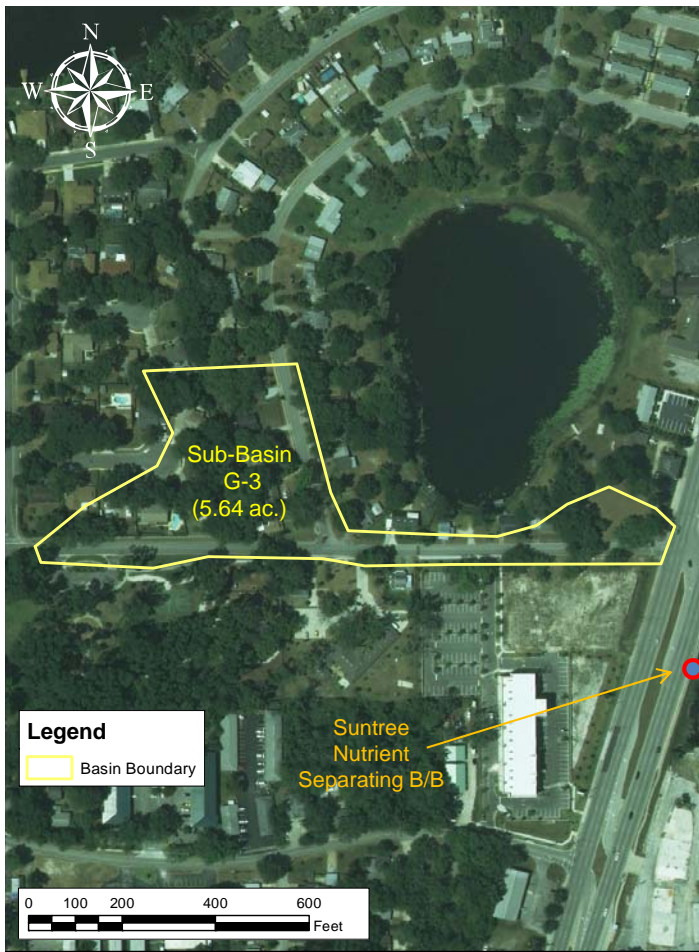
Figure 2-25.
Contributing Watershed
Area for the Lake Concord
Baffle Box Units.

The contributing watershed area for the Lake Concord baffle box is illustrated on Figure 2-25. The watershed area is referred to as sub-basin G-3 and consists of 5.64 acres of single-family residential, commercial, and roadway land uses on the west side of US 17-92. Soils within the sub-basin are well drained and classified in HSG A which implies a relatively low runoff potential for pervious areas within the basin.

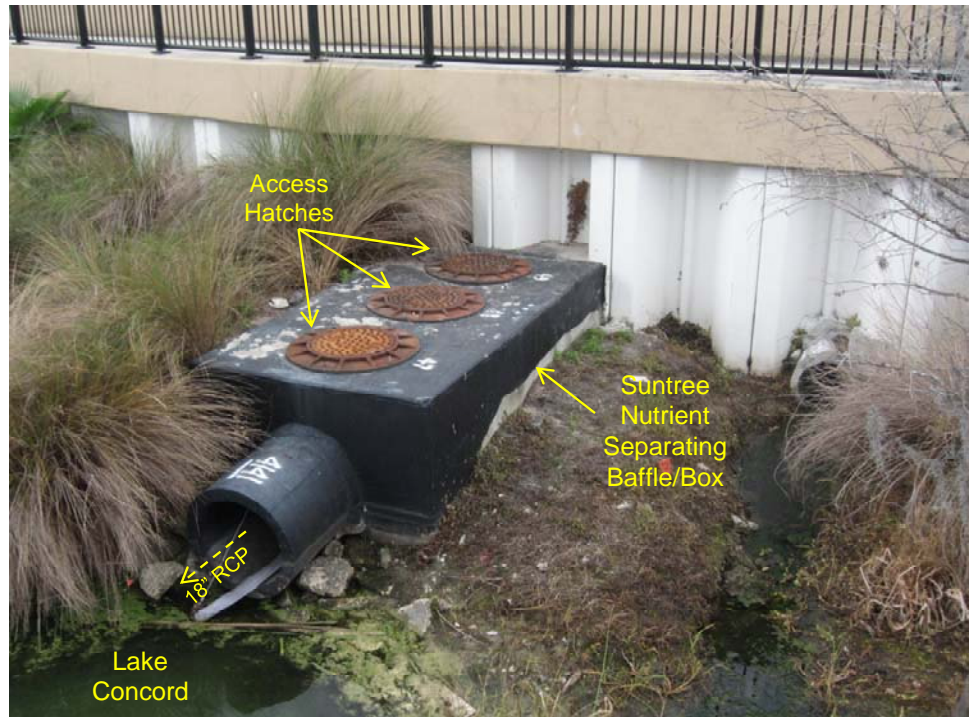
Figure 2-26.
Photograph of the
Outside of the Lake
Concord Baffle
Box Site.

A photograph of the Suntree baffle box unit is given on Figure 2-26. The unit contains three separate manhole covers which can be removed to provide access into interior portions of the baffle box unit during cleaning operations. Construction drawings for the Lake Concord baffle box unit are provided in Appendix B.4.

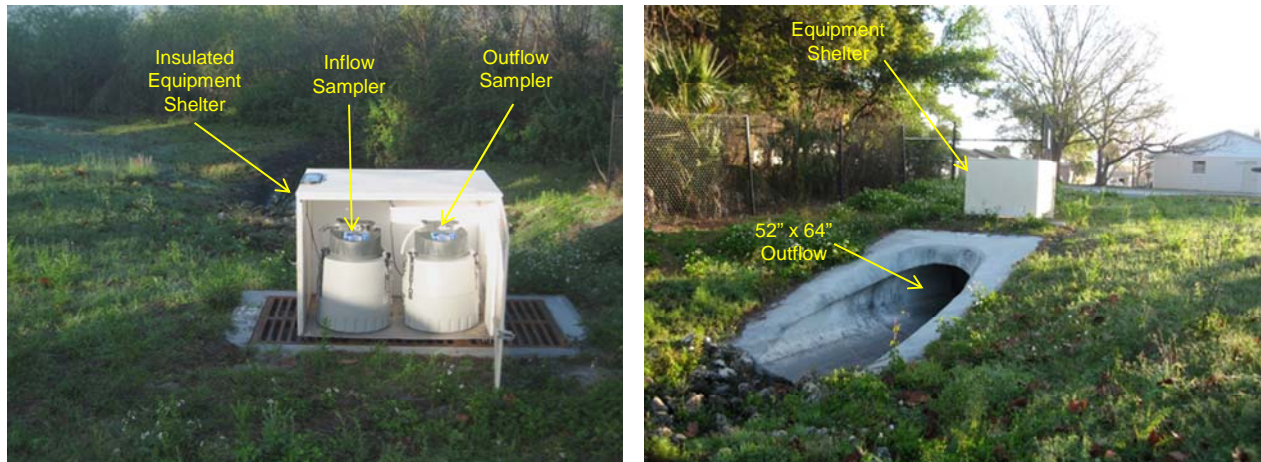
Figure 3-2. Overview of Sampling Equipment Installed at the Lake Hodge Site.

Each of the automatic samplers was housed inside a single insulated aluminum equipment shelter which was installed on the top of the downstream grate of the installation. Sensor cables and sample tubing were run through the open grate beneath the equipment shelter and extended through the stormsewer system to the point of flow measurement or sample collection. An overview of sampling equipment installed at the Lake Hodge site is given on Figure 3-2.

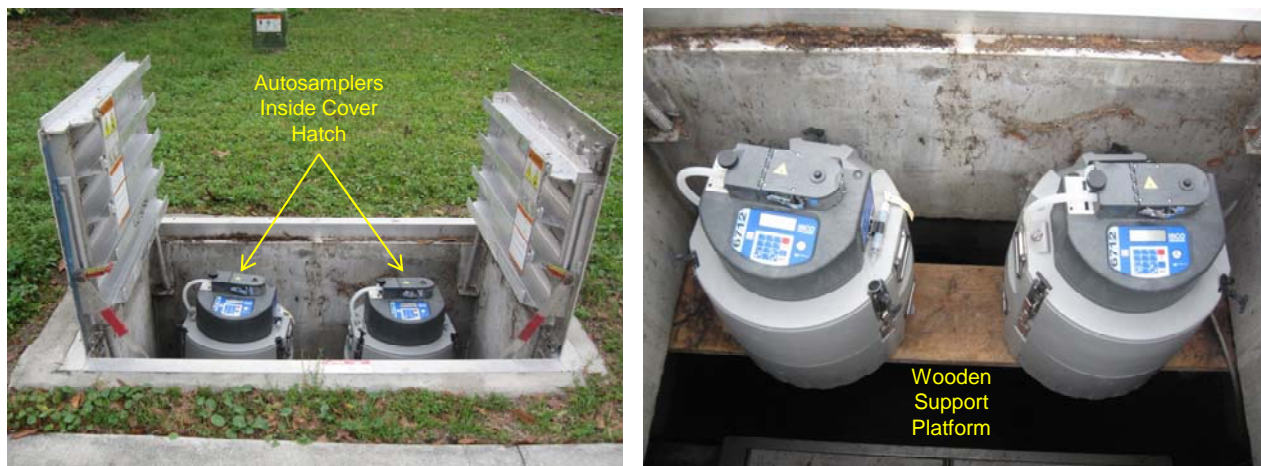
Figure 3-3. Overview of Sampling Equipment Installed at the Gee Creek Site.

Each of the automatic samplers were installed inside the access riser for the EcoVault® unit and supported on a wooden shelf constructed by ERD. The autosamplers were well above the hydraulic flow line within the unit and did not interfere with flow characteristics. Sensor cables and sample tubing were extended from the autosamplers to the points of flow measurement and sample collection. An overview of sampling equipment installed at the Gee Creek site is given on Figure 3-3.

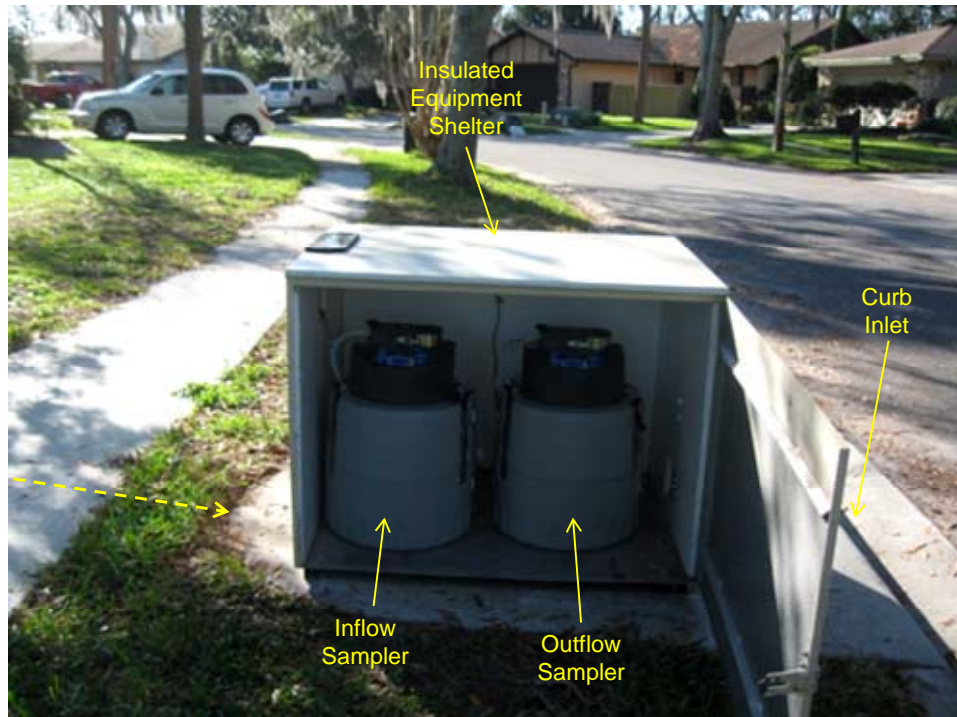
Figure 3-5. Photograph of Sampling Equipment Used at the San Pablo Avenue EcoVault® Site.

Each of the two automatic samplers contained single 5-gallon polyethylene bottles and was programmed to collect samples in a flow-weighted mode during storm events. The autosampler which contained the attached flow module was linked by cable to the other sampler so that a sampling event at the discharge monitoring site would trigger a simultaneous monitoring event at the inflow monitoring site. This process ensured that the inflow and outflow samples are related to runoff characteristics at the time each sample was collected. Each of the automatic samplers was operated on a gel cell battery connected to a solar panel. A photograph of sampling equipment used at the San Pablo Avenue EcoVault® site is given on Figure 3-5.

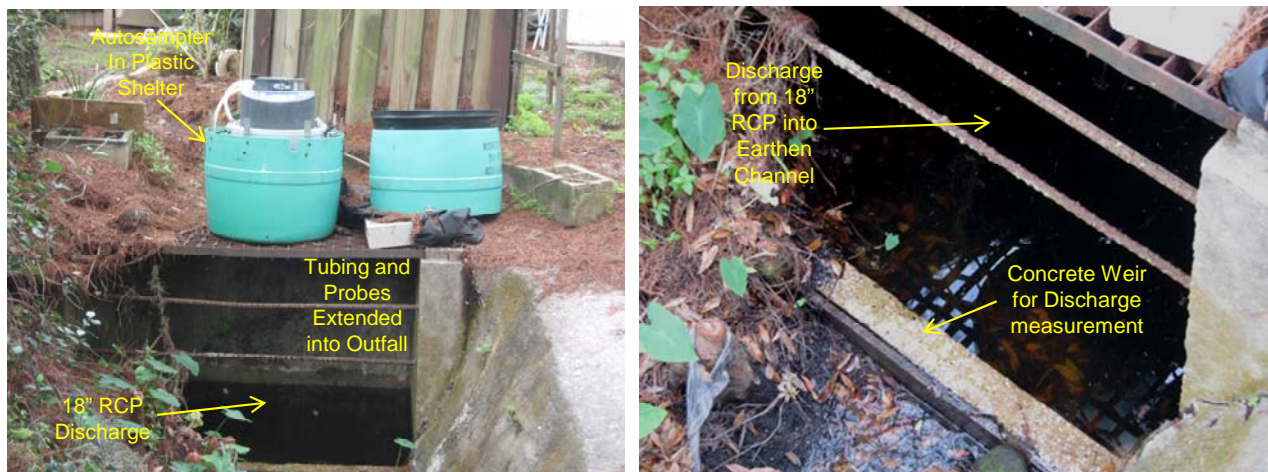
Figure 3-6. Photographs of the Sampling Equipment Used at the San Pablo CDS Unit Site.

The automatic sampler installed at the CDS site contained a single 5-gallon polyethylene bottle and was programmed to collect samples in a flow-weighted mode during storm events. The automatic sampler was operated on a gel cell battery connected to a solar panel. A photograph of the sampling equipment used at the San Pablo CDS unit site is given on Figure 3-6.

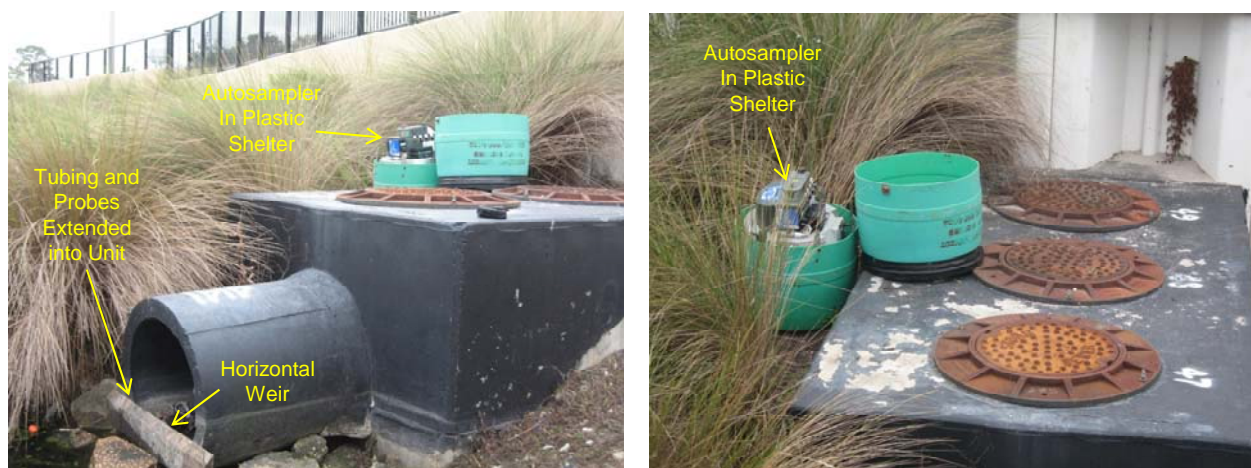
Figure 3-8. Photographs of Sampling Equipment Used at the Lake Concord Suntree Baffle Box Site.

The autosampler installed at the baffle box site contained a single 5-gallon polyethylene bottle and was programmed to collect samples in a flow-weighted mode during storm events. The automatic sampler was operated on a gel cell battery which was replaced during each visit to the site. A photograph of sampling equipment used at the Lake Concord Suntree baffle box unit site is given on Figure 3-8.

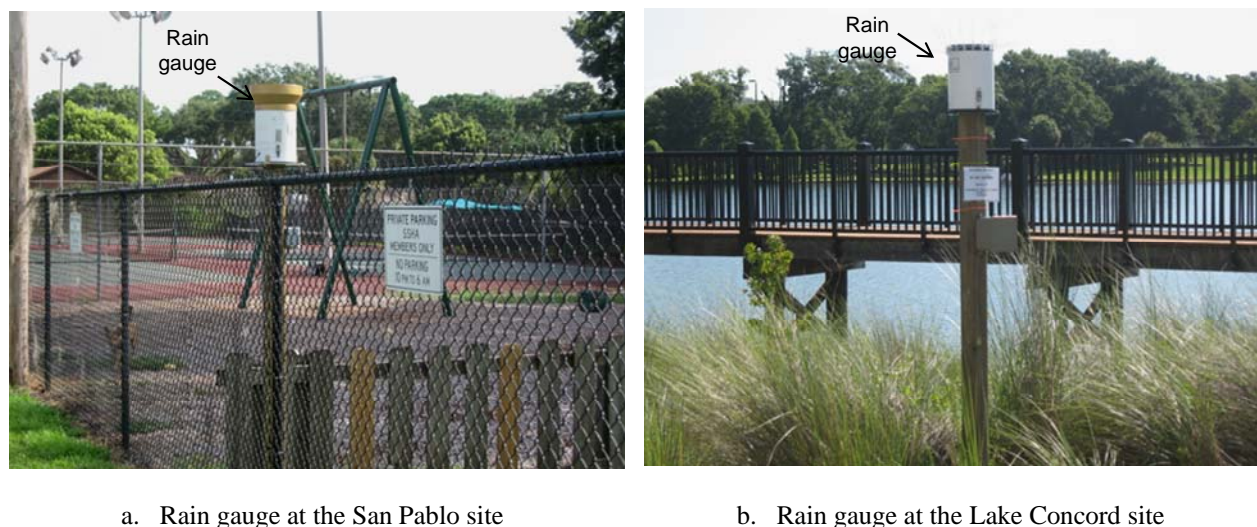
Figure 3-9. Photographs of Rain Gauges Installed at the San Pablo and Lake Concord Sites.

Photographs of rain gauges installed at the San Pablo Avenue and Lake Concord sites are given on Figure 3-9. The rain gauge at the San Pablo site was installed at a neighborhood park on Sausalito Blvd. The rain gauge at the Lake Concord site was installed adjacent to the baffle box unit. Rainfall at the Osceola Trail monitoring sites was monitored using a rain gauge installed at the Lake Hodge EcoVault® site. Each of the rain gauges provided a complete record of rain events which occurred in the vicinity of each of the monitored GPS units during the field monitoring program from June 2013-January 2014.

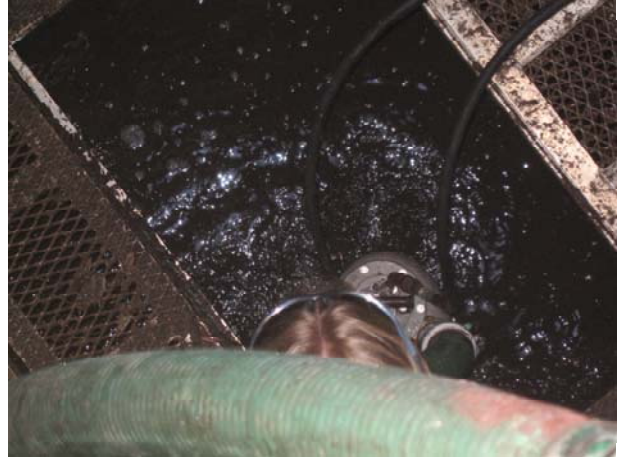
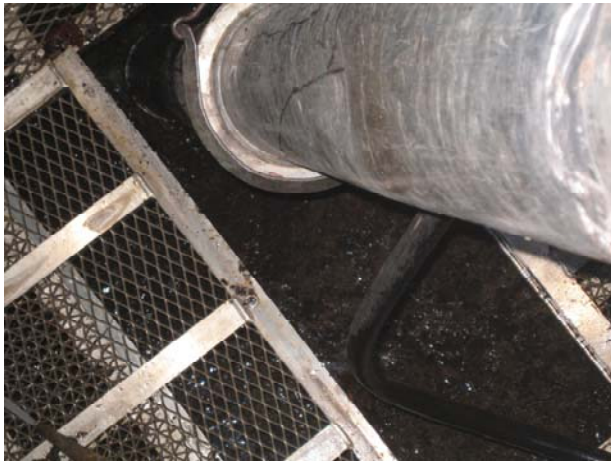
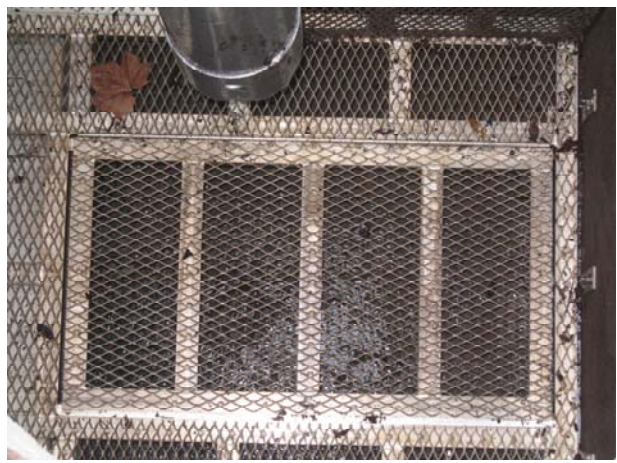
b. Water pumped from sump area

c. Solids removed using vacuum truck

d. Screen following cleaning

Figure 3-10. Clean-out Operations for the Lake Hodge EcoVault® Unit.

Photographs of clean-out operations for the Lake Hodge EcoVault® unit are illustrated on Figure 3-10. At the time of each of the clean-out events, the screen platform contained a large amount of leaves, vegetation, and other debris. This material was removed from the top of the unit using the vactor truck. Next, standing water was pumped from the sump area using a hydraulic pump. The hinged screens were then opened, allowing access to the lower sump areas for solids removal using the vactor truck. At the completion of the cleaning, virtually all of the solids had been removed from the screen platform and the lower sump area.

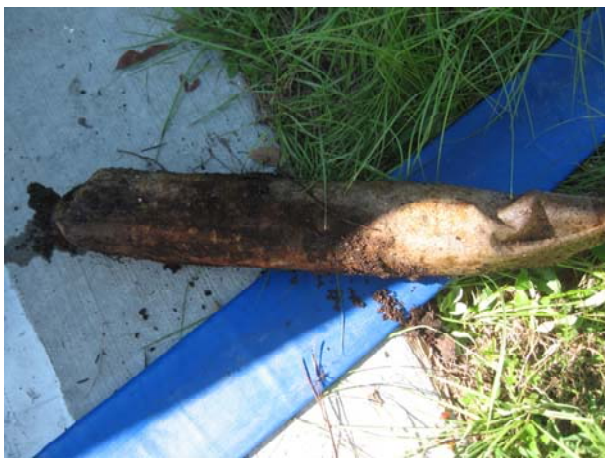
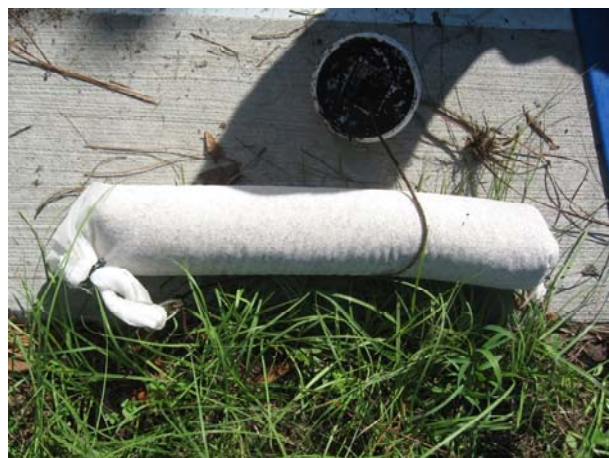
a. Exhausted Vault-Ox® insert removed from canister

b. New Vault-Ox® insert

Figure 3-11. Photographs of Exhausted and New Vault-Ox® Inserts.

The Lake Hodge EcoVault® unit contained multiple Vault-Ox® inserts which were also replaced during each clean-out operation. The inserts were replaced by opening the top of the PVC holder, removing the sock-type cartridge from the unit, and replacing with a new Vault-Ox® insert. Photographs of an exhausted Vault-Ox® insert removed from a canister at the Lake Hodge EcoVault® site is shown on Figure 3-11a, along with a new Vault-Ox® insert illustrated on Figure 3-11b.

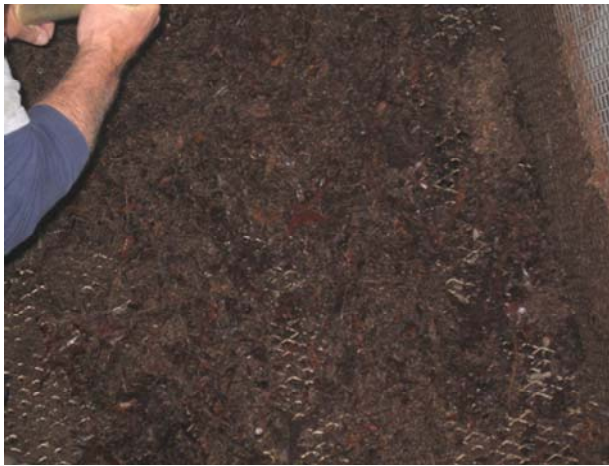
a. Accumulated vegetation on the screens

Photographs of clean-out operations at the Gee Creek EcoVault® site are given on Figure 3-12. In general, clean-out operations at the Gee Creek EcoVault® site were similar to those conducted at the Lake Hodge EcoVault® site. As indicated on Figure 3-12a, a large amount of accumulated vegetation was found on the top of the bottom screens. This material was removed using the vactor truck, and the screens were opened to expose the lower sump area. The standing water was pumped from the sump area, and the solids were removed using a vactor truck. A photograph of the Gee Creek screening system following cleaning is illustrated on Figure 3-12d. The Gee Creek unit also contained multiple Vault-Ox® inserts which were replaced at the time of each clean-out operation.

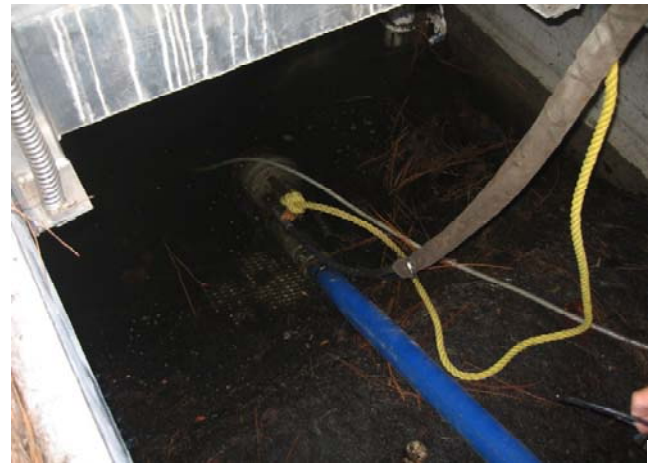
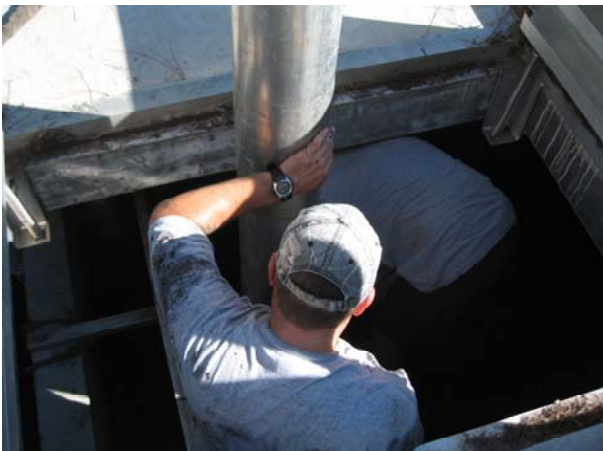
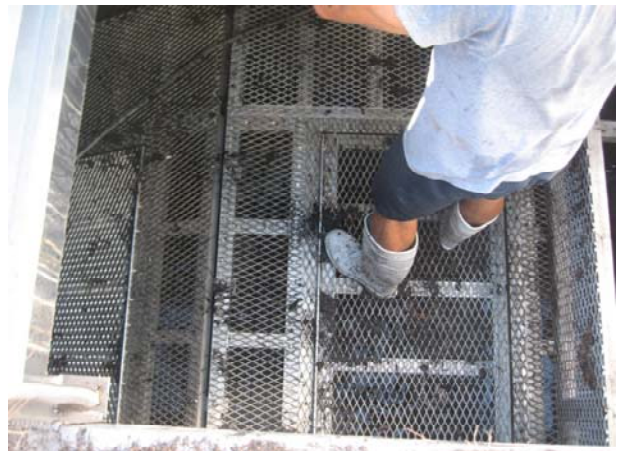
b. Standing water is pumped from the sump area

c. Solids removed from screen using vactor truck

d. Screening following cleaning

Figure 3-12. Clean-Out Operations for the Gee Creek EcoVault® Site.

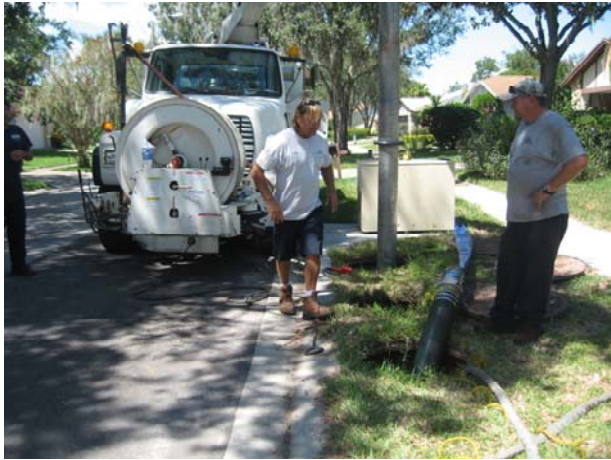
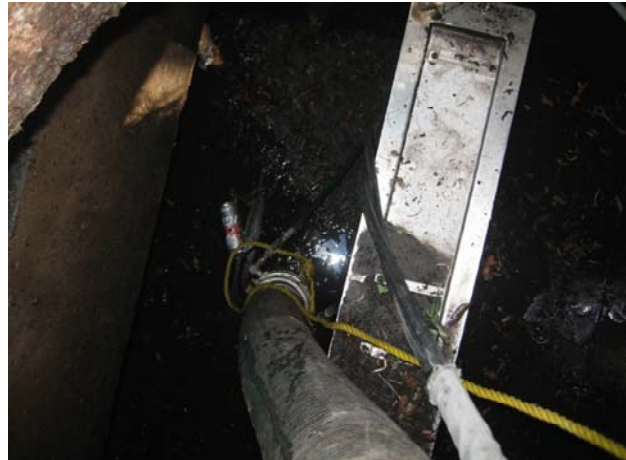
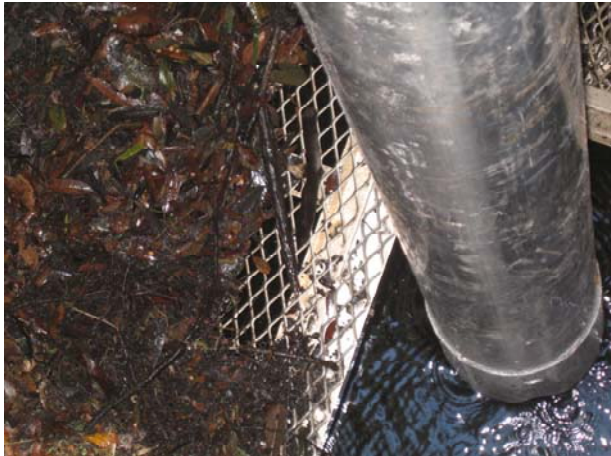
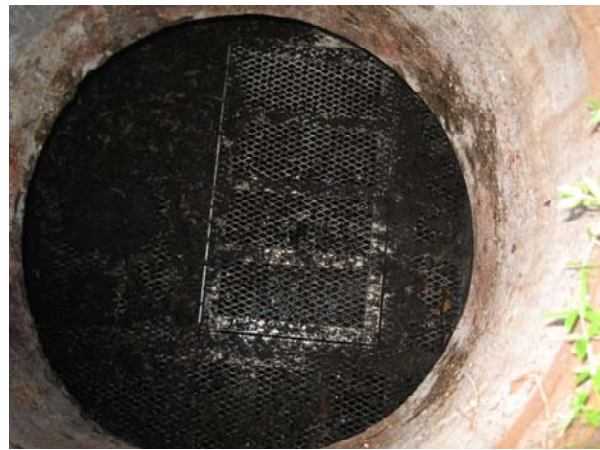
a. Clean-out operations

b. Standing water pumped from bottom chambers

c. Solids vacuumed from chambers

d. Screens following cleaning

Figure 3-13. Clean-out Operations for the San Pablo EcoVault® Unit.

Photographs of clean-out operations for the San Pablo EcoVault® baffle box site are illustrated on Figure 3-13. Access to this system was obtained through a series of manhole covers rather than the larger hatches associated with the Lake Hodge and Gee Creek Vault-Ox® units. Standing water was pumped from the bottom chambers, and solids were vacuumed from the bottom screen and sump areas. A photograph of the screen structure following cleaning is given on Figure 3-13d.

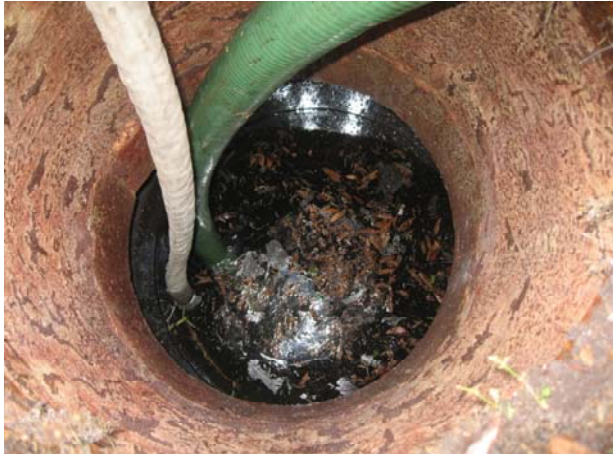
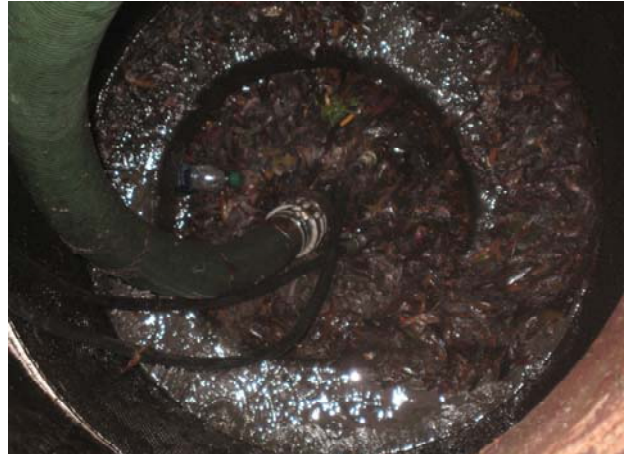
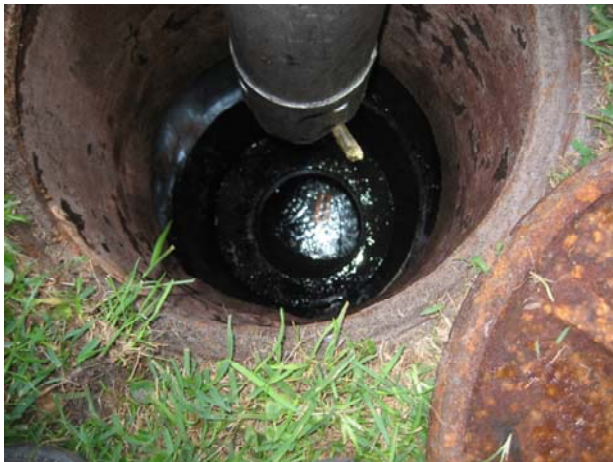
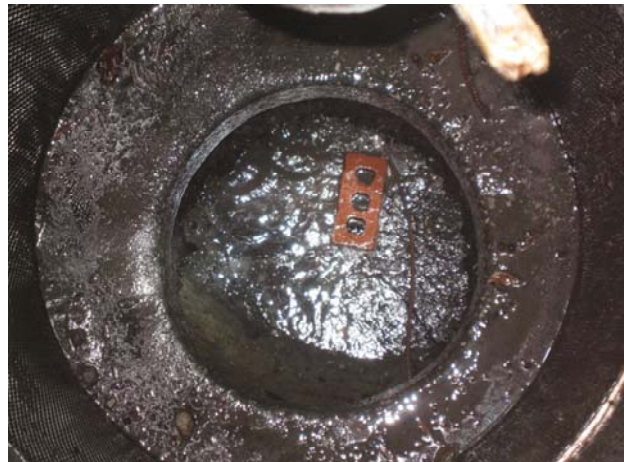
a. Interior of CDS unit prior to cleaning

b. Standing water is pumped from the unit

c. Sump area cleaned using vactor truck

d. Sump area of CDS unit following cleaning

Figure 3-14. Clean-Out Operations for San Pablo CDS Unit.

Photographs of clean-out operations for the San Pablo CDS unit are illustrated on Figure 3-14. Access into the CDS unit for cleaning is obtained through a circular manhole cover located in the grassed median. Excess water is pumped from the CDS unit, and the central sump area is cleaned using the vactor truck. A photograph of the sump area of the CDS unit following the cleaning process is given on Figure 3-14d.

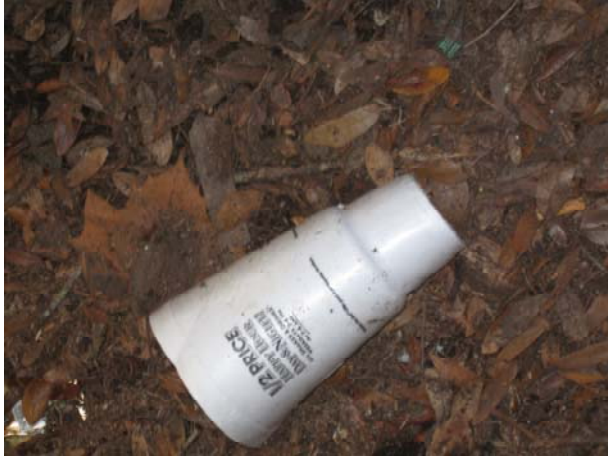
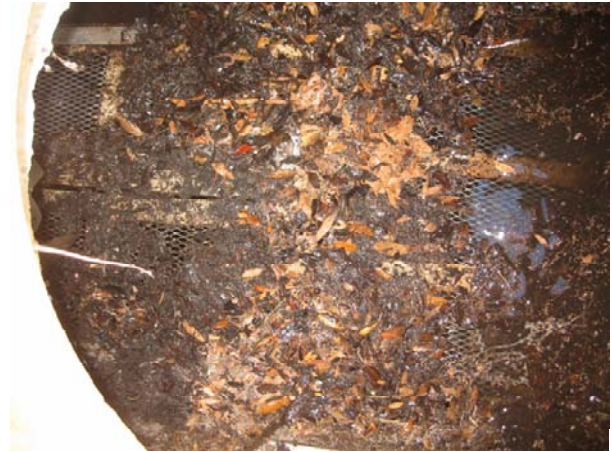
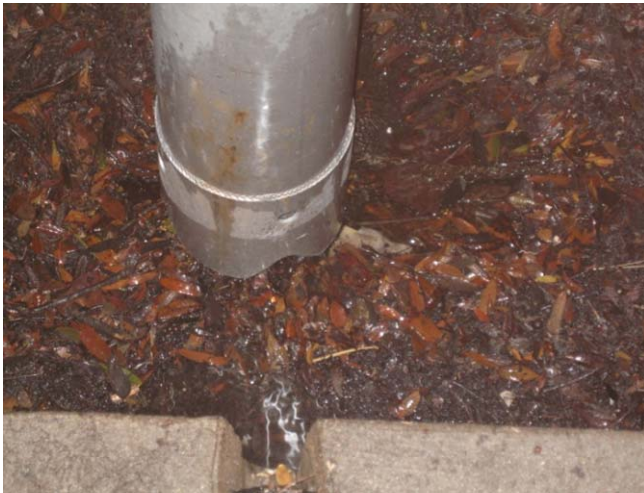
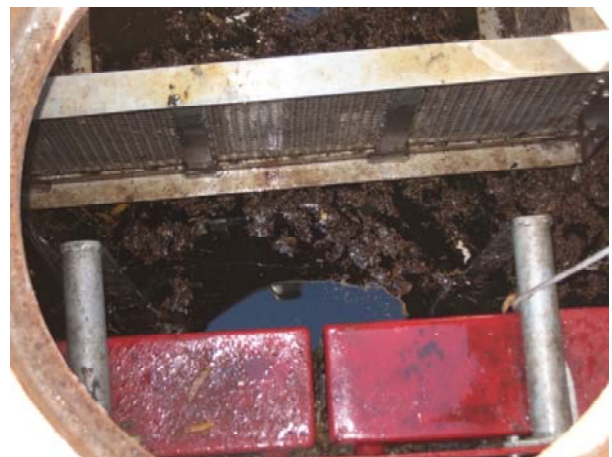
a. Accumulated solids and debris

b. Vegetation screen prior to cleaning

c. Solids removed from screen using vector truck

d. Baffle box unit following cleaning

Figure 3-15. Clean-Out Operations for the Lake Concord Baffle Box Unit.

Photographs of clean-out operations for the Lake Concord baffle box unit are given on Figure 3-15. This unit was cleaned in a manner similar to the EcoVault® units discussed previously. Trapped leaves were first vacuumed from the screen structures, and the screens were opened to expose the bottom sump areas which were also cleaned using the vector truck.

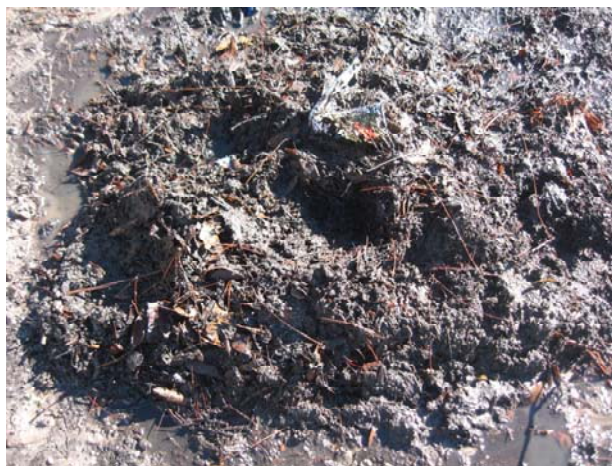
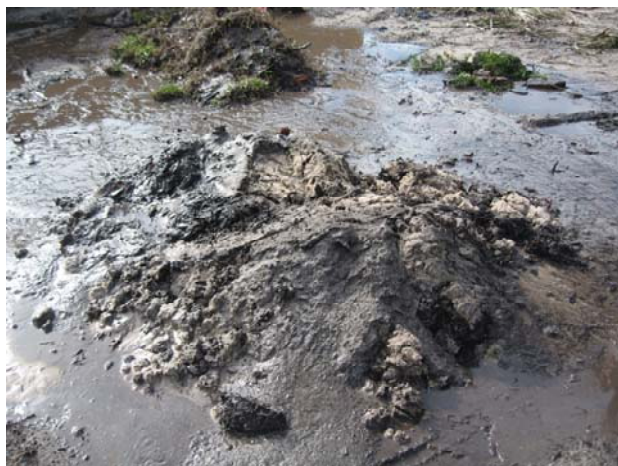
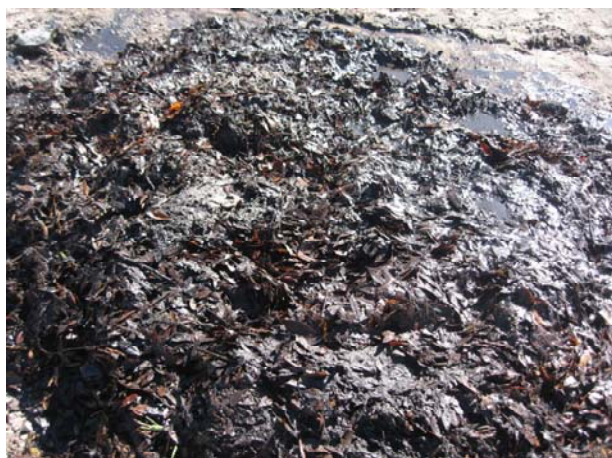
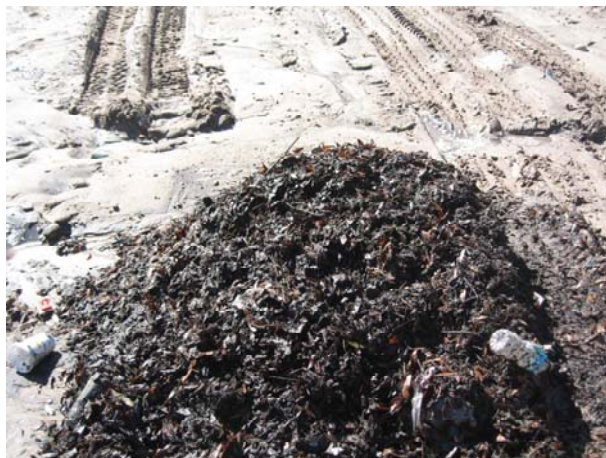
a. Material removed from the Lake Hodge baffle box

b. Material removed from the Gee Creek baffle box

c. Material removed from the San Pablo baffle box

d. Material removed from the Lake Concord baffle box

Figure 3-16. Photographs of Solids Removed from the Baffle Box Units.

Cleaning operations for each of the units were conducted individually such that the vector truck contained only the solids removed from a specific unit. The material was then transported to a City-owned yard where the contents of the vector truck were emptied onto the ground. Photographs of solids removed from the Lake Hodge baffle box, Gee Creek baffle box, San Pablo baffle box, and Lake Concord baffle box units are illustrated on Figure 3-16. Material removed from the units appears to consist primarily of vegetation and fine sand. A photograph of material removed from the San Pablo CDS unit is given on Figure 3-17 and appears to be visually similar to debris removed from the other units.

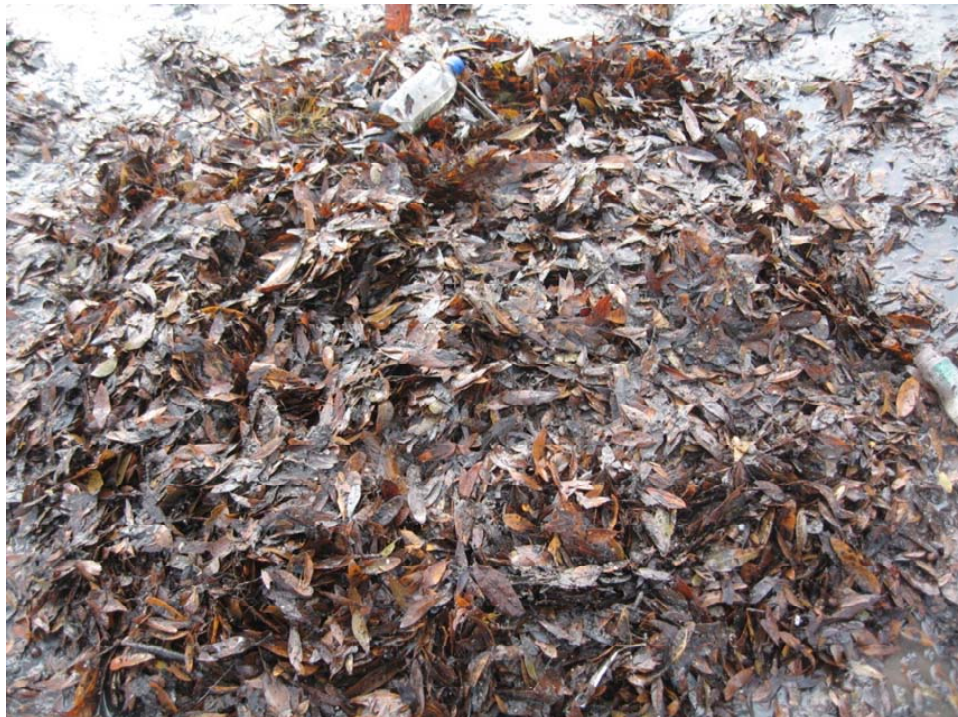
Figure 3-17. Photograph of Solids Removed from the CDS Unit.

After the contents of the vacor truck were deposited in the yard, a period of approximately one hour was allowed for the free water to drain from the solids. The solid material was then formed into a rectangular shape so that the dimensions could be measured relatively accurately and the volume of material removed could be calculated. This process was repeated for clean-out operations conducted during September 2013 as well as January 2014 to provide estimates of the total volume of material removed from each of the units during the field monitoring program.

After start-up of the field monitoring program, each of the five monitored GPS units were cleaned on two separate occasions, with one clean-out operation near the mid-point of the field monitoring program and the final at the completion of the field monitoring program. The collected solids from each of the units were transported to a City maintenance facility and deposited. The volume of the material removed was estimated by ERD, and a well-mixed sub-sample of the solid material was collected and returned to the ERD Laboratory for physical and chemical characterization. Photographs of solids collected from each of the five GPS units are given on Figures 3-16 and 3-17.

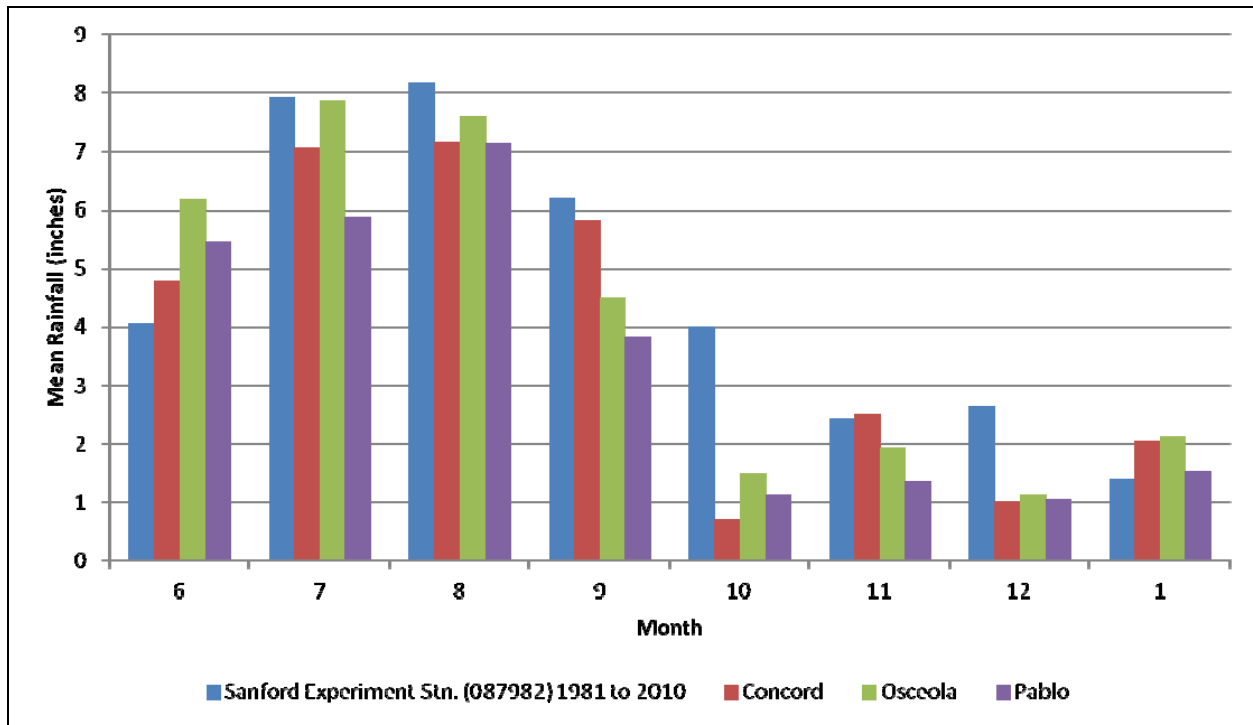
Figure 4-1. Comparison of “Average” and Measured Rainfall in the Vicinity of the GPS Monitoring Sites.

A comparison of measured and typical “normal” rainfall in the vicinity of the Casselberry GPS units is given in Figure 4-1. Measured rainfall in this figure is based upon the field measured rain events at each of the three rainfall recording sites, summarized on a monthly basis. “Normal” rainfall conditions are based upon historical rainfall recorded at the Sanford Experimental Station (Site 087982) over the 30-year period from 1981-2010. Comparisons for rainfall during the months of June 2013 and January 2014 for both the measured and “normal” data sets reflect only partial months, with the values for June reflecting measured and typical rainfall characteristics from June 15-30, 2013 and the January values reflecting measured and “normal” rainfall characteristics over the period from January 1-15, 2014.

As seen in Figure 4-1, measured rainfall in the vicinity of the GPS monitoring sites was approximately normal only during the month of August. Slightly higher than “normal” rainfall was observed at the GPS monitoring sites during June and January, with lower than “normal” rainfall observed during the remaining months. Overall, “normal” rainfall in the general area during the field monitoring program is approximately 36.78 inches, compared with measured rainfall amounts of 31.09 inches at the Lake Concord site, 32.82 inches at the Osceola Trail sites, and 27.38 inches at the San Pablo Avenue monitoring sites. Overall, rainfall was somewhat less than “normal” at each of the monitoring sites during the field monitoring program.

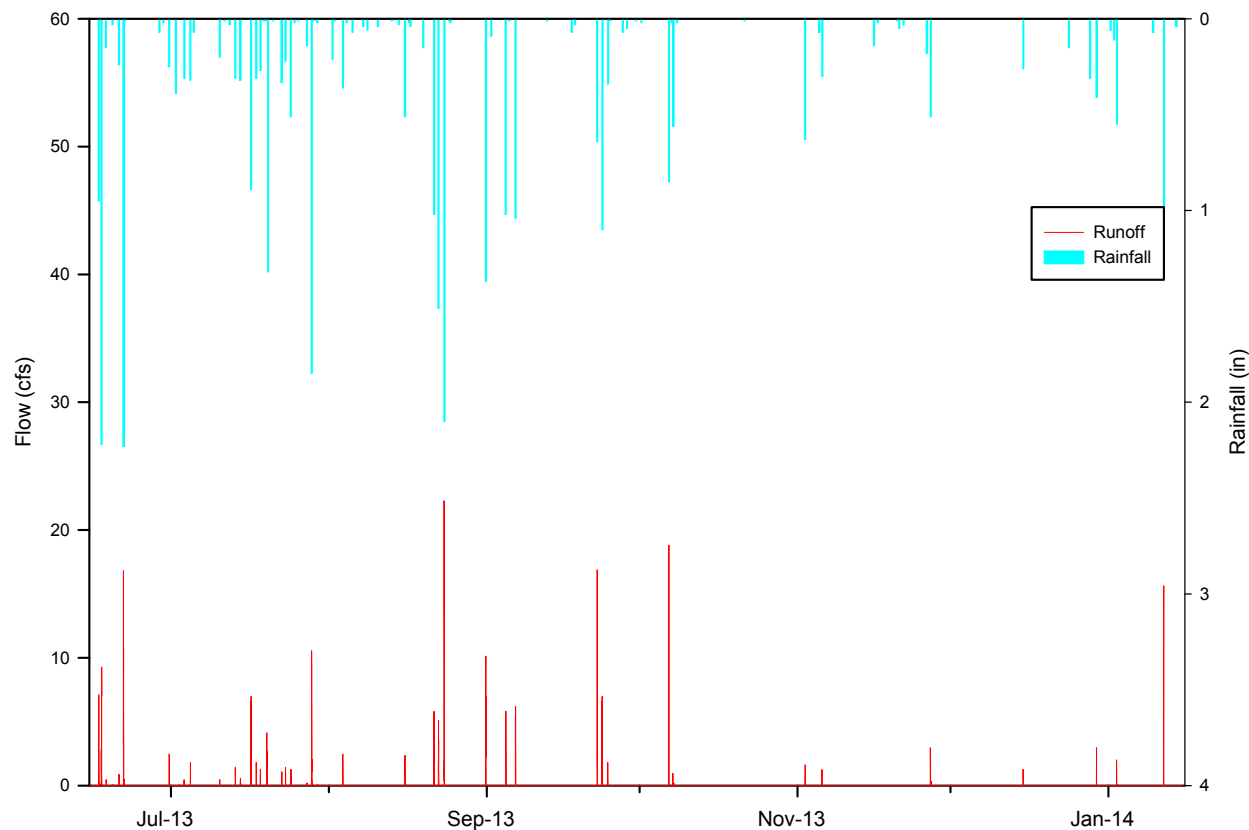
Figure 4-2. Measured Runoff Hydrographs at the Lake Hodge EcoVault® Site from June 15, 2013-January 15, 2014.

A graphical summary of measured runoff hydrographs at the Lake Hodge EcoVault® site from June 15, 2013-January 15, 2014 is given on Figure 4-2. Monitored rain events are also included for evaluation of relationships between rainfall and runoff. Measured discharge rates at the Lake Hodge site ranged from approximately 0-22 cfs, with the vast majority of monitored runoff rates less than approximately 10 cfs. The highest runoff inflow rates were observed from rain events in excess of 2 inches or from multiple significant rain events occurring on sequential days. In general, peak flows measured during storm events appear to be closely related to the depth of the rainfall event. Rainfall events of approximately 0.25 inches or less resulted in relatively insignificant runoff inflow rates.
