Baffle Box with Media Filtration Installation,
Effectiveness Evaluation, and Associated Education for
the Lake Jesup Watershed

Contract S0497

Final Report

City of Casselberry

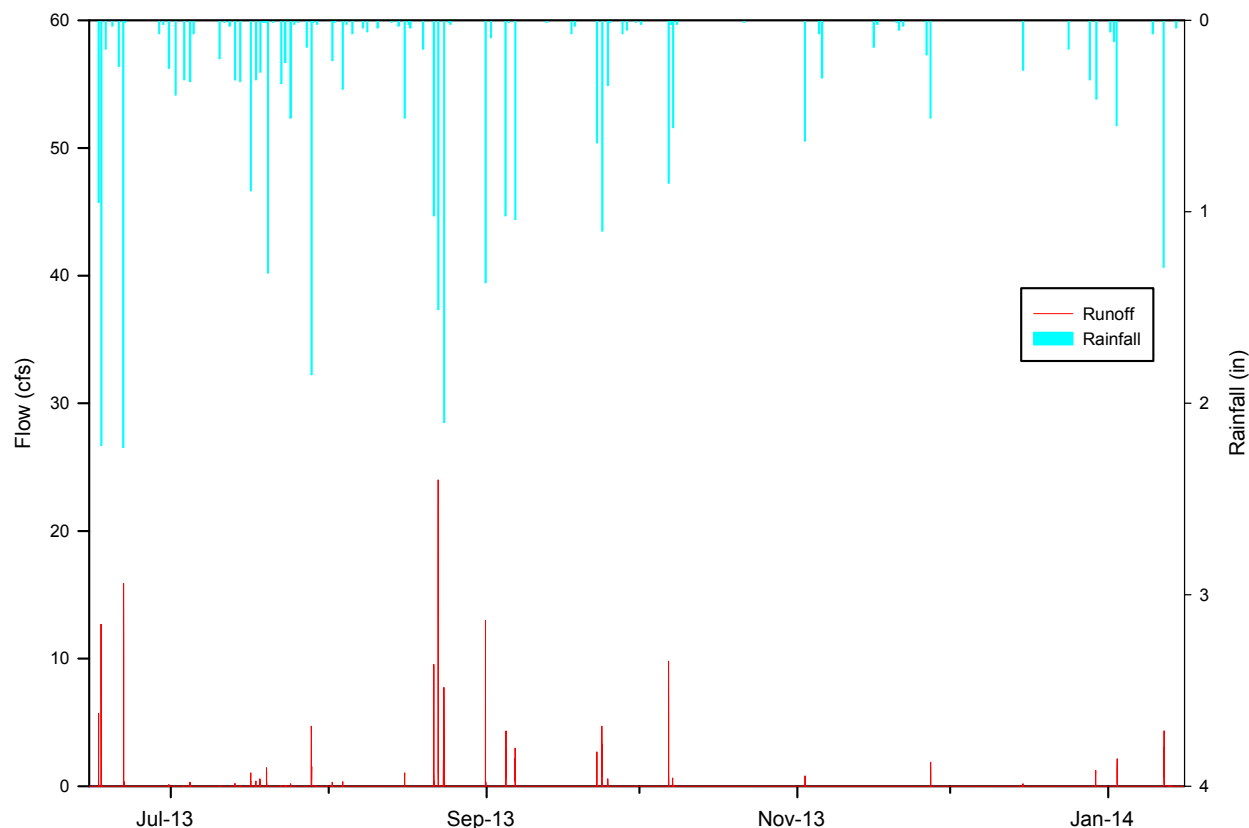
A graphical summary of measured runoff hydrographs at the Gee Creek EcoVault® site from June 15, 2013-January 15, 2014 is given on Figure 4-3. Rain events at the monitoring site are also included for evaluation of relationships between rainfall and runoff. Measured discharge rates at the Gee Creek EcoVault® site ranged from 0 cfs to approximately 23 cfs, although the vast majority of peak runoff values were less than 10 cfs. Runoff inflow rates in excess of 10 cfs were typically generated by rain events in excess of 2 inches or multiple smaller rain events occurring over consecutive days. Rain events less than approximately 0.25 inches resulted in relatively insignificant runoff inputs. Peak flows measured during storm events appear to be closely related to the depth of the rainfall event.

Figure 4-3. Measured Runoff Hydrographs at the Gee Creek EcoVault® Site from June 15, 2013-January 15, 2014.

A tabular summary of measured monthly runoff inputs to the Gee Creek EcoVault® unit is given in Table 4-7. The runoff inputs summarized in this table were generated by integrating the runoff hydrographs illustrated on Figure 4-3 for each monthly monitoring period. Measured runoff inputs ranged from a high of 2.65 ac-ft during August to a low of 0.06 ac-ft during December. Overall, approximately 6.56 ac-ft of runoff discharged through the Gee Creek EcoVault® unit during the field monitoring program.

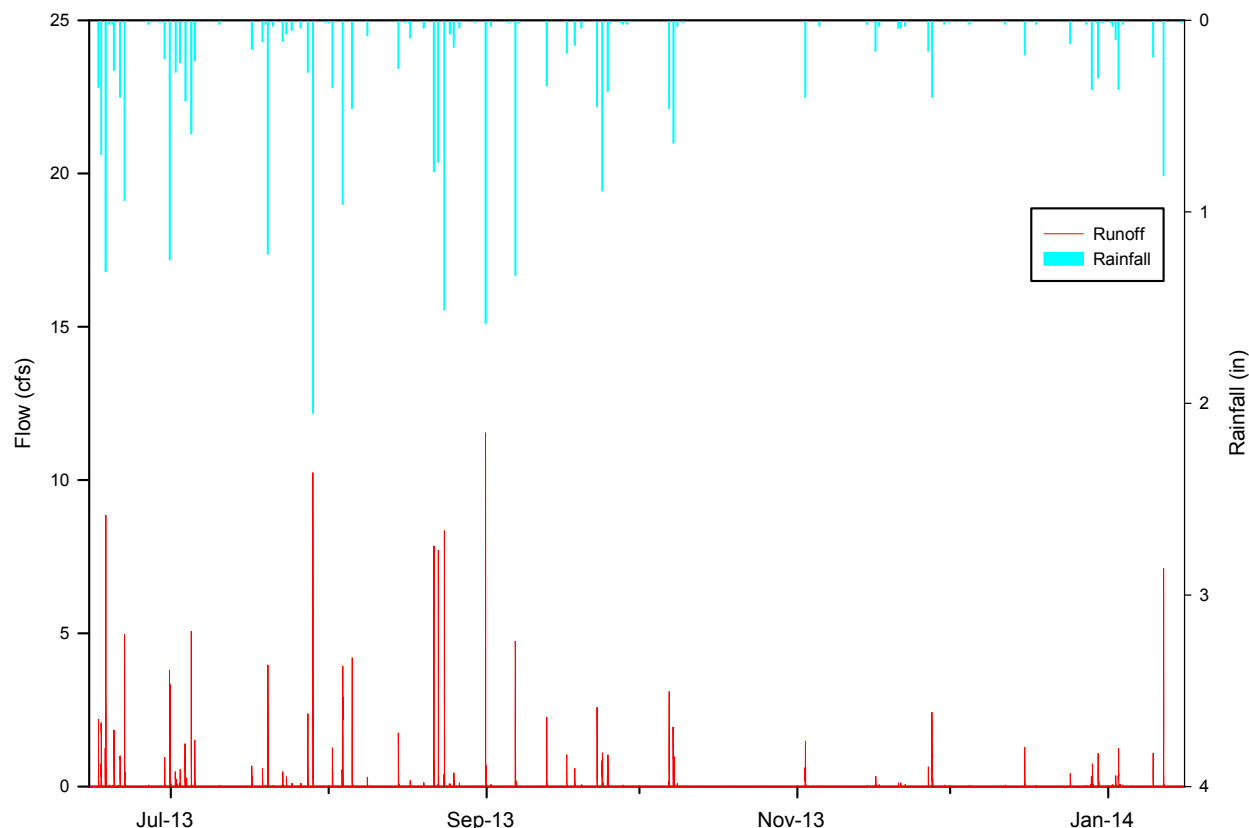
A graphical summary of measured runoff hydrographs at the San Pablo EcoVault® site from June 15, 2013-January 15, 2014 is given on Figure 4-4. Rainfall depths for measured rain events at the monitoring site are also included for evaluation of relationships between rainfall and runoff. Measured discharge rates at the EcoVault® monitoring site ranged from approximately 0-12 cfs, although the vast majority of measured peak discharge values were less than 5 cfs. Runoff peaks in excess of 5 cfs generally required rain events in excess of approximately 1-1.5 inches or a series of multiple significant rain events on consecutive days. Relatively insignificant runoff flow rates were generated from rain events of approximately 0.1 inch or less. In general, peak flow rates measured during storm events appear to be closely related to the depth of the rainfall event.

Figure 4-4. Measured Runoff Hydrographs at the San Pablo EcoVault® Site from June 15, 2013-January 15, 2014.

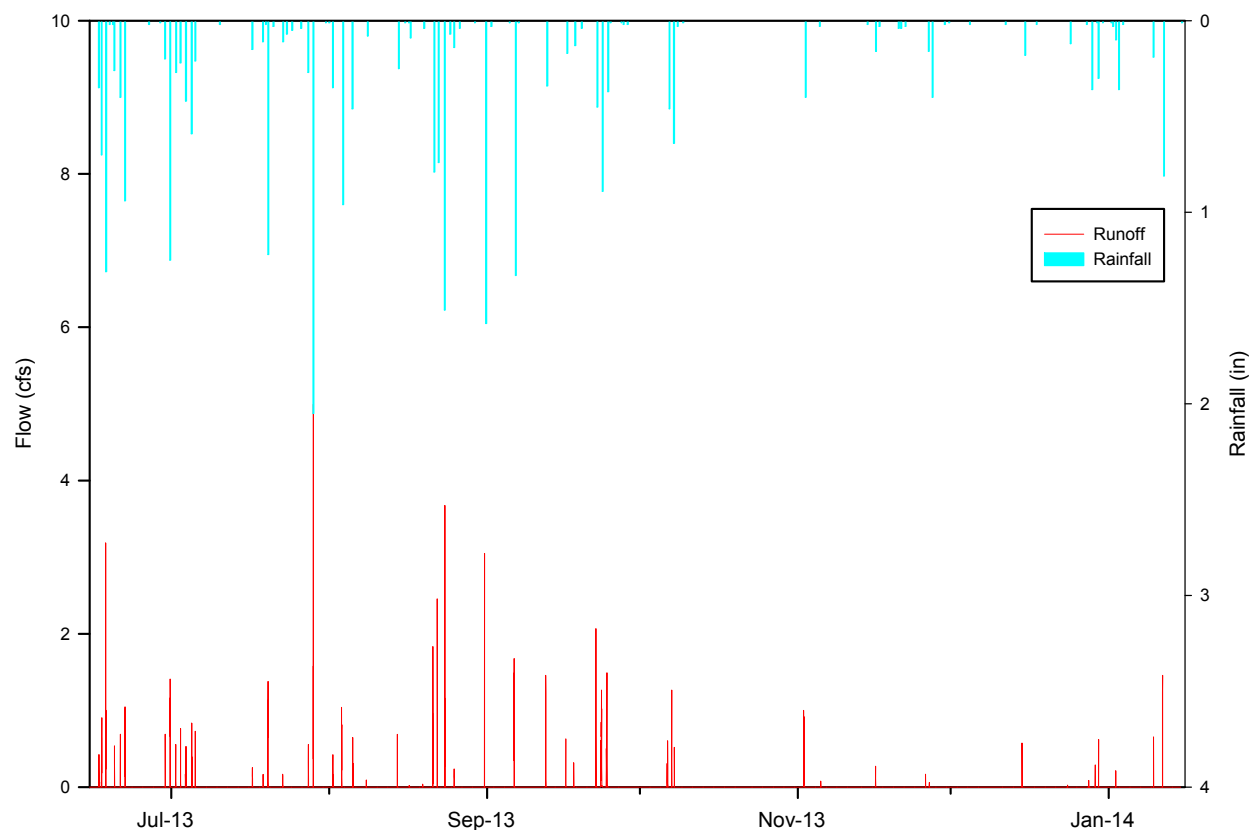
Figure 4-5. Measured Runoff Hydrographs at the San Pablo CDS Site from June 15, 2013- January 15, 2014.

A graphical summary of measured runoff hydrographs at the San Pablo CDS site from June 15, 2013-January 15, 2014 is given on Figure 4-5. Rainfall depths for measured events at the monitoring site are also included for evaluation of relationships between rainfall and runoff. Measured discharge rates at the CDS unit monitoring site ranged from approximately 0-5 cfs, with the majority of peak runoff inflows less than approximately 2 cfs. Relatively insignificant runoff inflow rates were generated from rain events of approximately 0.1 inch or less. The observed peak flows measured during storm events appear to be closely related to the depth of the rainfall event.

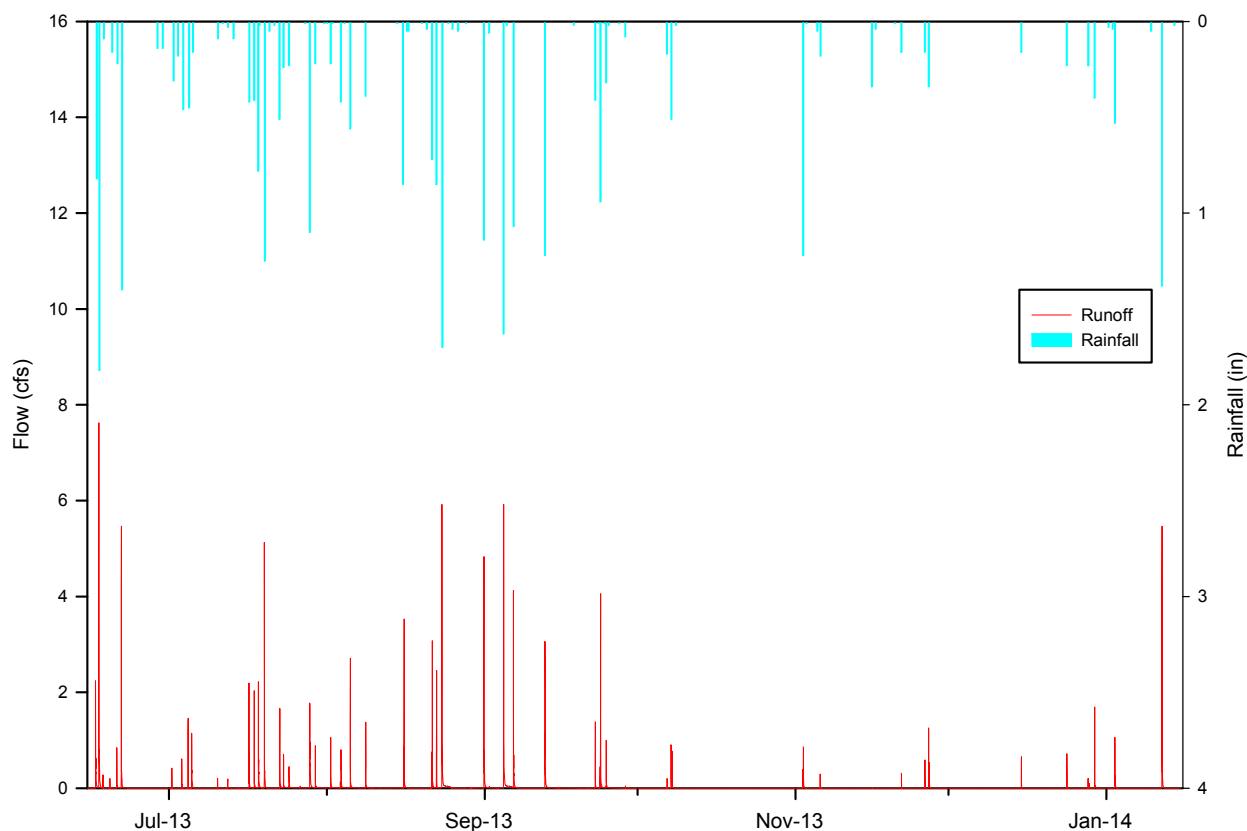
A graphical summary of measured runoff hydrographs at the Lake Concord Suntree baffle box site from June 15, 2013-January 15, 2014 is given on Figure 4-6. Rainfall depths for measured rain events at the monitoring site are also included for evaluation of relationships between rainfall and runoff. Measured discharge rates at the Suntree baffle box monitoring site ranged from approximately 0-8 cfs, although the vast majority of measured peak runoff values were less than approximately 3 cfs. Relatively insignificant runoff inflow rates were generated from rain events of approximately 0.1 inch or less. The peak flows measured during storm events appear to be closely related to the depth of the rainfall event.

Figure 4-6. Measured Runoff Hydrographs at the Lake Concord Suntime Baffle Box Site from June 15, 2013-January 15, 2014.

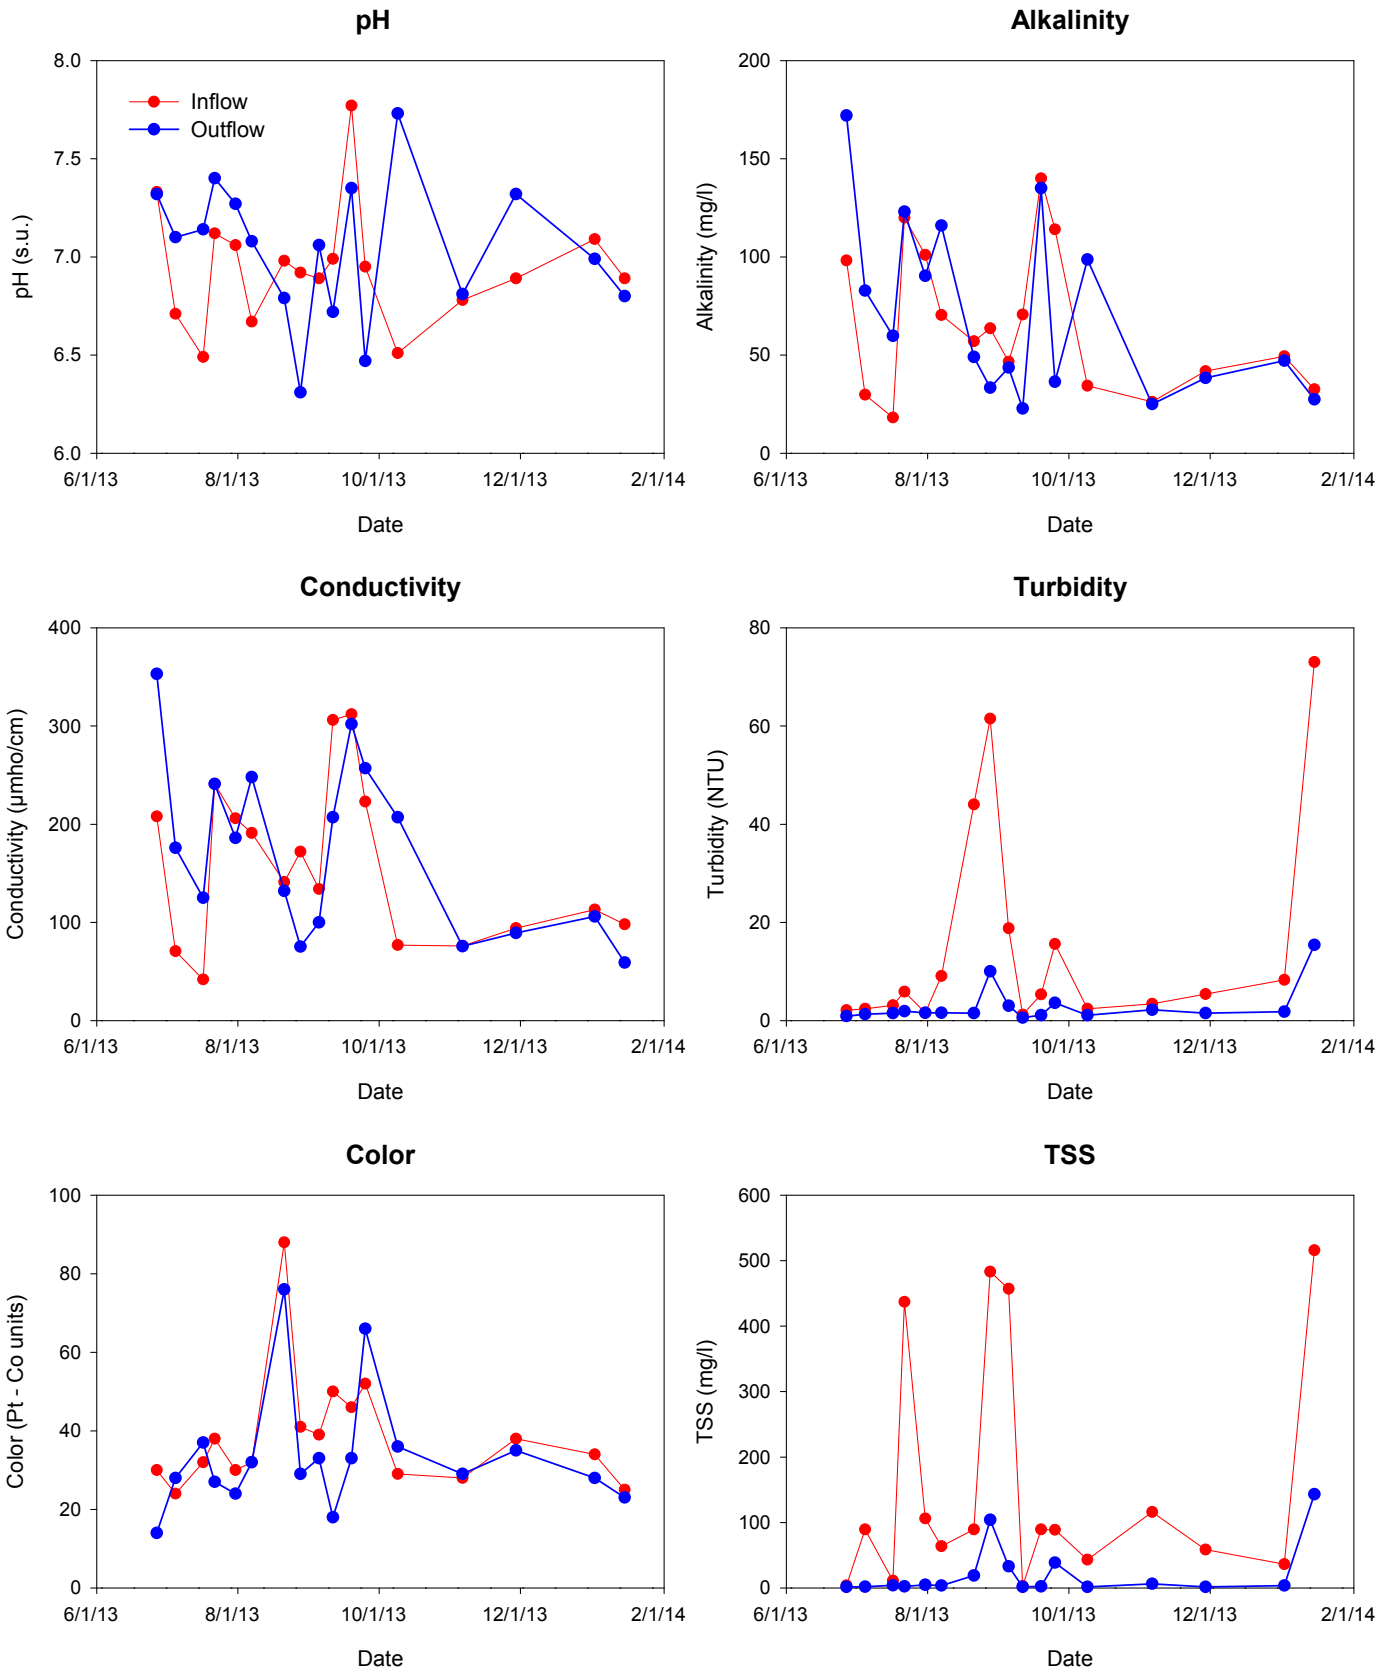
Figure 4-7. Comparison of Inflow and Outflow Concentrations of pH, Alkalinity, Conductivity, Turbidity, Color, and TSS at the Lake Hodge EcoVault® Site.

Measured alkalinity values of the inflow and outflow samples were also highly variable, ranging from approximately 20-75 mg/l during the field monitoring program. With the exception of June 2013, when measured alkalinity values in the outflow samples were substantially higher than alkalinity values measured in the inflow, a relatively close agreement was observed between inflow and outflow alkalinity values during most monitoring events.

Measured conductivity values of the inflow and outflow samples ranged from approximately 30-360 $\mu\text{mho/cm}$ during the field monitoring program. With the exception of inflow and outflow samples collected during July 2013, when conductivity values at the outflow were substantially greater than values measured at the inflow, a relatively close agreement was observed between measured inflow and outflow values for most monitored events.

Unlike the previous trends observed for pH, alkalinity, and conductivity where inflow and outflow concentrations were relatively similar, measured turbidity levels were substantially lower in the outflow samples than the inflow samples during virtually all of the monitoring events. Measured turbidity values of inflows ranged from approximately 1-73 NTU, while turbidity measurements in discharge samples ranged from 0.6-15.4 NTU.

In general, the observed pattern for TSS concentrations is similar to the pattern previously discussed for turbidity. Measured TSS concentrations in the inflow ranged from 2.8-516 mg/l, with TSS concentrations in the discharge ranging from 1.4-143 mg/l. Measured TSS concentrations in discharges from the EcoVault® unit were substantially lower than inflow concentrations during virtually all monitoring events. These data indicate that a large amount of the incoming TSS loading was retained within the system.

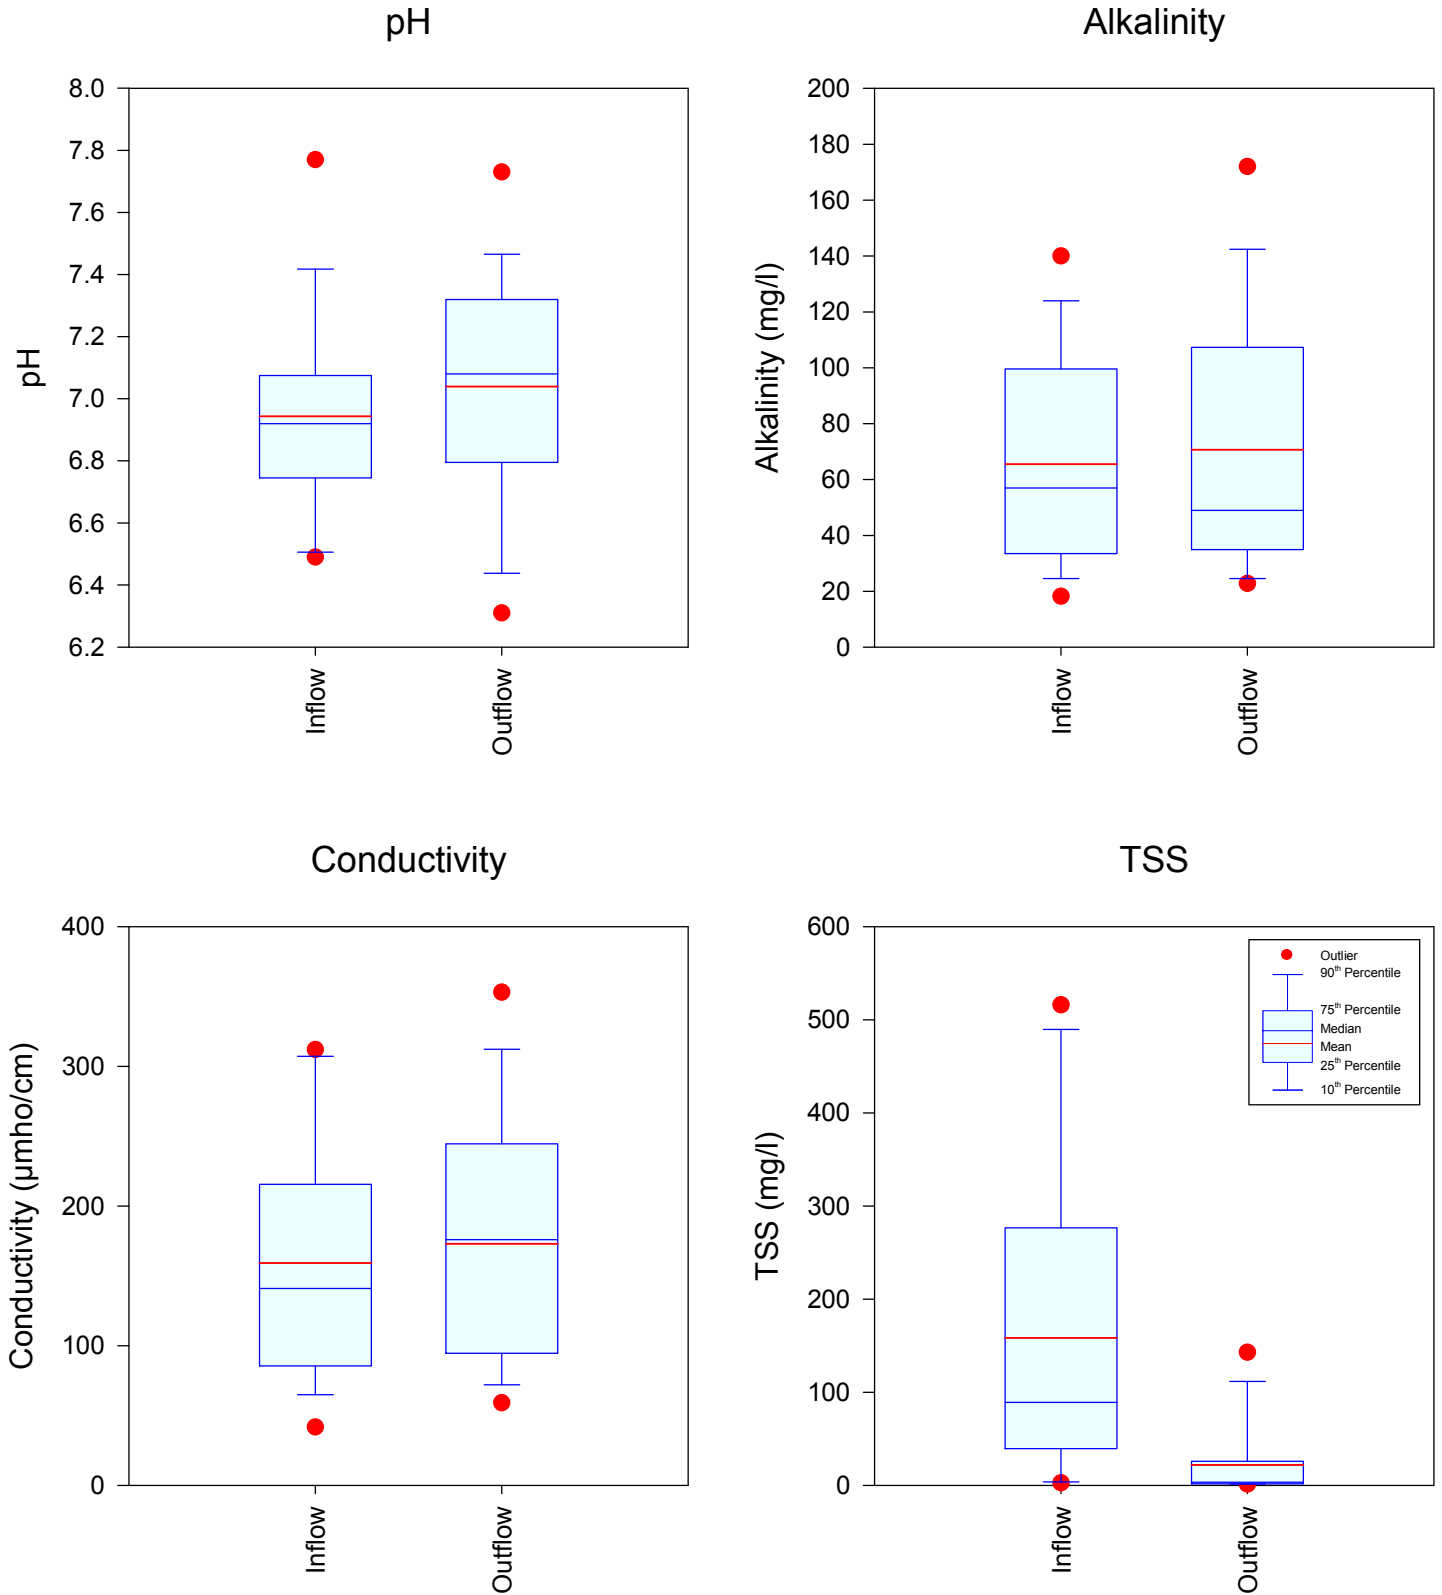
Figure 4-8. Statistical Comparison of Inflow and Outflow Concentrations of pH, Alkalinity, Conductivity, and TSS at the Lake Hodge EcoVault® Site.

In general, measured pH values in the discharge samples for the EcoVault® unit appear to exhibit a higher degree of variability, along with a higher overall median pH value, than measurements conducted at the inflow. The observed variability in alkalinity concentrations between inflow and outflow samples appears to be relatively similar, although the outflow samples may be characterized by a slightly lower median alkalinity value. The observed variability in measured conductivity values is also similar between the inflow and outflow samples, although the outflow samples are characterized by a slightly greater median conductivity value. However, a large difference is apparent in the characteristics of measured TSS samples at the inflow and outflow locations. Measured TSS concentrations for inflow samples are highly variable and contain a number of substantially elevated TSS concentrations. In contrast, TSS concentrations in the outflow samples are primarily within a relatively narrow range of values with a substantially lower median concentration.

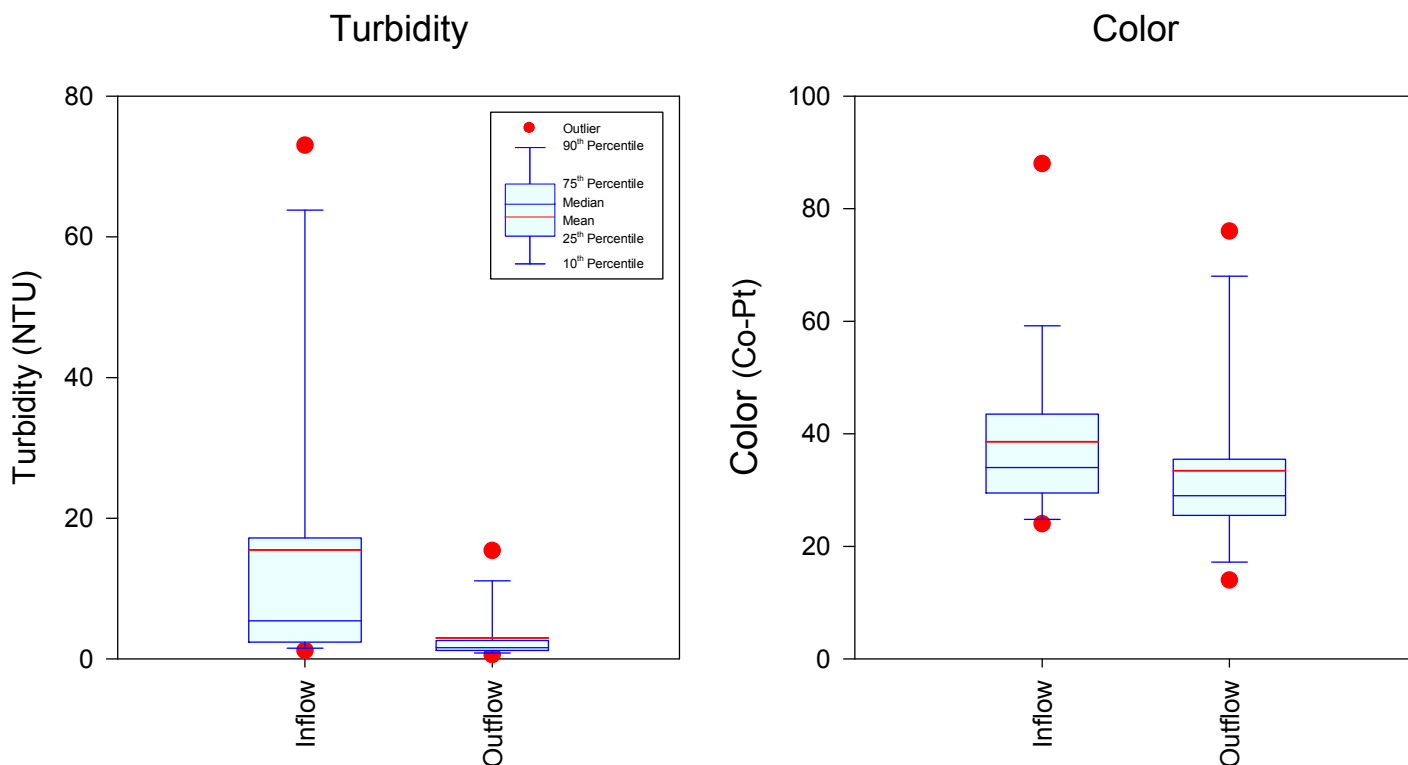
Figure 4-9. Statistical Comparison of Inflow and Outflow Concentrations of Turbidity and Color at the Lake Hodge EcoVault® Site.

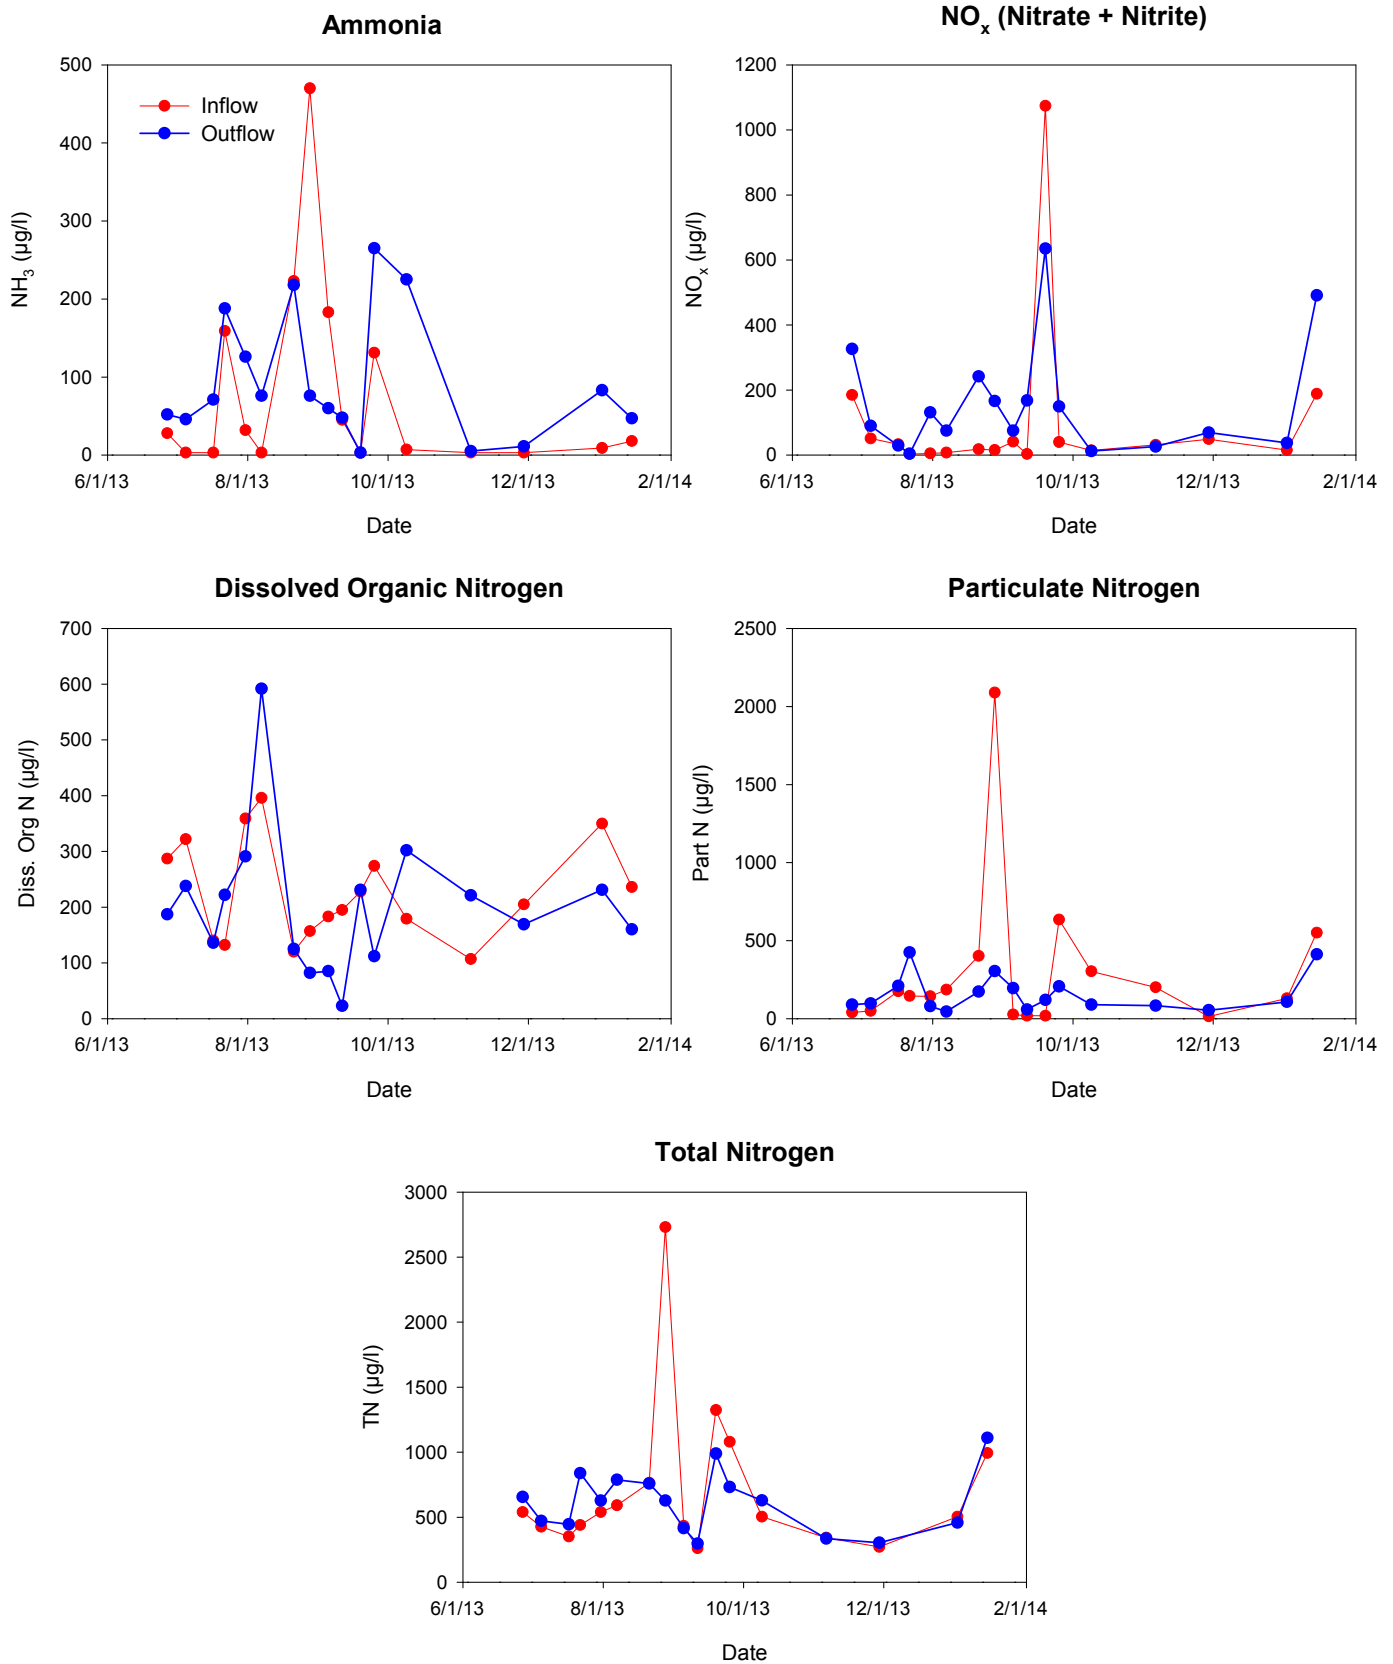
Measured concentrations of NO_x (nitrate + nitrite) exhibited a large degree of variability in both inflow and outflow characteristics, with NO_x inflow concentrations ranging from 3-1074 $\mu\text{g/l}$, and discharge samples ranging from 4-635 $\mu\text{g/l}$. In general, NO_x concentrations in the outflow appear to be somewhat higher in value than the inflow during a majority of the monitoring events.

Measured concentrations of dissolved organic nitrogen exhibited a wide range of values in both the inflow and outflow samples. Although the inflow and outflow concentrations appear to be closely related, there does not appear to be a clear pattern of either higher or lower concentrations for the inflow or outflow.

Figure 4-10. Comparison of Inflow and Outflow Concentrations of Nitrogen Species at the Lake Hodge EcoVault® Site.

Measured concentrations of particulate nitrogen were also highly variable, with inflow concentrations ranging from 14-2,088 $\mu\text{g/l}$ and outflow concentrations ranging from 45-424 $\mu\text{g/l}$. Particulate nitrogen concentrations in the outflow were generally lower in value than inflow concentrations during a majority of the monitoring events.

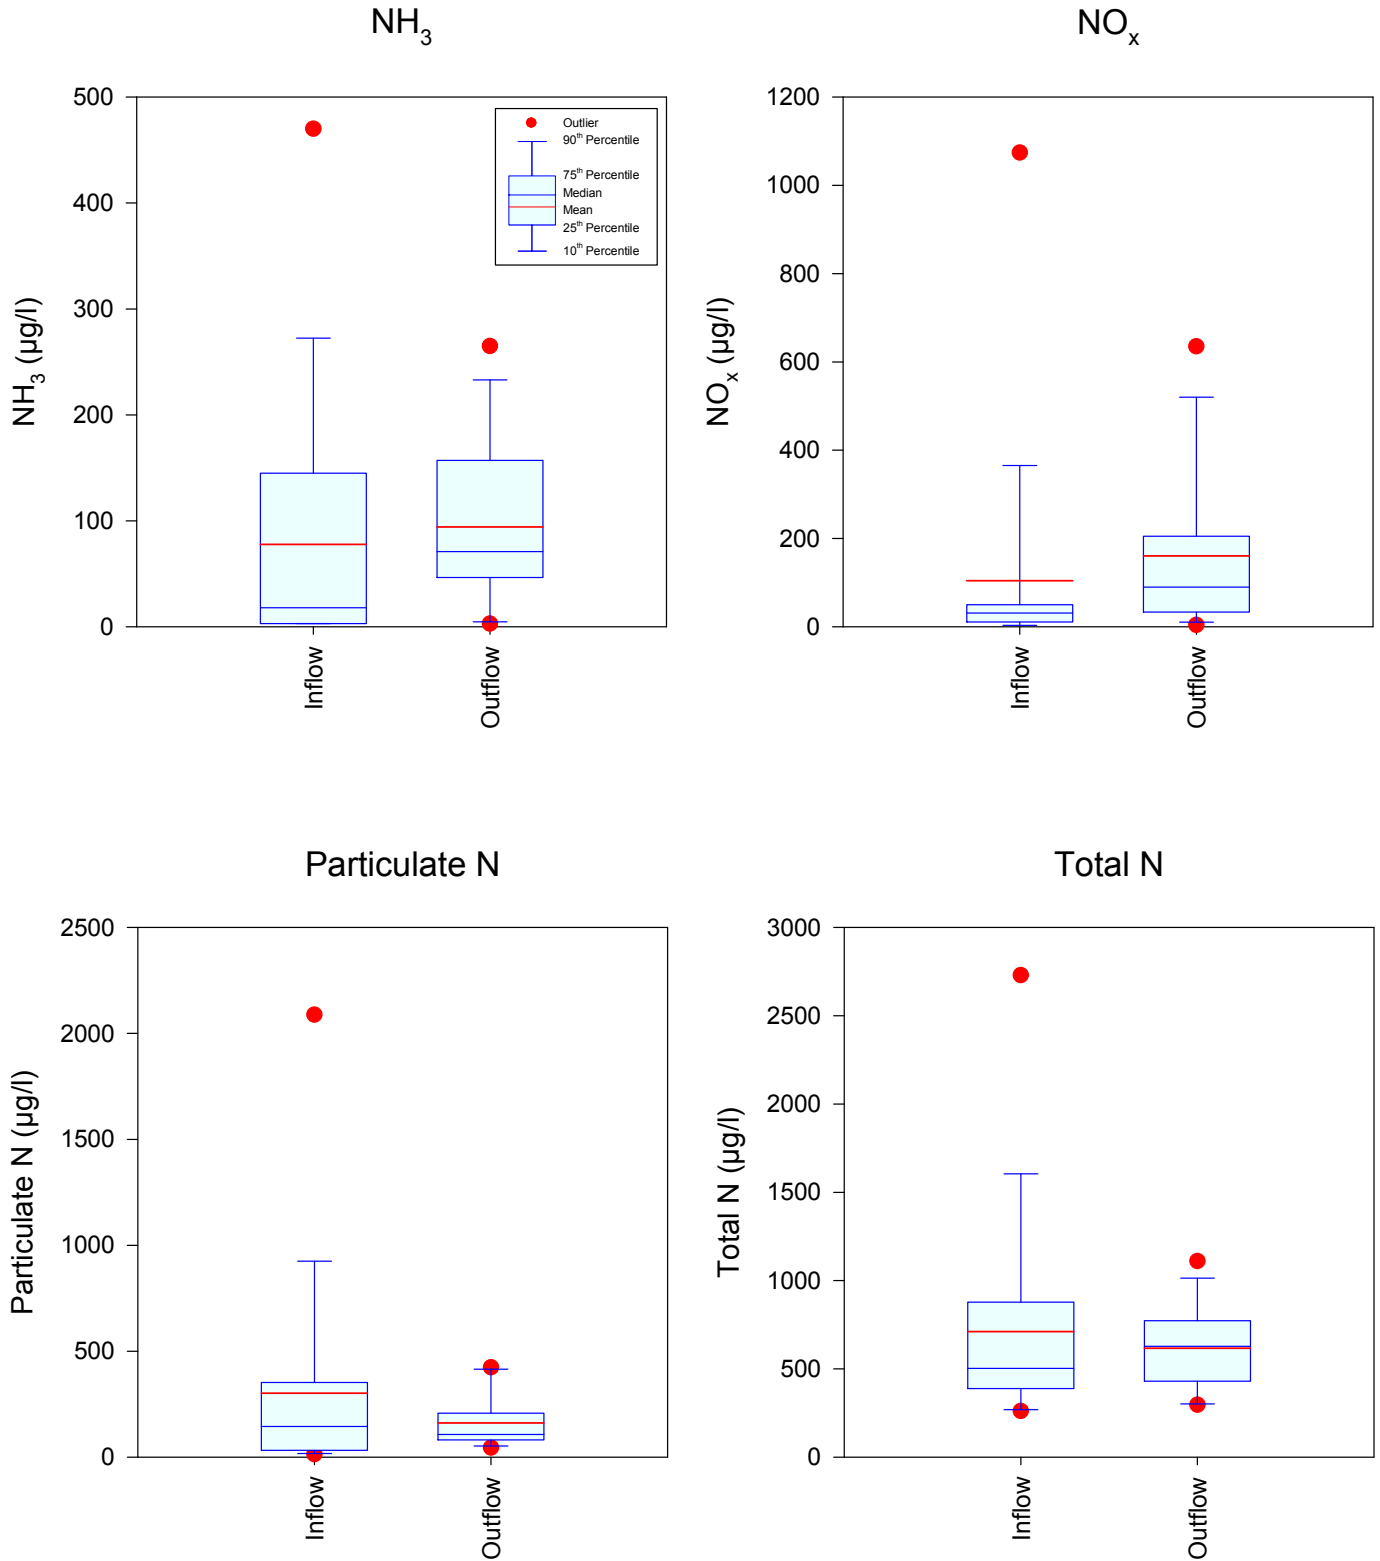
Figure 4-11. Statistical Comparison of Inflow and Outflow Concentrations of Nitrogen Species at the Lake Hodge EcoVault® Site.

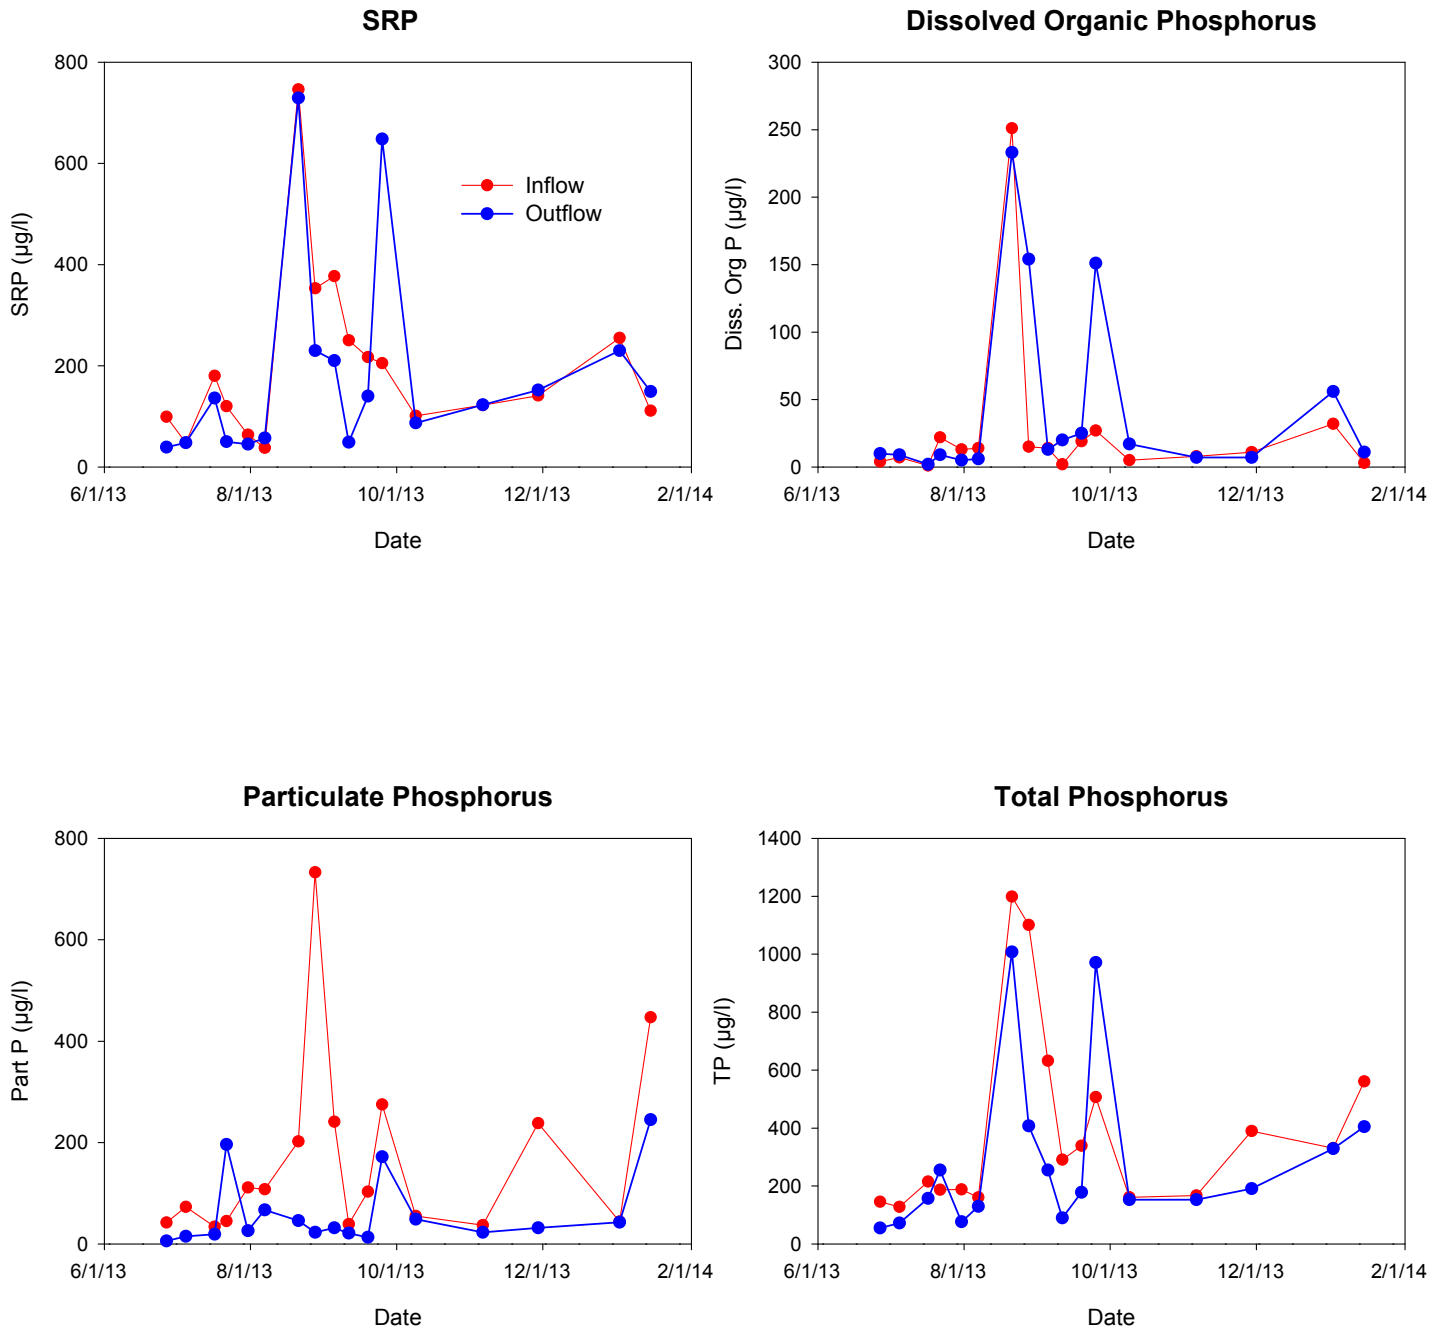
Figure 4-12. Comparison of Inflow and Outflow Concentrations of Phosphorus Species at the Lake Hodge EcoVault® Site.

A graphical comparison of inflow and outflow concentrations of phosphorus species at the Lake Hodge EcoVault® site is given on Figure 4-12. Measured concentrations of SRP were highly variable during the field monitoring program at both the inflow and outflow monitoring sites. A relatively close agreement appears to occur in SRP concentrations between inflow and outflow samples during most monitoring events, although a trend of slightly lower outflow SRP concentrations is apparent during portions of the study. A relatively close agreement was also observed between inflow and outflow concentrations for dissolved organic phosphorus which also exhibited a large degree of variability in concentrations. In general, measured dissolved organic phosphorus concentrations appear to be slightly greater in the outflow samples during many of the monitoring events.

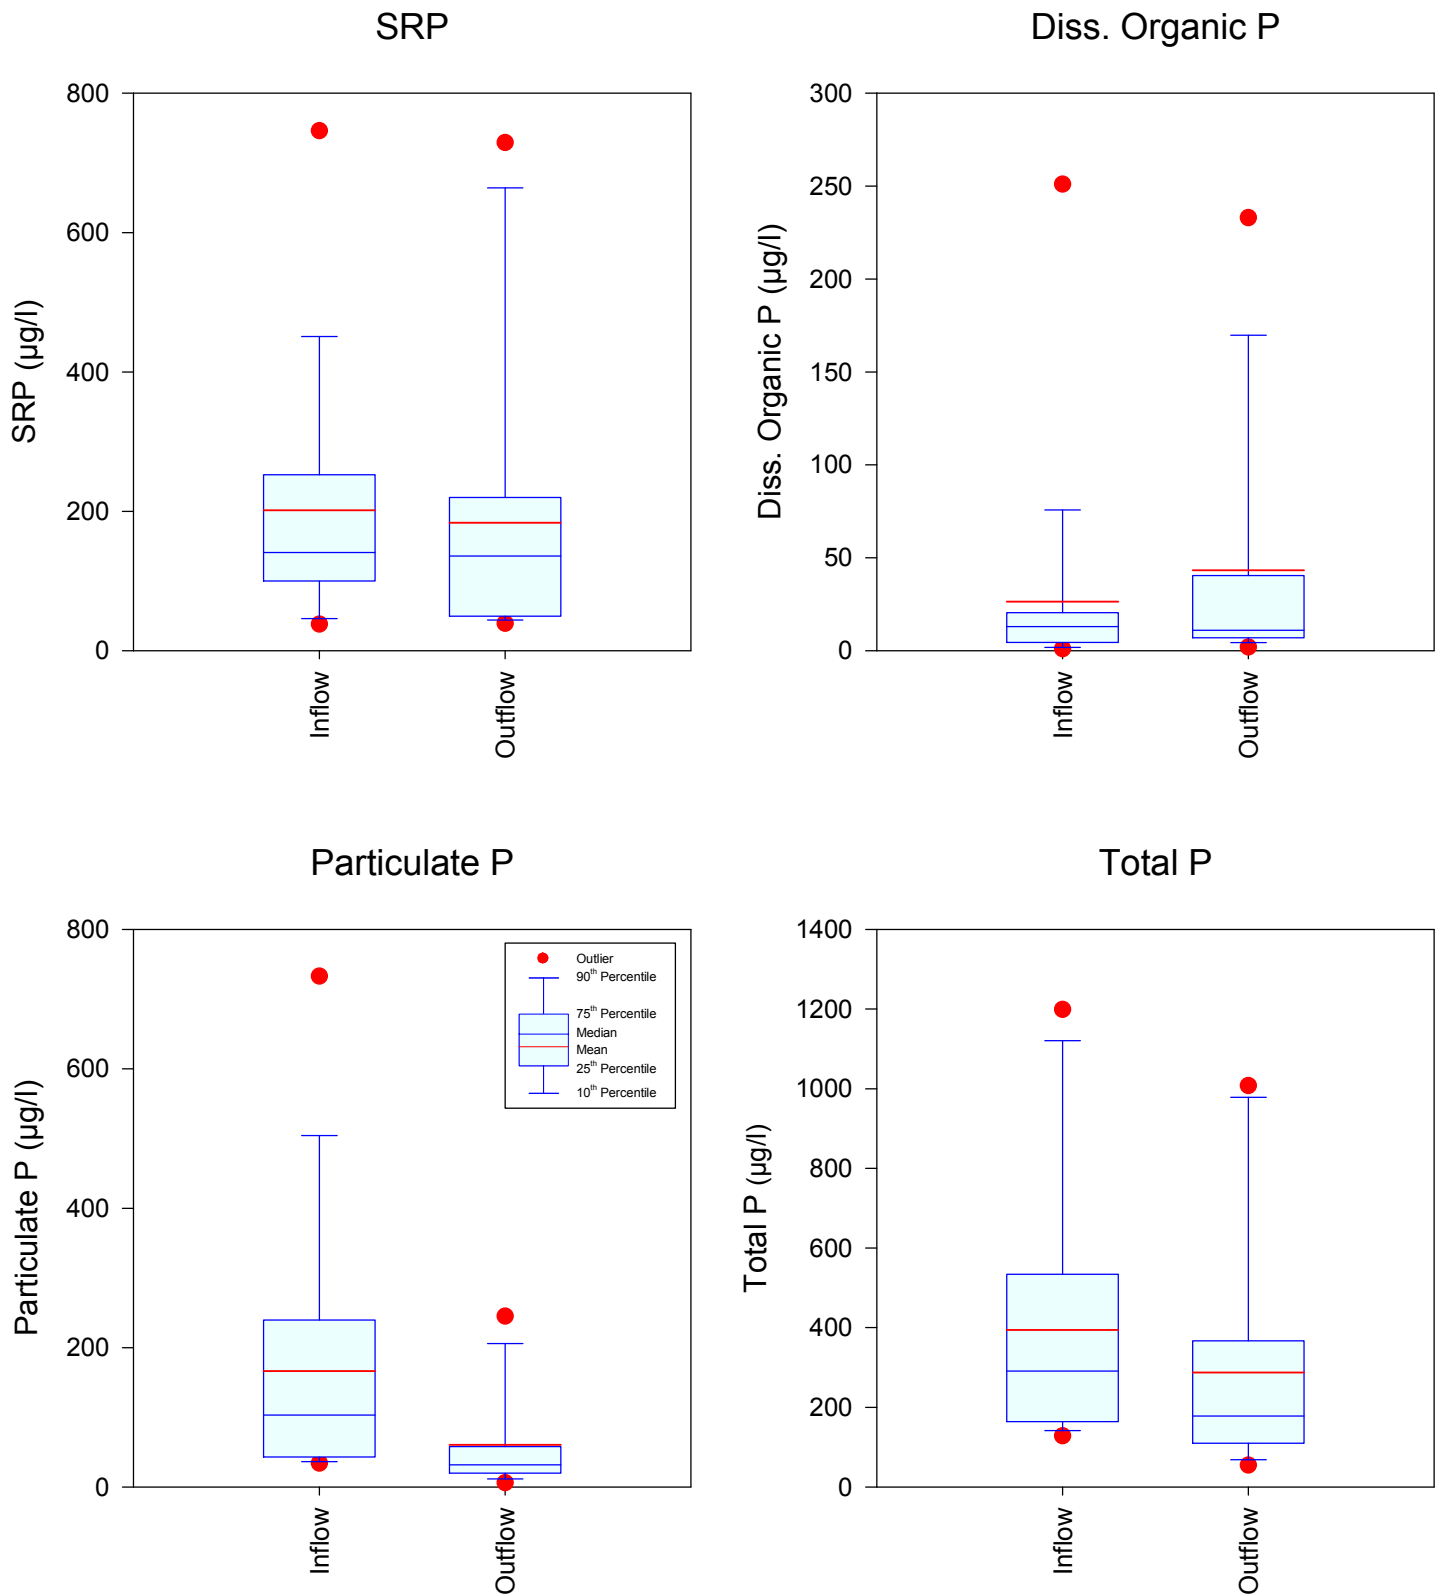
Figure 4-13. Statistical Comparison of Inflow and Outflow Concentrations of Phosphorus Species at the Lake Hodge EcoVault® Site.
