Baffle Box with Media Filtration Installation,
Effectiveness Evaluation, and Associated Education for
the Lake Jesup Watershed

Contract S0497

Final Report

City of Casselberry

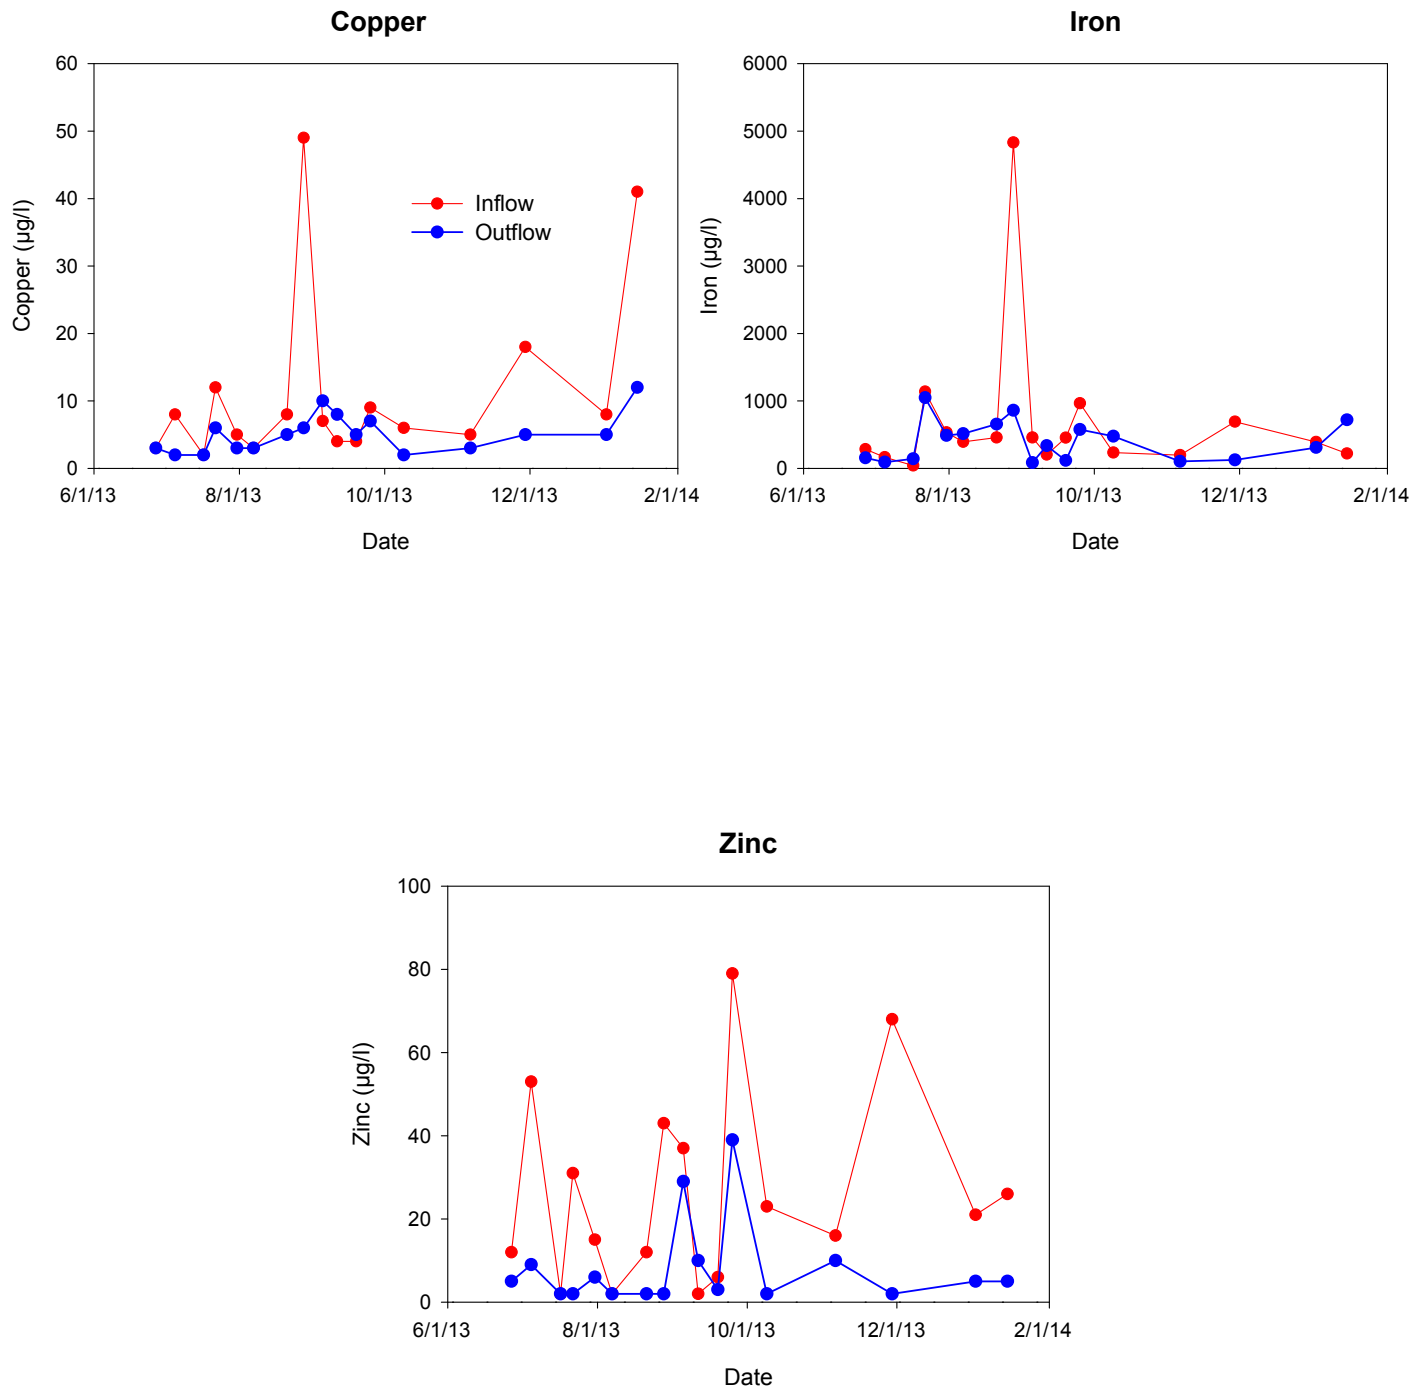
Figure 4-14. Comparison of Inflow Concentrations of Copper, Iron, and Zinc at the Lake Hodge EcoVault® Site.

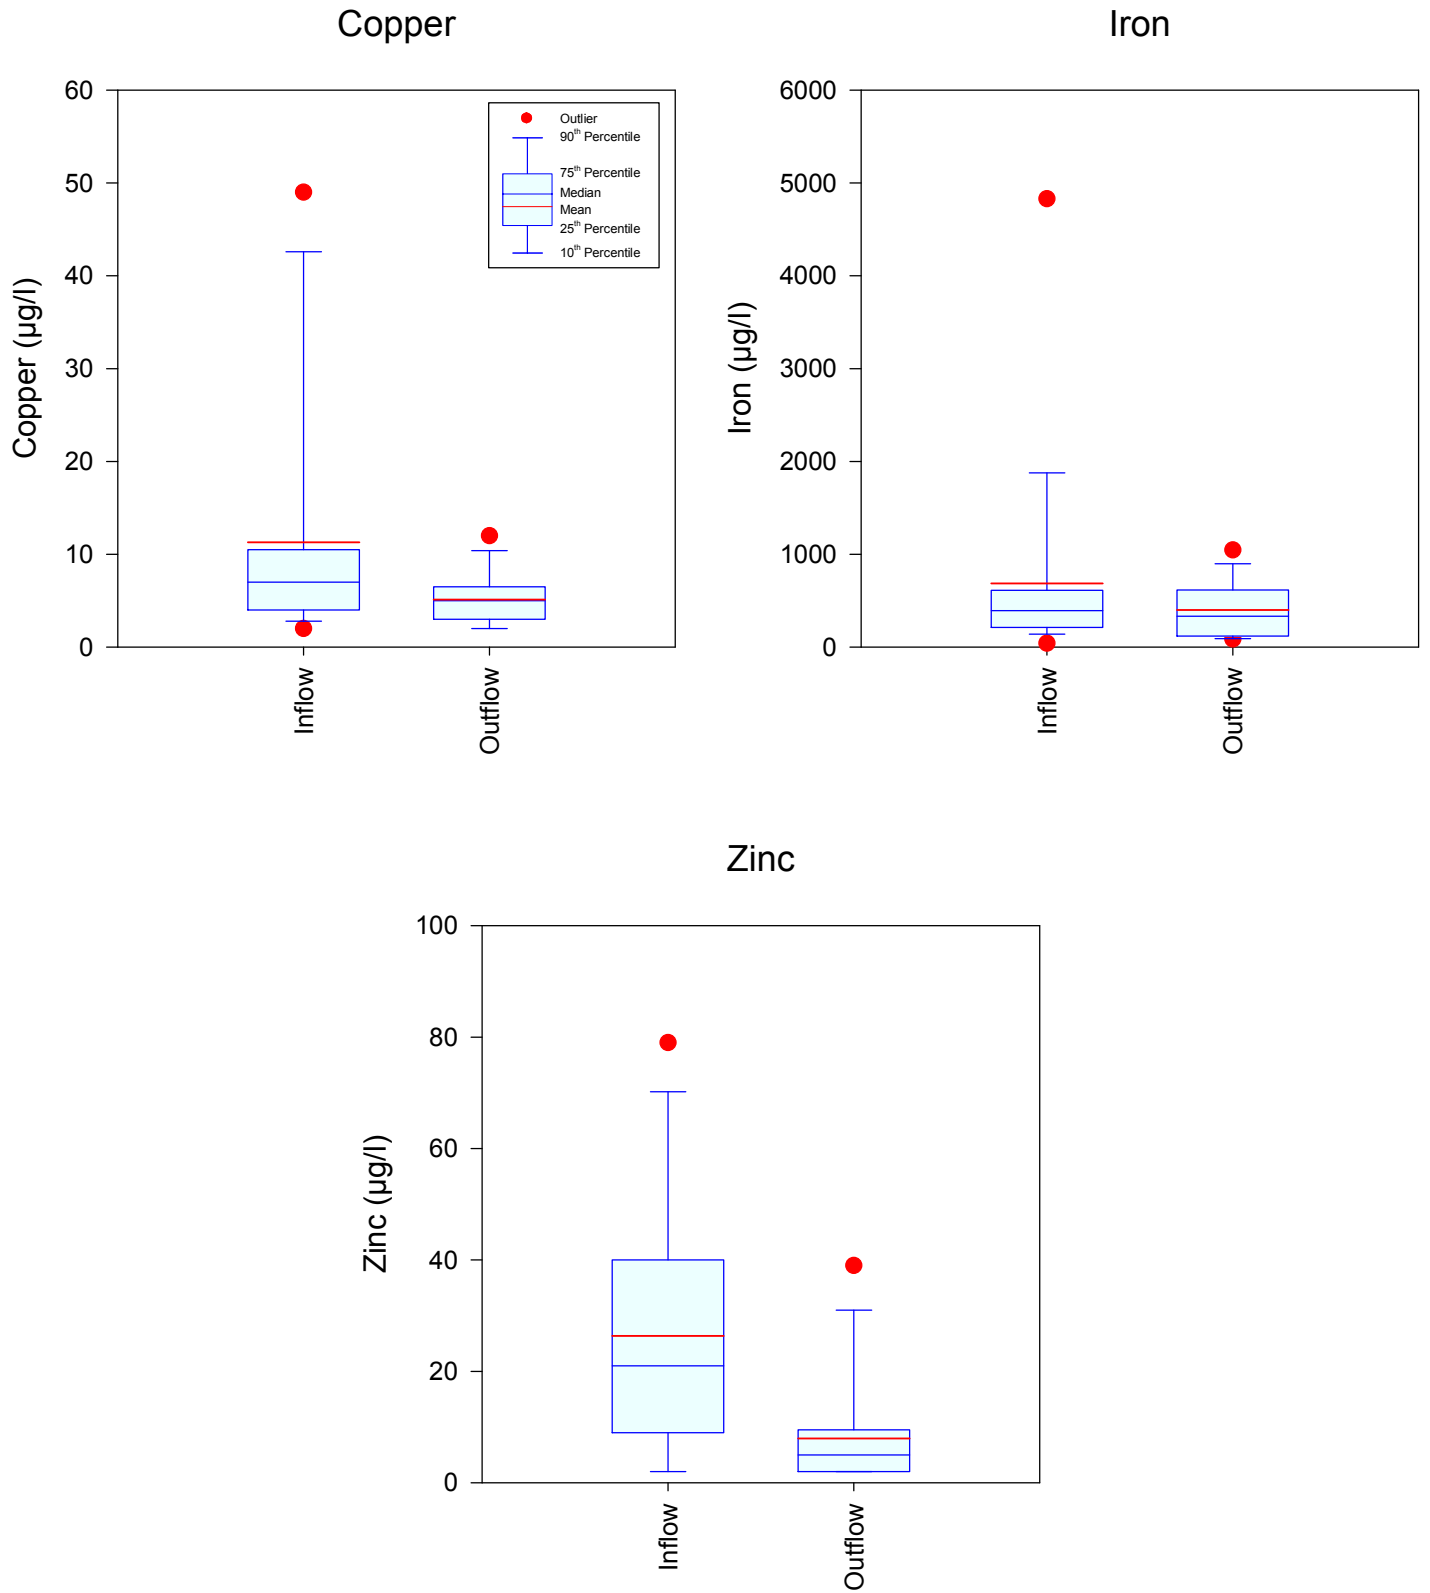
A statistical comparison of inflow and outflow concentrations of copper, iron, and zinc at the Lake Hodge EcoVault® site is given on Figure 4-15. Inflow concentrations of copper exhibited a moderate degree of variability along with a relatively low input concentration. Measured concentrations of total copper in the outflow exhibited a lower median concentration as well as a lower degree of variability.

Variability in inflow and outflow concentrations of total iron were relatively similar, with similar median concentrations. The Lake Hodge EcoVault® site appears to have little significant impact on measured concentrations of total iron. In contrast, the Lake Hodge EcoVault® appears to have a significant impact on concentrations of total zinc. Inflow concentrations of total zinc were highly variable, with a moderately elevated median concentration. Outflow concentrations of total zinc exhibited a low degree of variability with an extremely low median concentration.

Figure 4-15. Statistical Comparison of Inflow and Outflow Concentrations of Copper, Iron, and Zinc at the Lake Hodge EcoVault® Site.

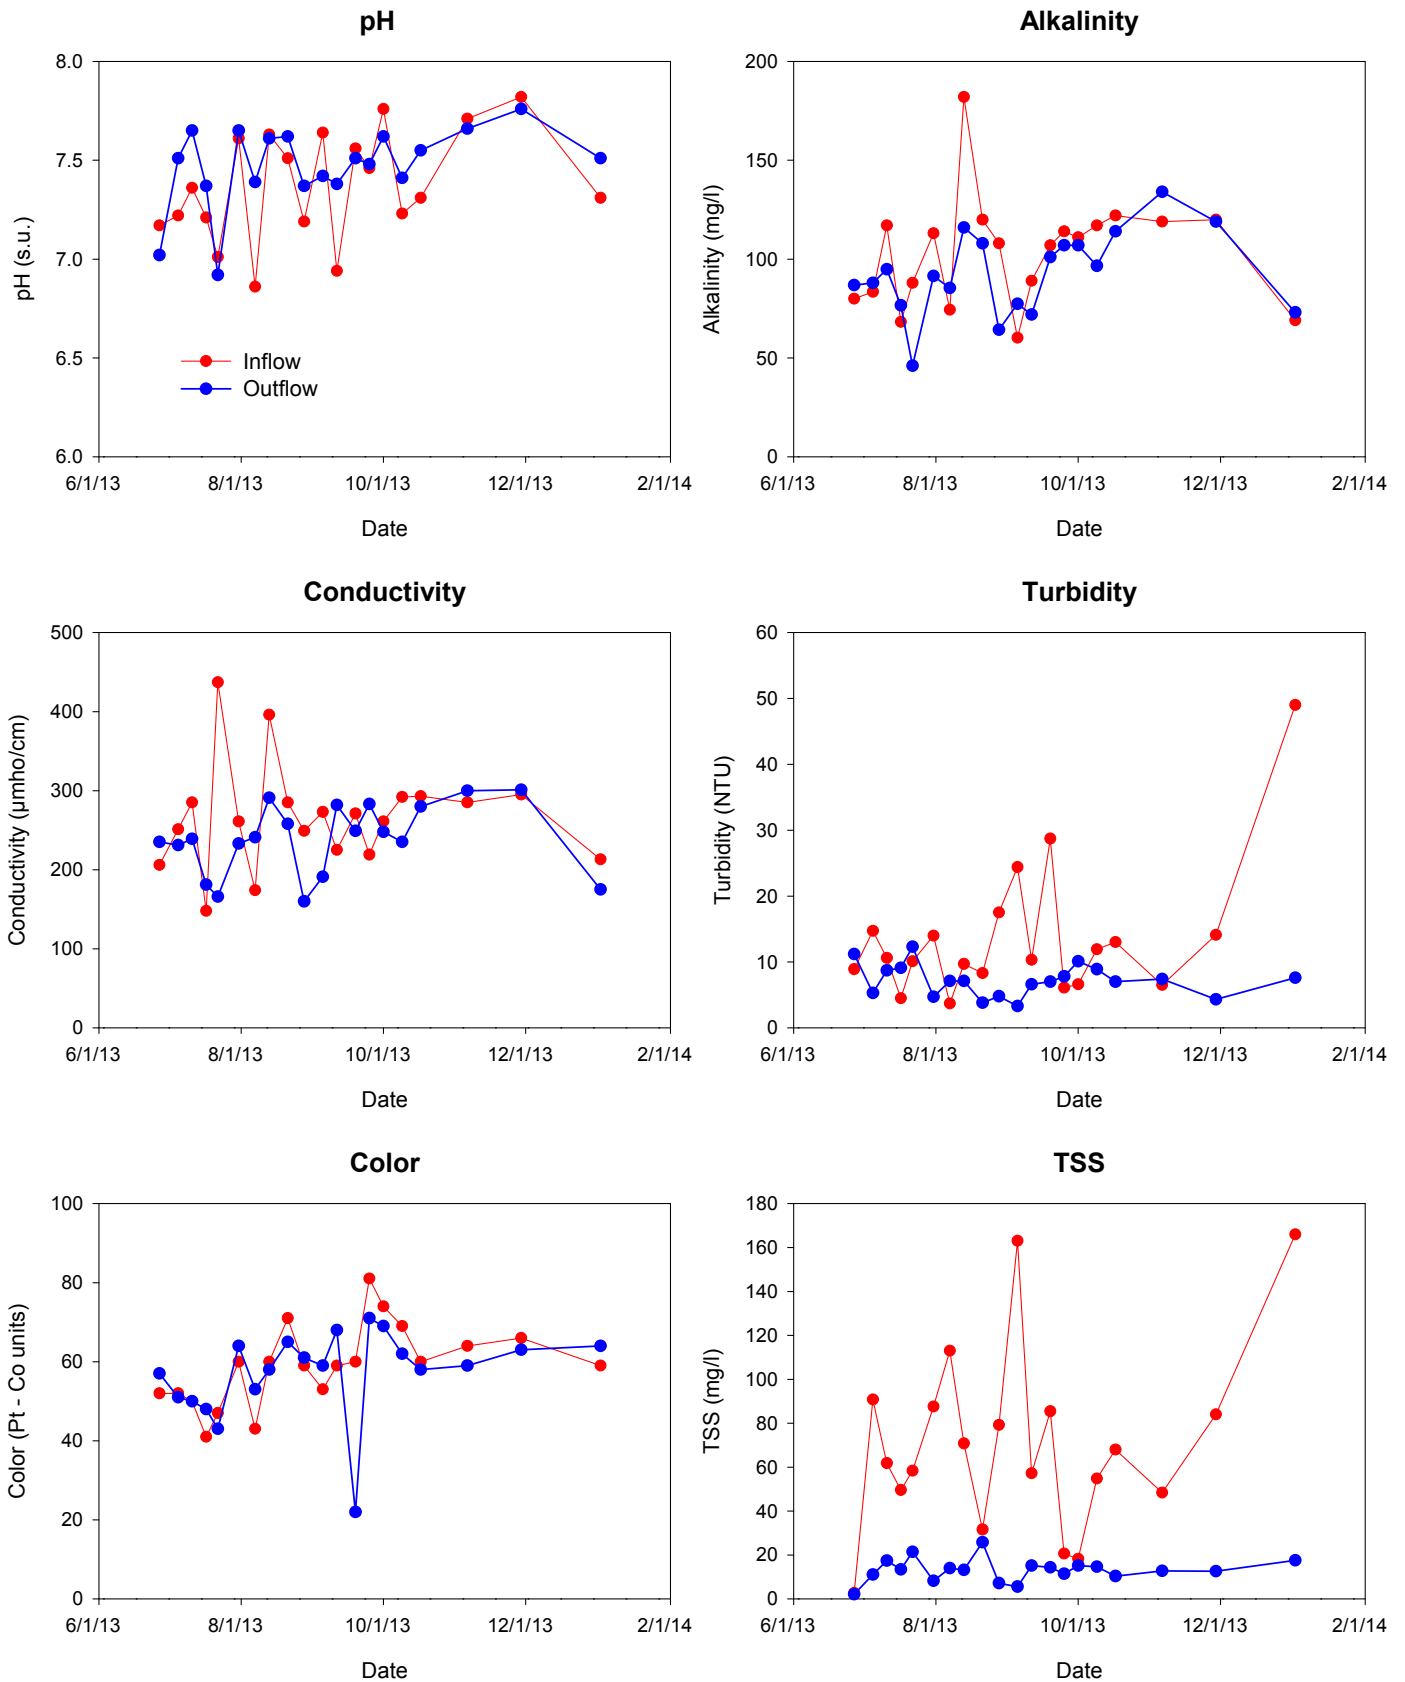
Figure 4-16. Comparison of Inflow and Outflow Concentrations of pH, Alkalinity, Conductivity, Turbidity, Color, and TSS at the Gee Creek EcoVault® Site.

A comparison of inflow and outflow concentrations of pH, alkalinity, conductivity, turbidity, color, and TSS at the Gee Creek EcoVault® site is given on Figure 4-16. Measured pH values in the inflow samples ranged from 6.86-7.82, reflecting approximately neutral characteristics. Measured inflow and outflow pH values were relatively similar during a majority of the monitored events, although somewhat lower inflow concentrations were observed during several events. Measured alkalinity values were highly variable in the inflow, with measured values ranging from 60.2-182 mg/l. A relatively close agreement was observed between inflow and outflow concentrations during most events, although a slight trend of lower alkalinity values in the outflow is apparent during multiple monitored events.

Highly variable conductivity values were observed at the Gee Creek EcoVault® site, particularly for the inflow samples. A somewhat lower degree of variability was observed for the discharge samples, particularly during the first half of the monitoring program. Overall, measured concentrations in the outflow appear to be lower than inflow concentrations during most monitored events.

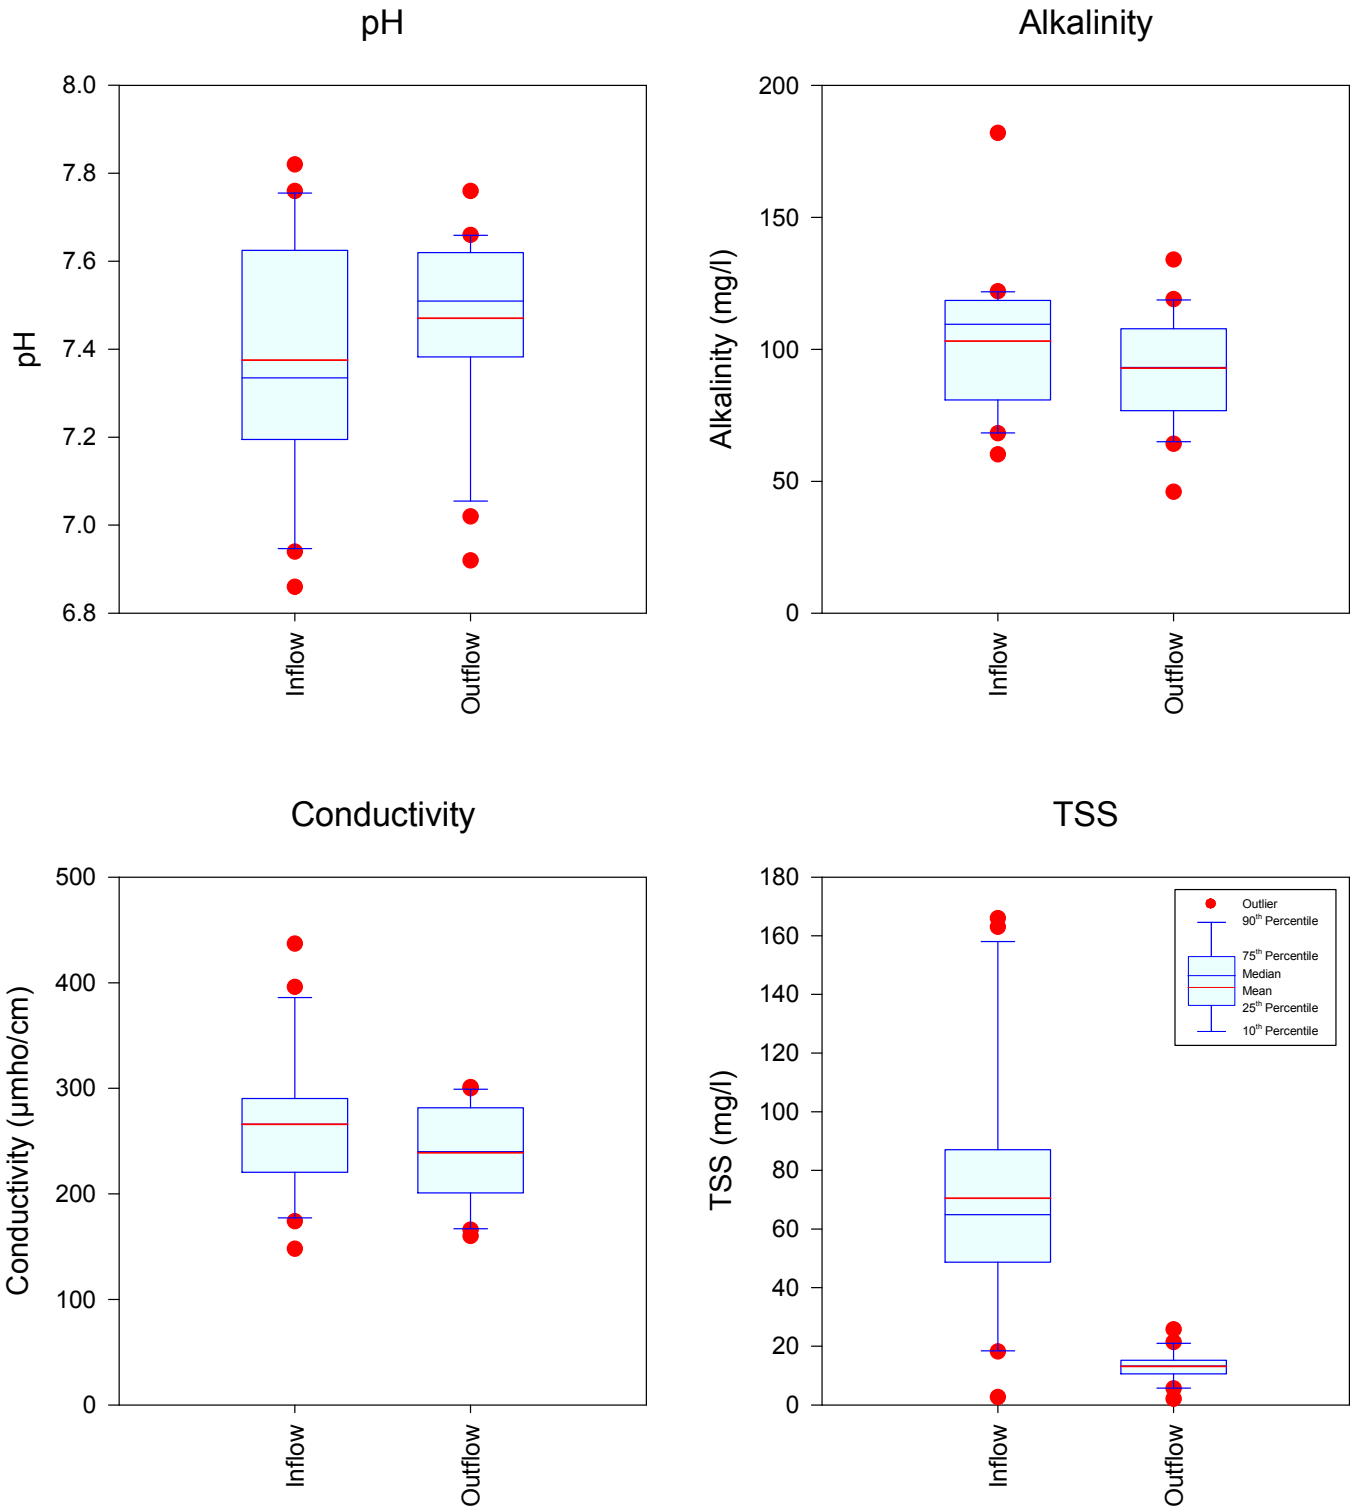
A statistical comparison of inflow and outflow concentrations of pH, alkalinity, conductivity, and TSS at the Gee Creek EcoVault® site are illustrated on Figure 4-17. Measured pH values of the inflow samples exhibited a relatively high range, with a fairly narrow range observed in the discharge samples, combined with a slightly higher median pH value. Measured inflow alkalinity concentrations exhibited a higher degree of variability as well as a higher median value than observed in the discharge samples.

Figure 4-17. Statistical Comparison of Inflow and Outflow Concentrations of pH, Alkalinity, Conductivity, and TSS at the Gee Creek EcoVault® Site.

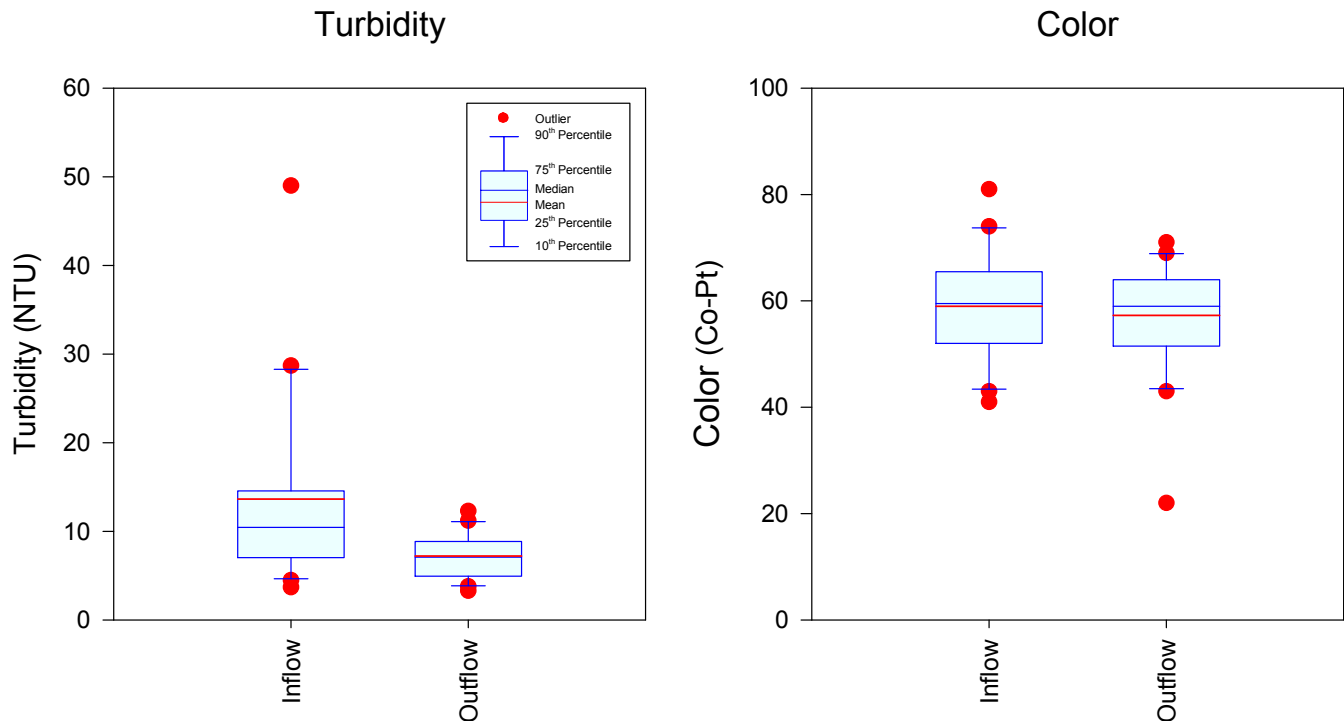
A statistical comparison of inflow and outflow concentrations for turbidity and color at the Gee Creek EcoVault® Site are given on Figure 4-18. Measured turbidity values at the inflow exhibited a relatively high degree of variability compared with the outflow samples which also exhibited a substantially lower median concentration. However, in contrast, little change appears to occur within the Gee Creek EcoVault® unit for color, with virtually identical statistical profiles for the inflow and outflow samples.

Figure 4-18. Statistical Comparison of Inflow and Outflow Concentrations of Turbidity and Color at the Gee Creek EcoVault® Site.

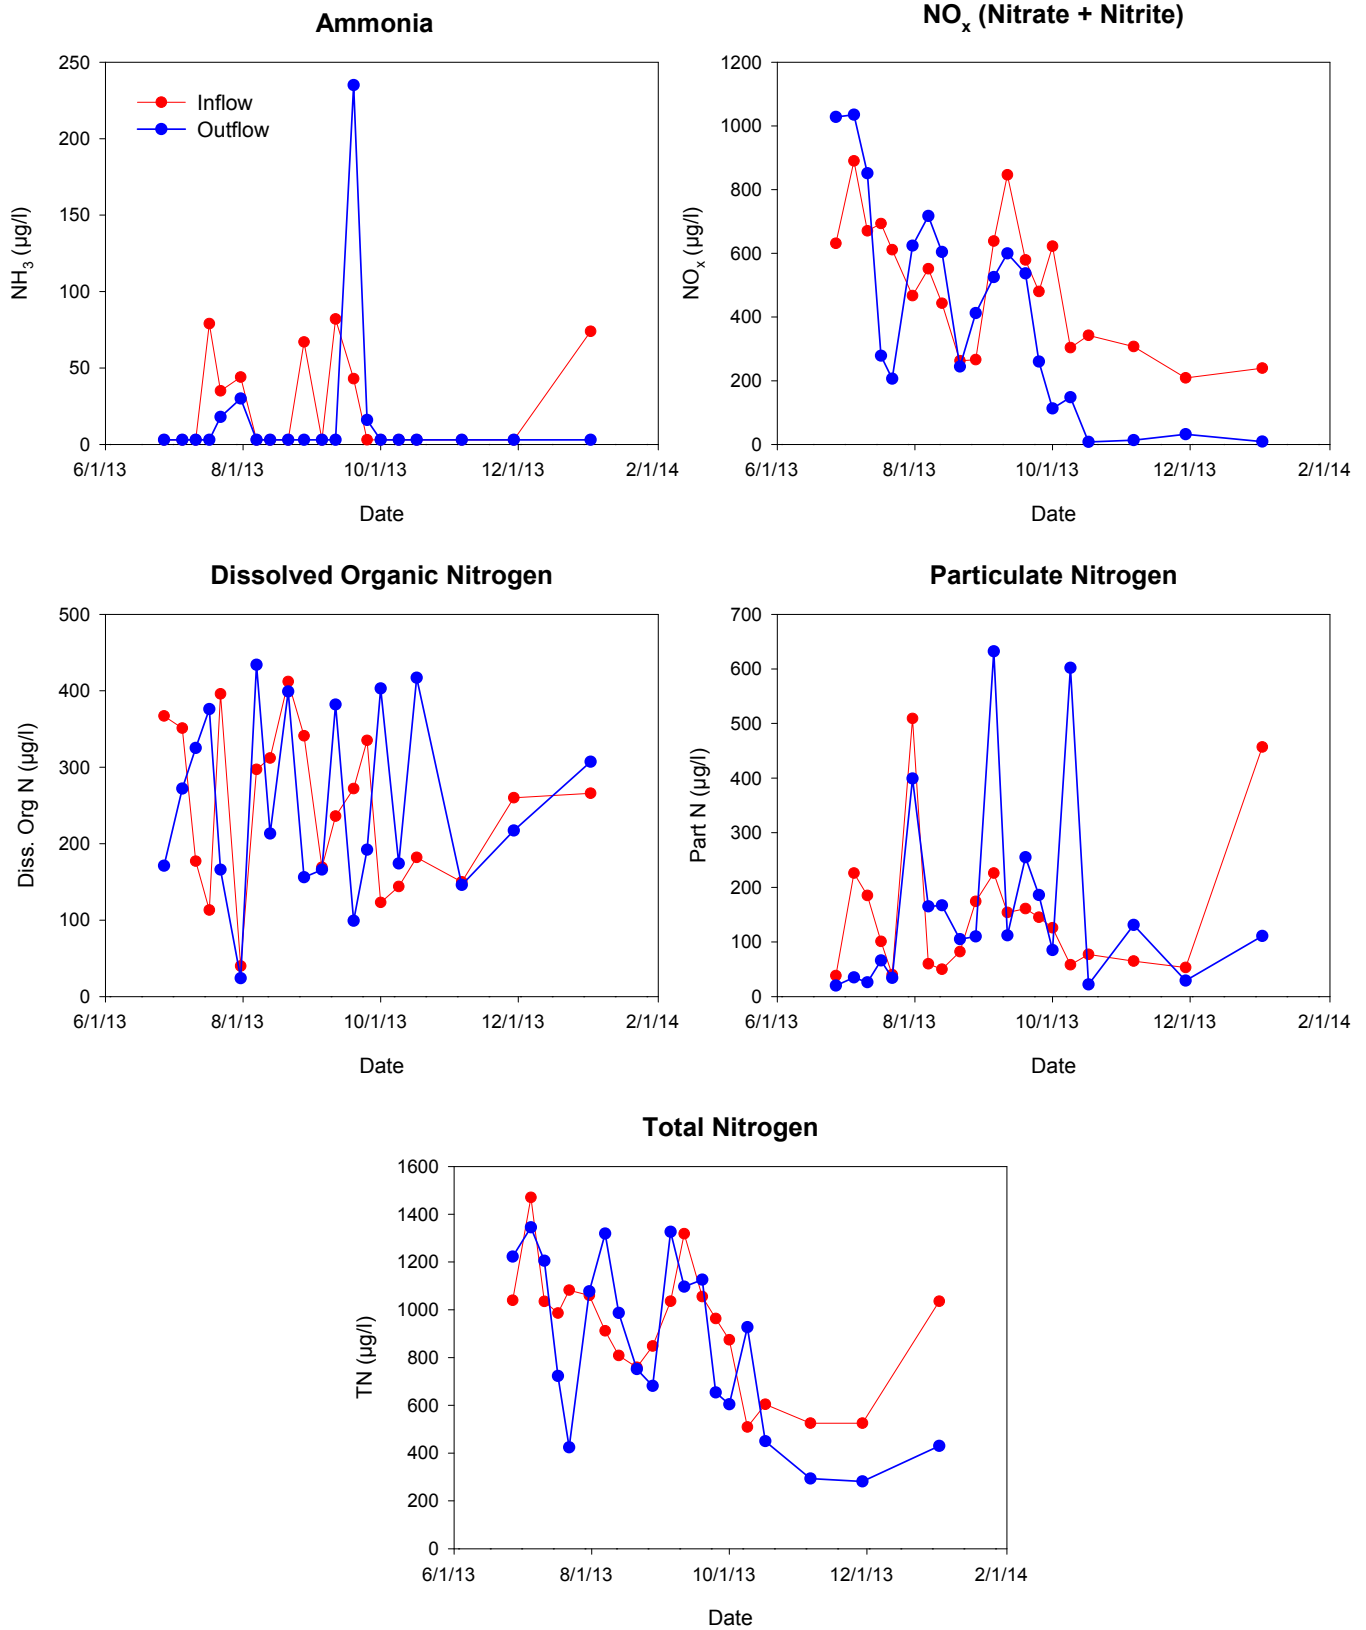
Figure 4-19. Comparison of Inflow and Outflow Concentrations of Nitrogen Species at the Gee Creek EcoVault® Site.

Measured NO_x concentrations in both the inflow and outflow samples exhibited an extremely high degree of variability throughout the field monitoring program, with inflow concentrations ranging from 209-890 $\mu\text{g}/\text{l}$. No defined pattern in inflow and outflow NO_x concentrations appears to exist during the first 2-3 months of the field monitoring program. However, beginning during September 2013, NO_x concentrations in the outfall samples were substantially lower during each monitoring even than observed in the inflow samples.

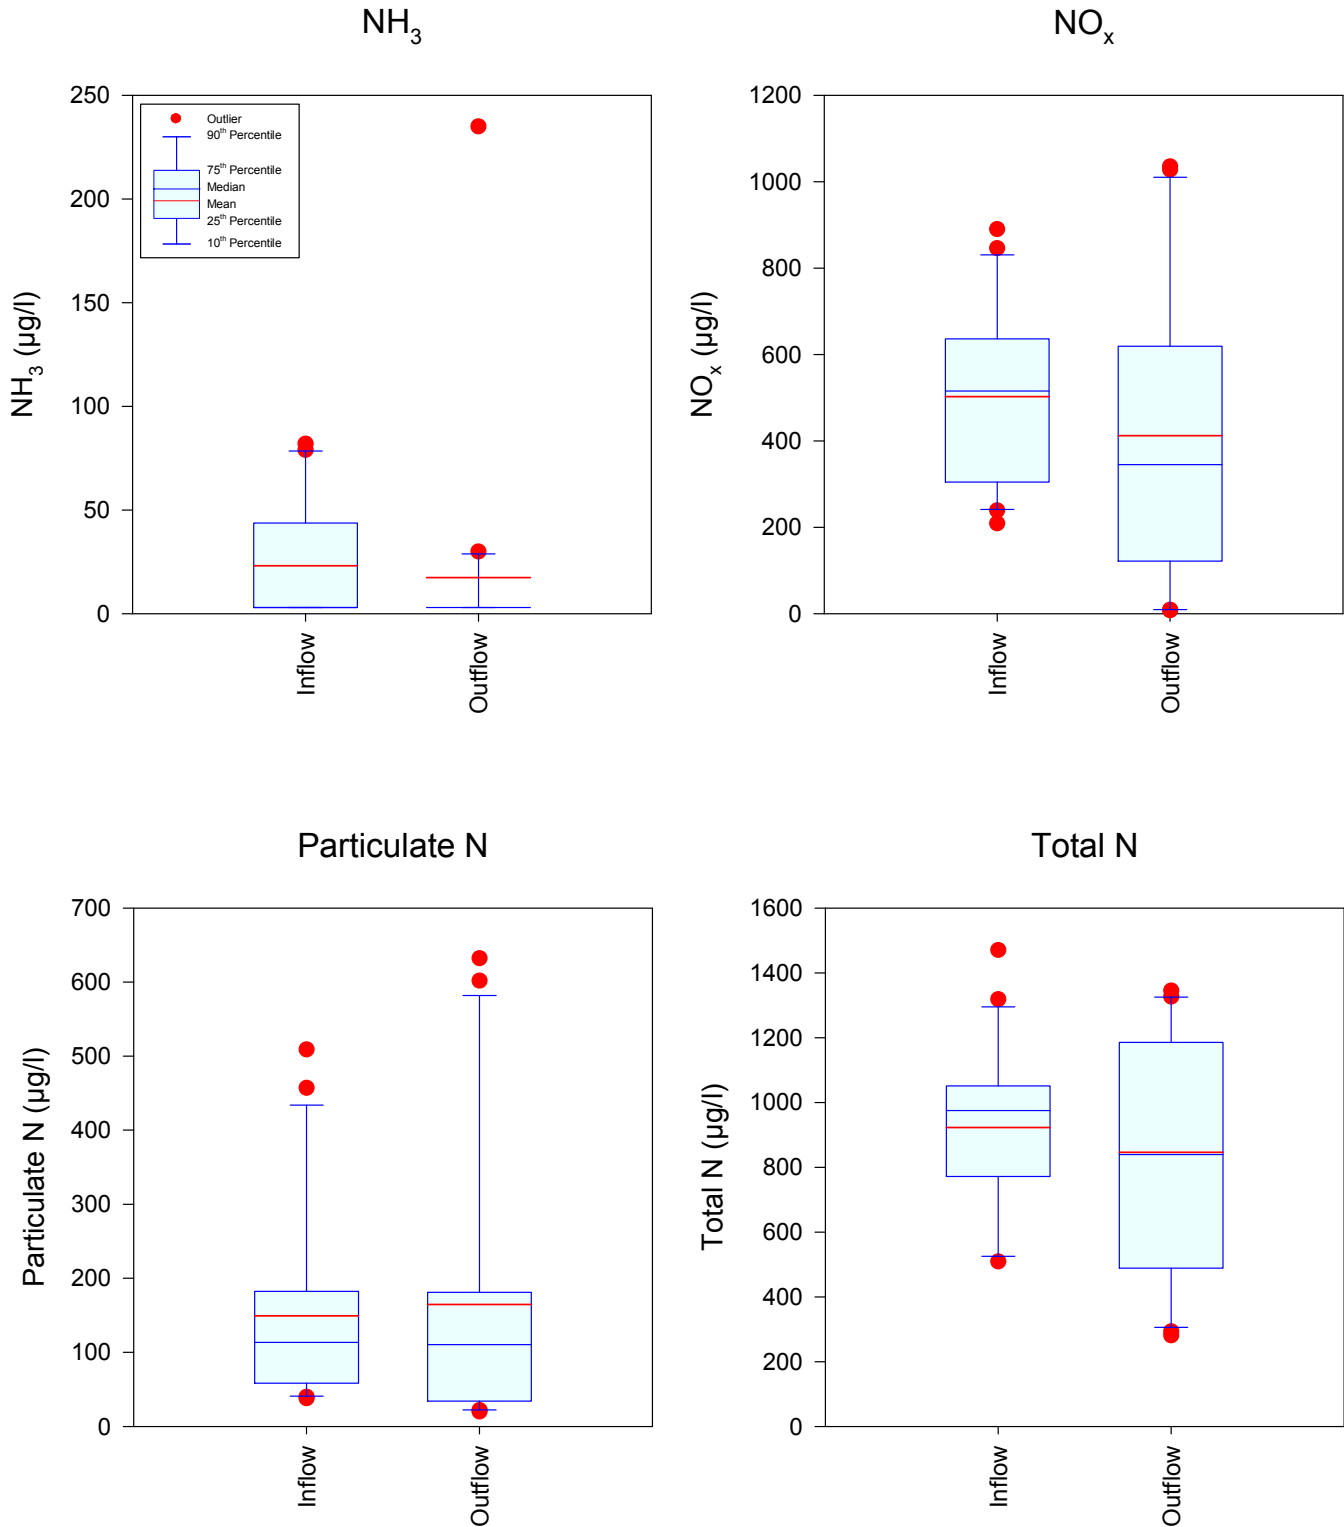
Figure 4-20. Statistical Comparison of Inflow and Outflow Concentrations of Nitrogen Species at the Gee Creek EcoVault® Site.

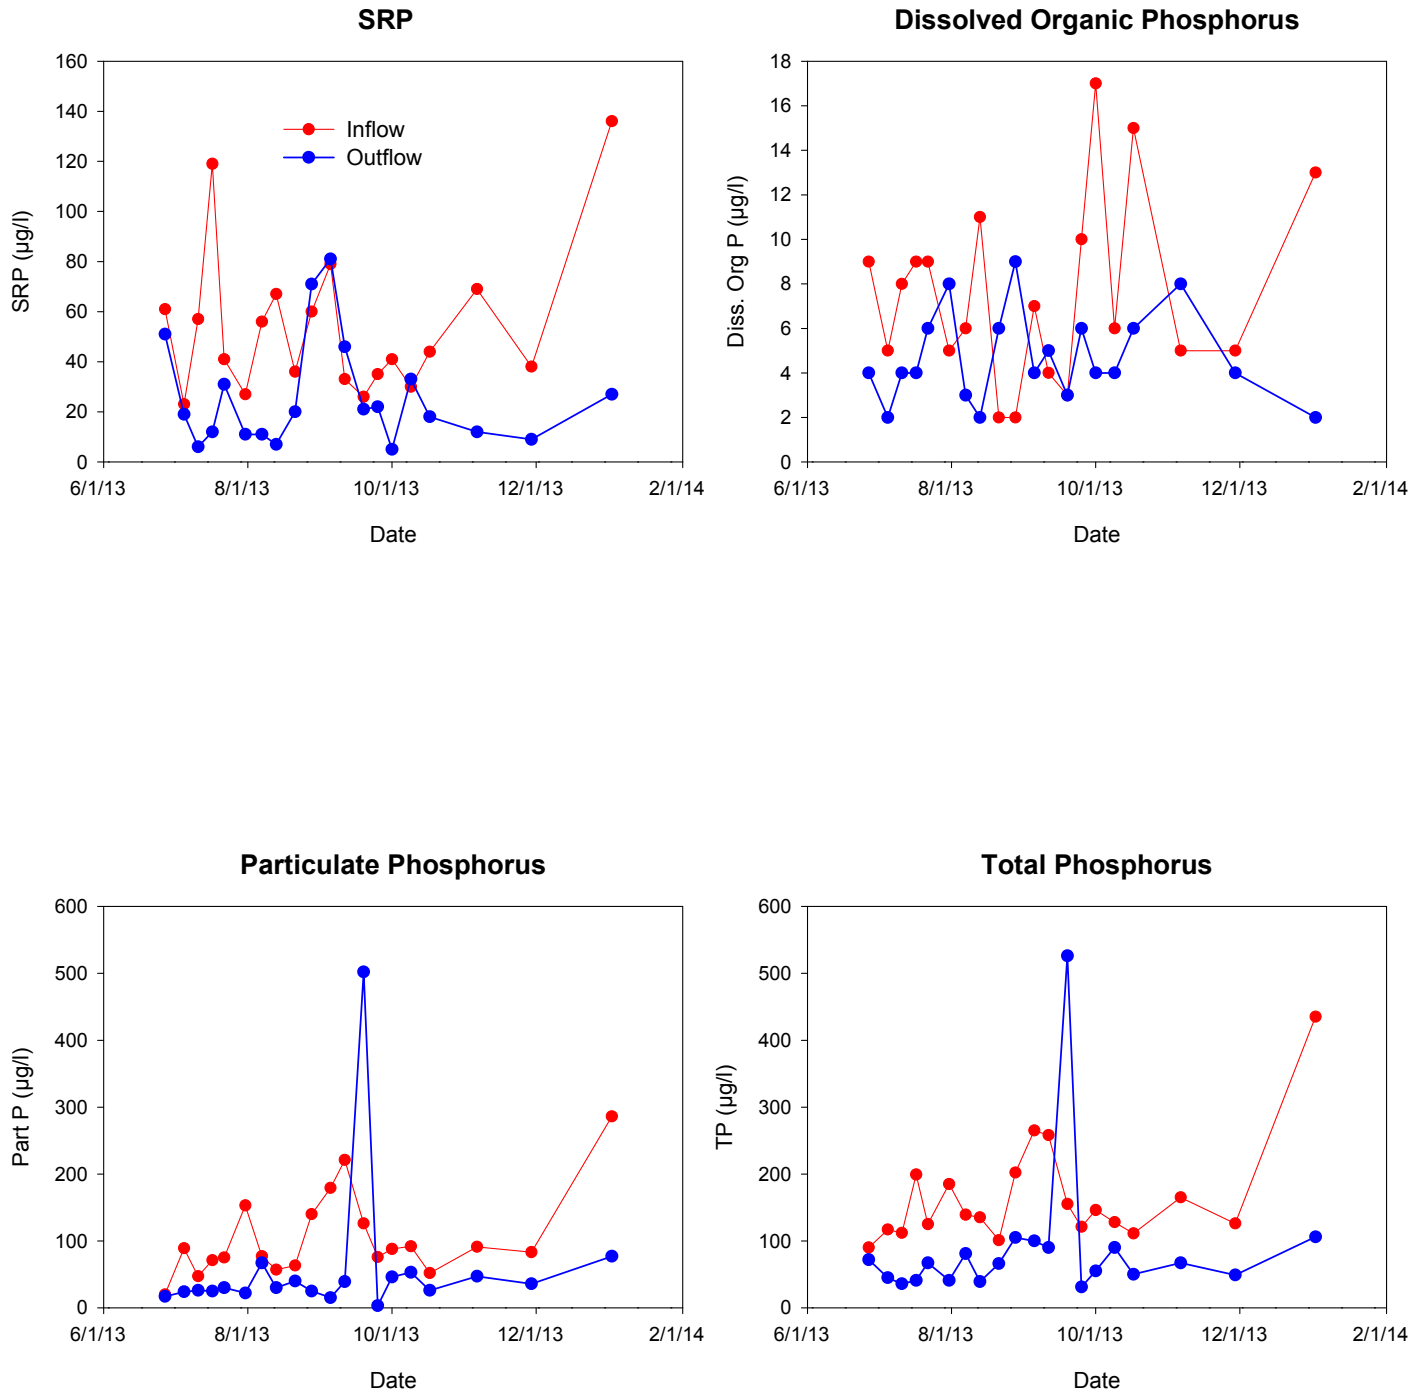
Figure 4-21. Comparison of Inflow and Outflow Concentrations of Phosphorus Species at the Gee Creek EcoVault® Site.

Measured concentrations of dissolved organic phosphorus were also highly variable in both the inflow and outflow, although the range of measured inflow values extended only from 2-17 µg/l. During many events, it appears that outflow concentrations of dissolved organic phosphorus are lower than inflow, although substantially more elevated outflow concentrations were observed on multiple occasions.

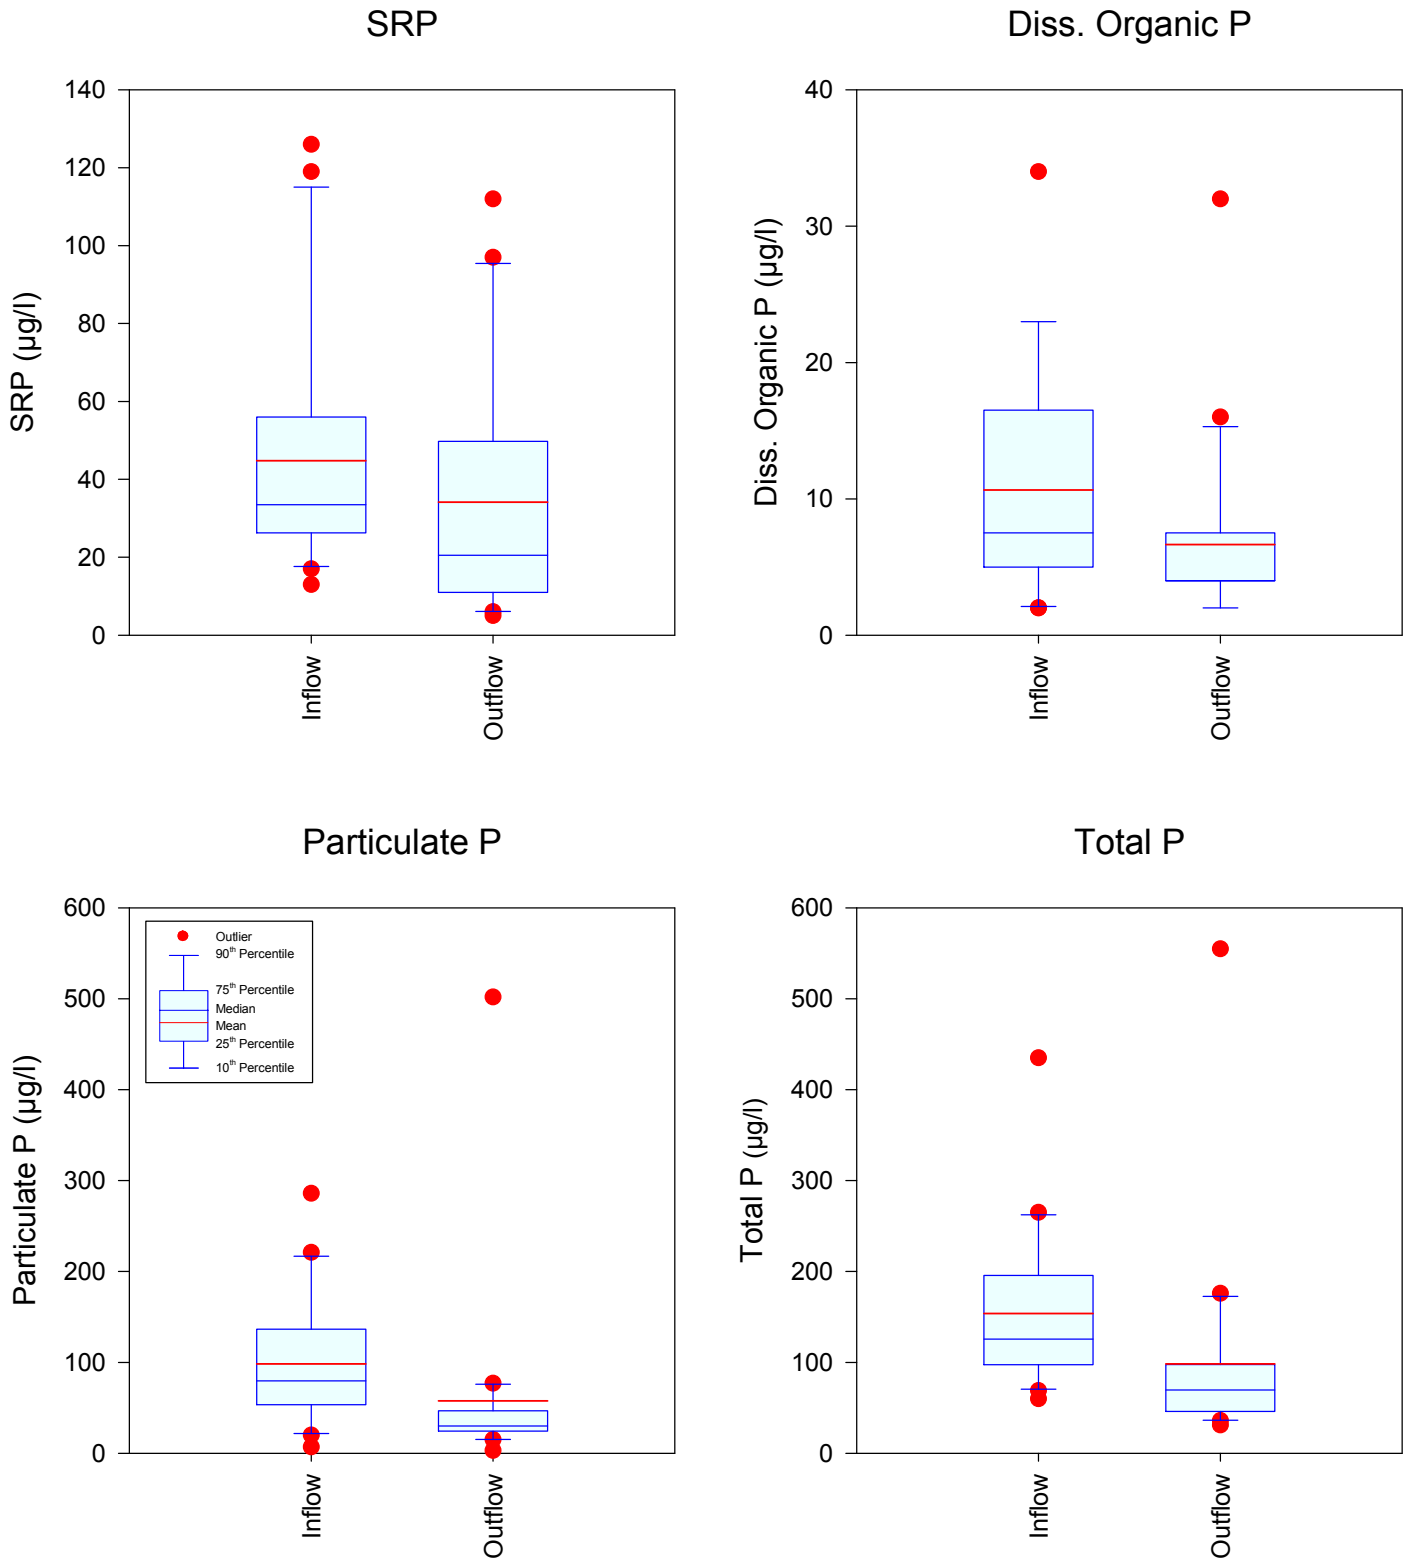
Figure 4-22. Statistical Comparison of Inflow and Outflow Concentrations of Phosphorus Species at the Gee Creek EcoVault® Site.

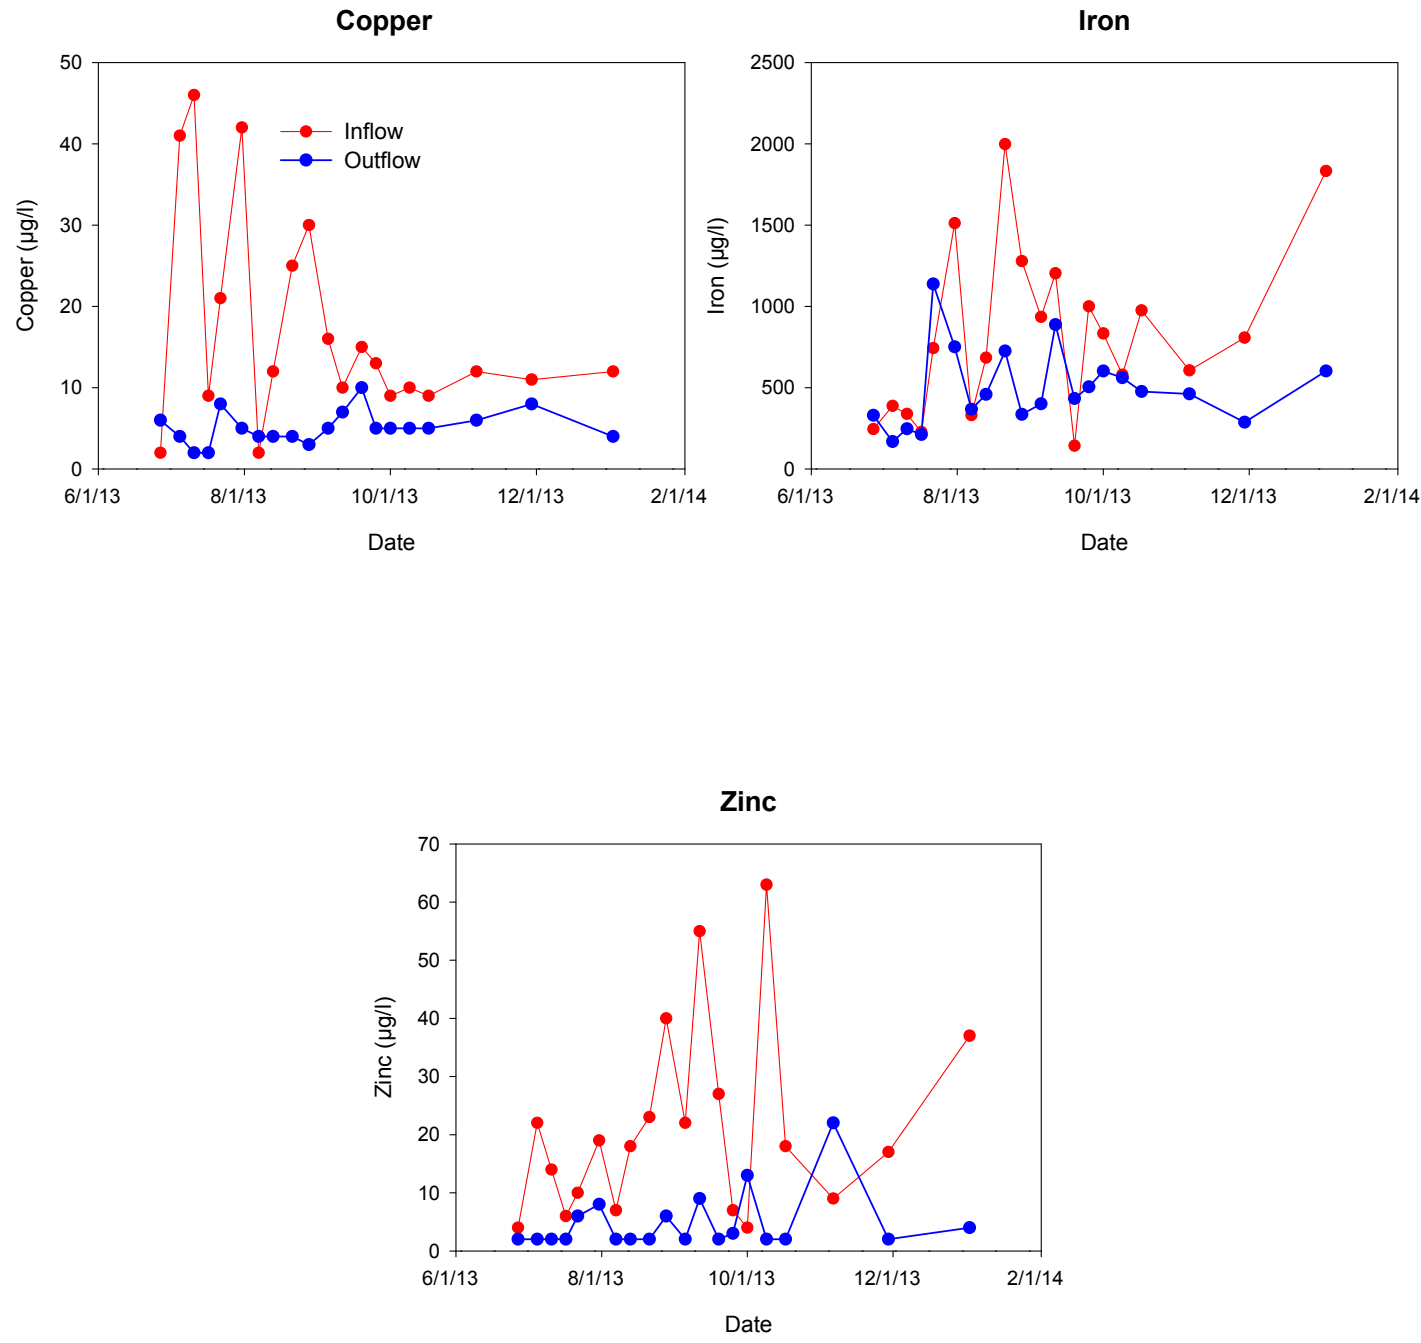
Figure 4-23. Comparison of Inflow Concentrations of Copper, Iron, and Zinc at the Gee Creek EcoVault® Site.

Highly variable concentrations of total zinc were observed at the inflow for the EcoVault® site, with measured concentrations ranging from 4-63 µg/l. In contrast, outflow concentrations were generally low in value, ranging from 2-22 µg/l, with concentrations substantially less than inflow concentrations during virtually all events. Overall, it appears that the Gee Creek EcoVault® unit is retaining substantial portions of the zinc loadings within the unit.
