Baffle Box with Media Filtration Installation,
Effectiveness Evaluation, and Associated Education for
the Lake Jesup Watershed

Contract S0497

Final Report

City of Casselberry

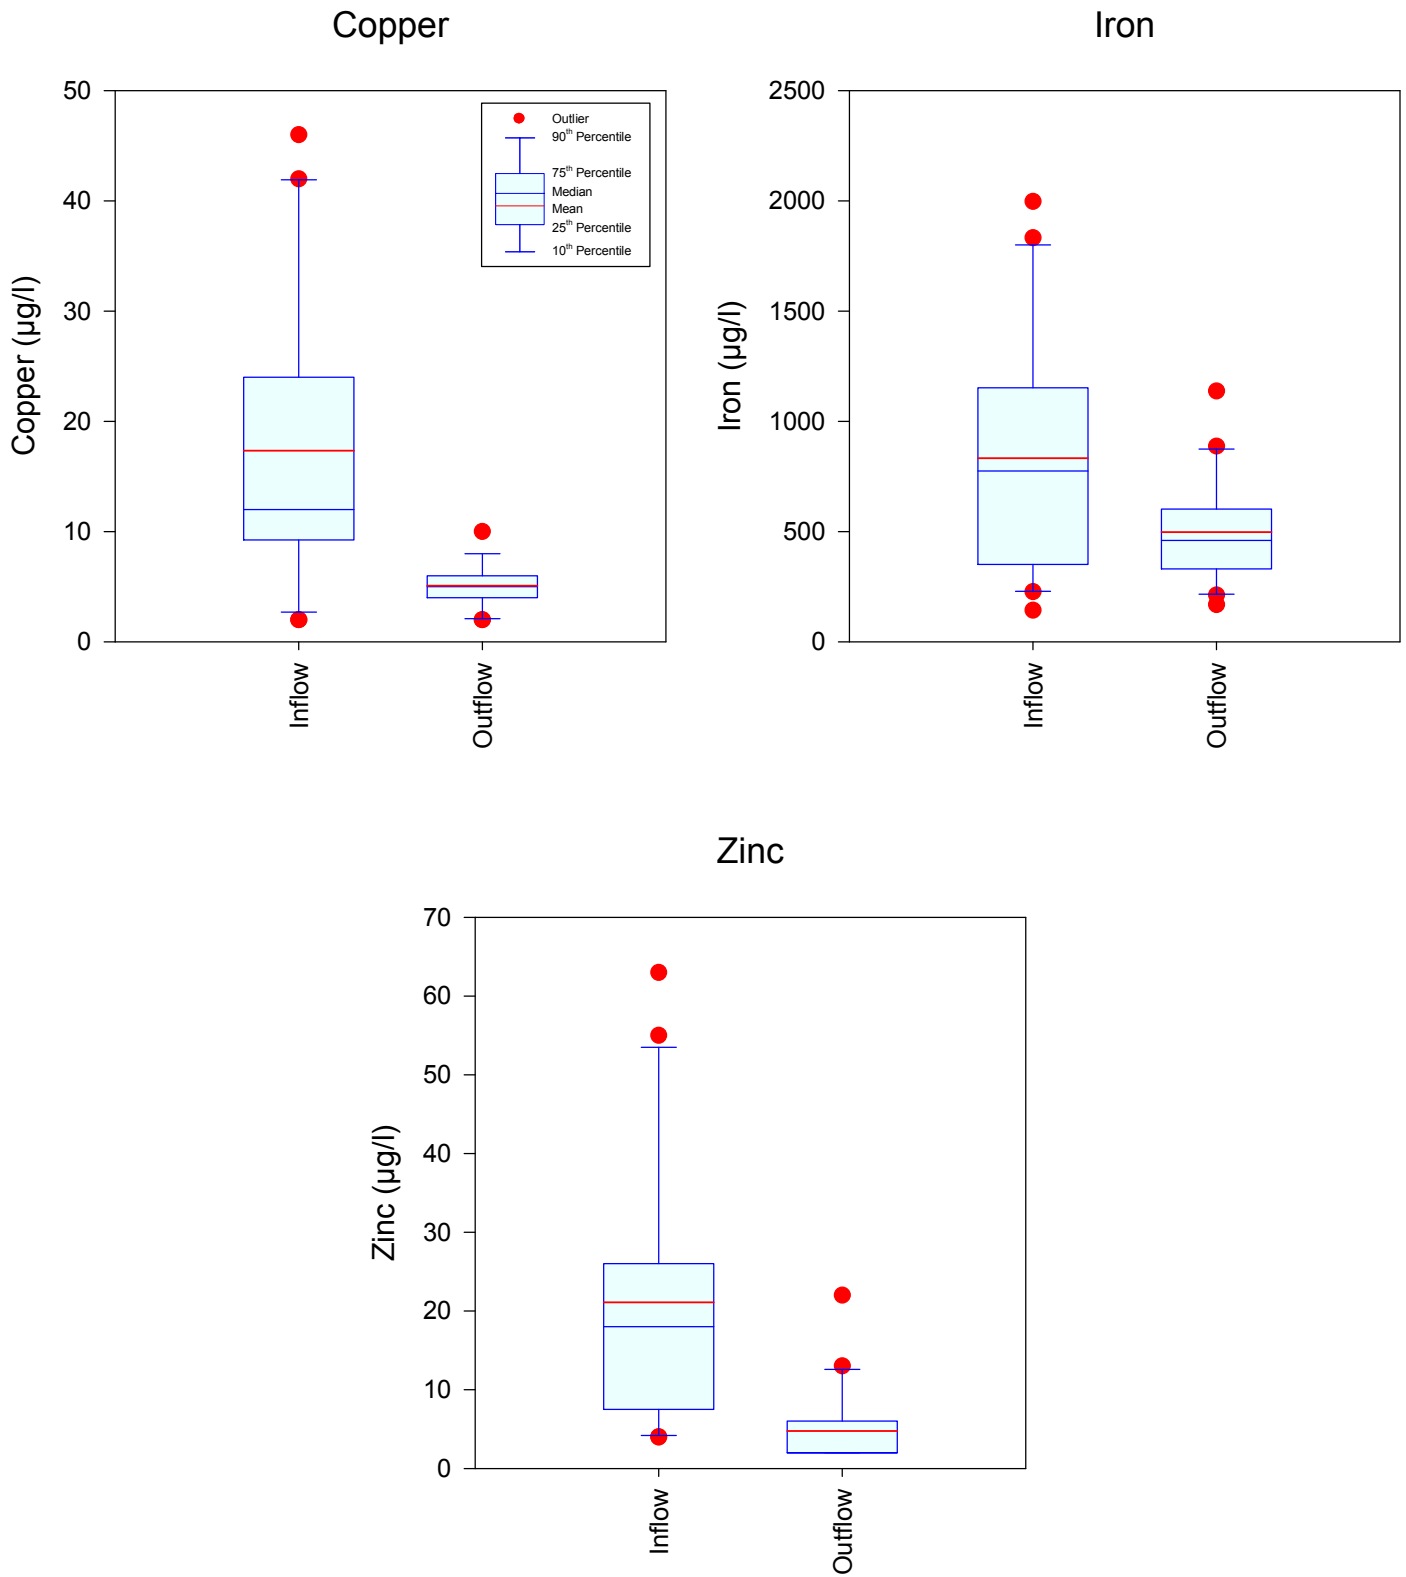
A statistical comparison of inflow and outflow concentrations of copper, iron, and zinc at the Gee Creek EcoVault® site is given on Figure 4-24. Measured inflow concentrations of total copper at the Gee Creek site exhibited a relatively high degree of variability in values. In contrast, outflow samples exhibited a low degree of variability and a substantially lower median concentration for total copper than observed at the inflow. A similar pattern is also apparent for iron. Measured iron concentrations in the inflow were highly variable, with a relatively elevated median concentration. In contrast, total iron concentrations in the discharge exhibited a substantially lower degree of variability as well as a lower median value. A similar pattern was also observed for zinc, with highly variable and elevated concentrations at the inflow compared with a low degree of variability and a lower median concentration observed at the outflow.

Figure 4-24. Statistical Comparison of Inflow and Outflow Concentrations of Copper, Iron, and Zinc at the Gee Creek EcoVault® Site.

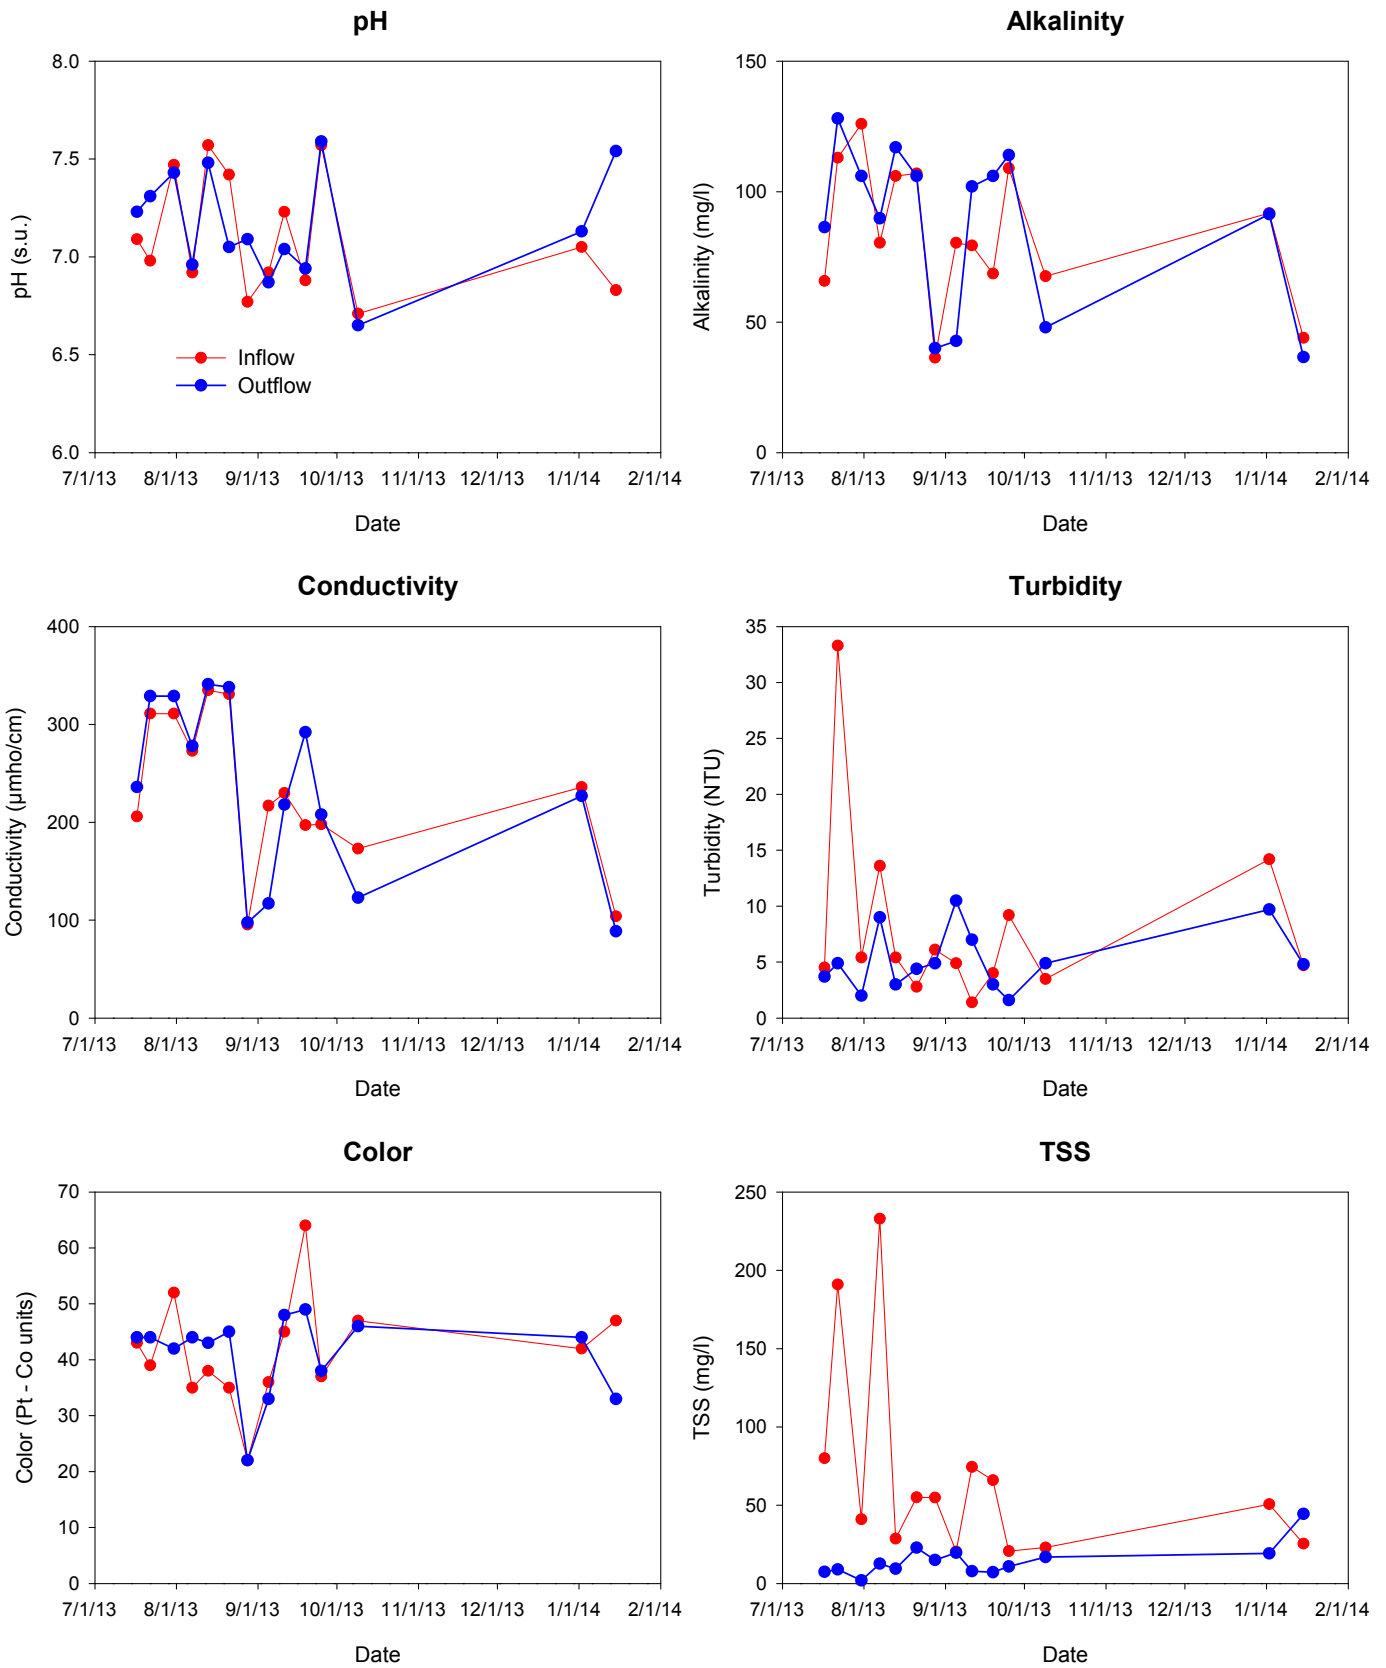
Figure 4-25. Comparison of Inflow and Outflow Concentrations of pH, Alkalinity, Conductivity, Turbidity, Color, and TSS at the San Pablo EcoVault® Site.

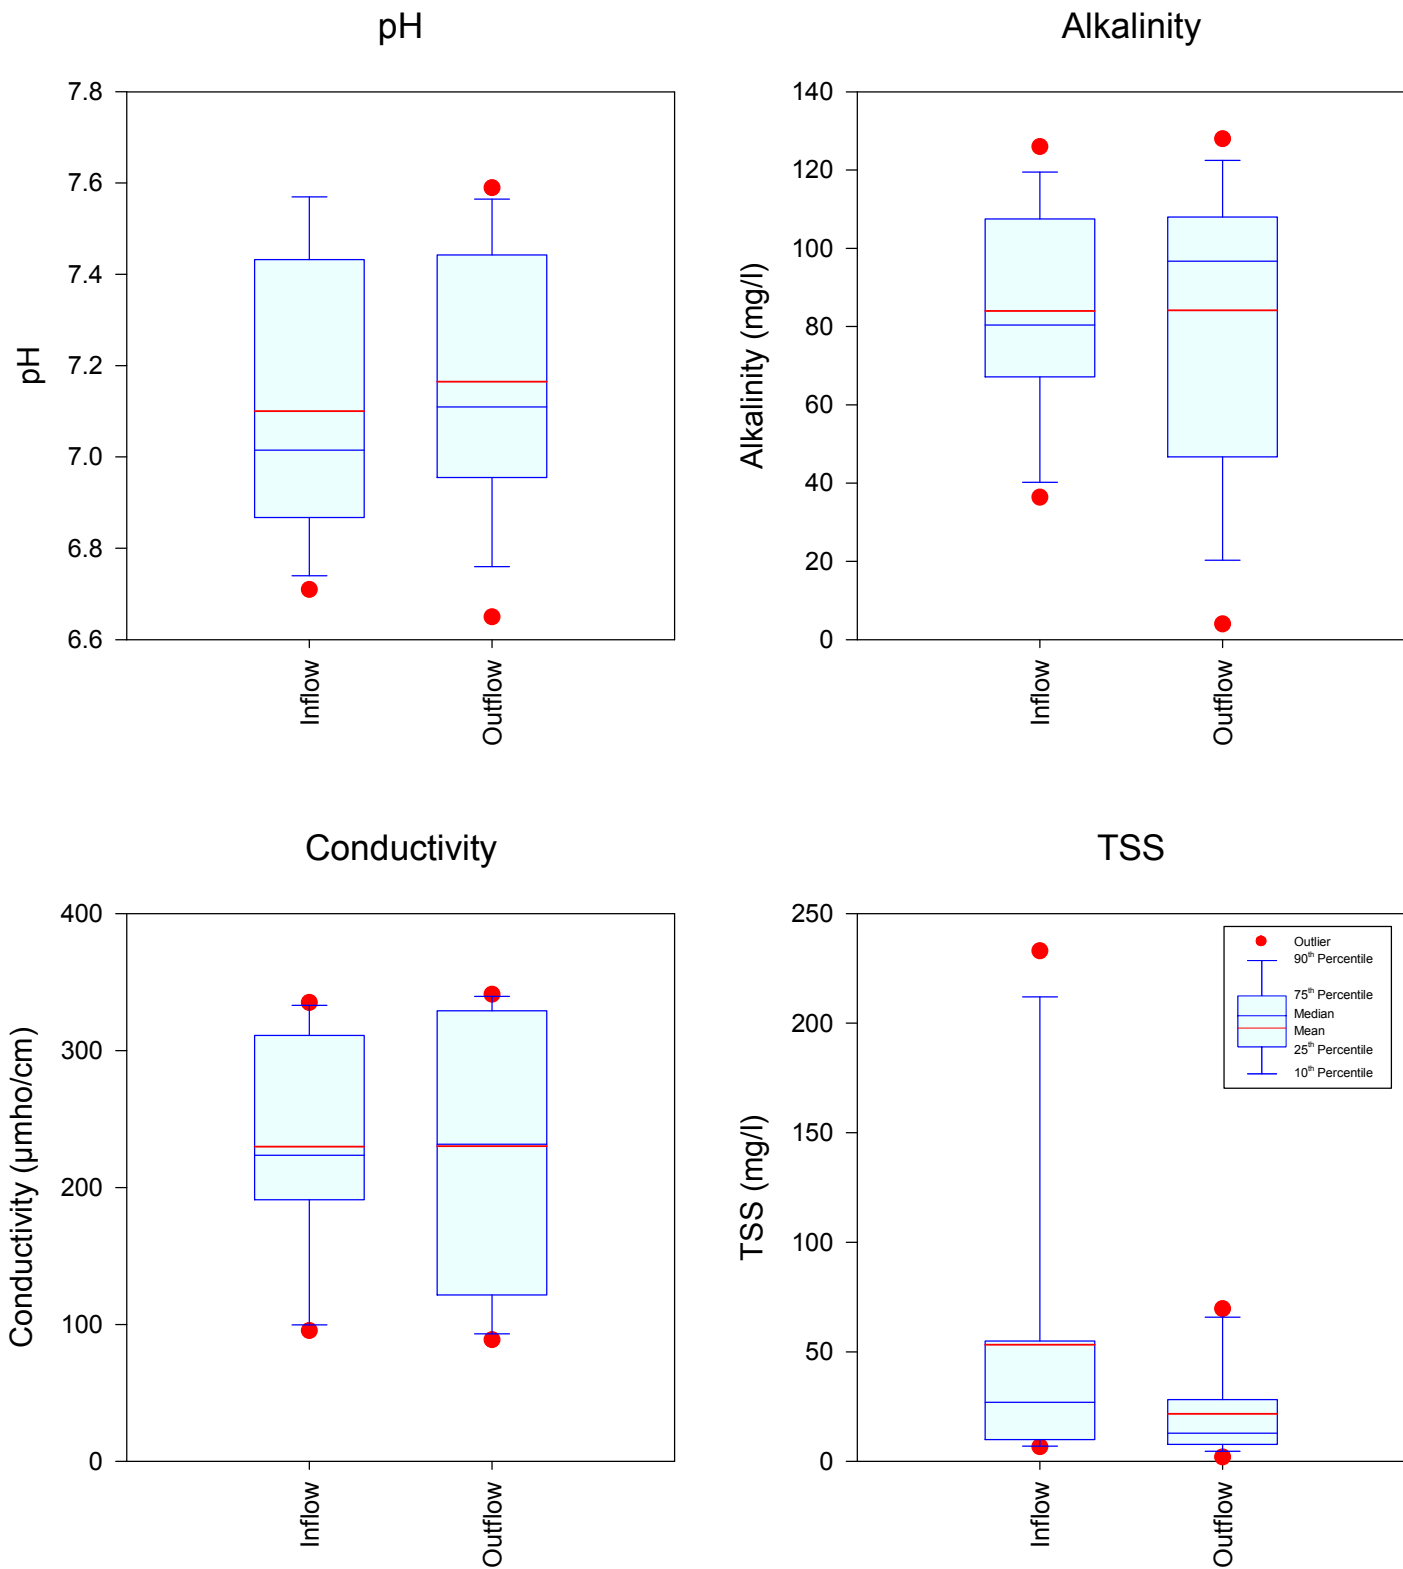
Figure 4-26. Statistical Comparison of Inflow and Outflow Concentrations of pH, Alkalinity, Conductivity, and TSS at the San Pablo EcoVault® Site.

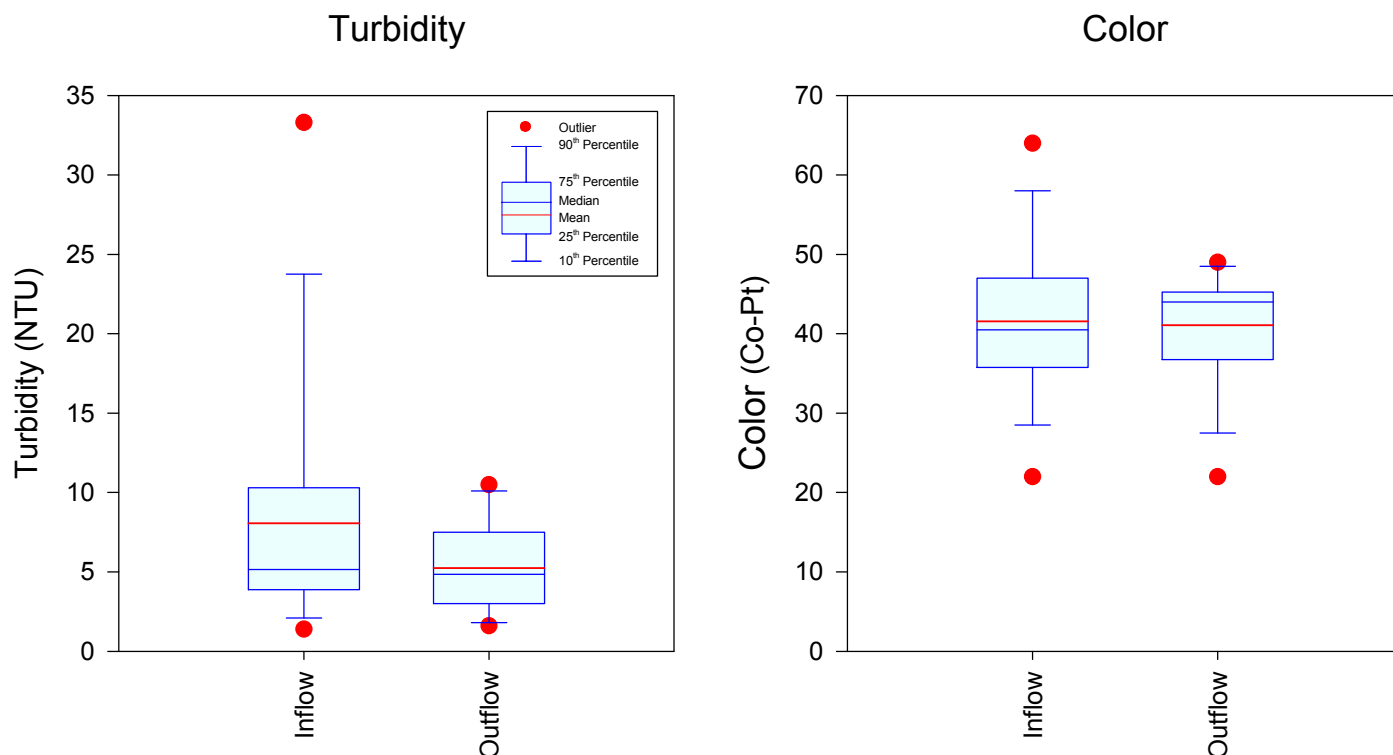
Figure 4-27. Statistical Comparison of Inflow and Outflow Concentrations of Turbidity and Color at the San Pablo EcoVault® Site.

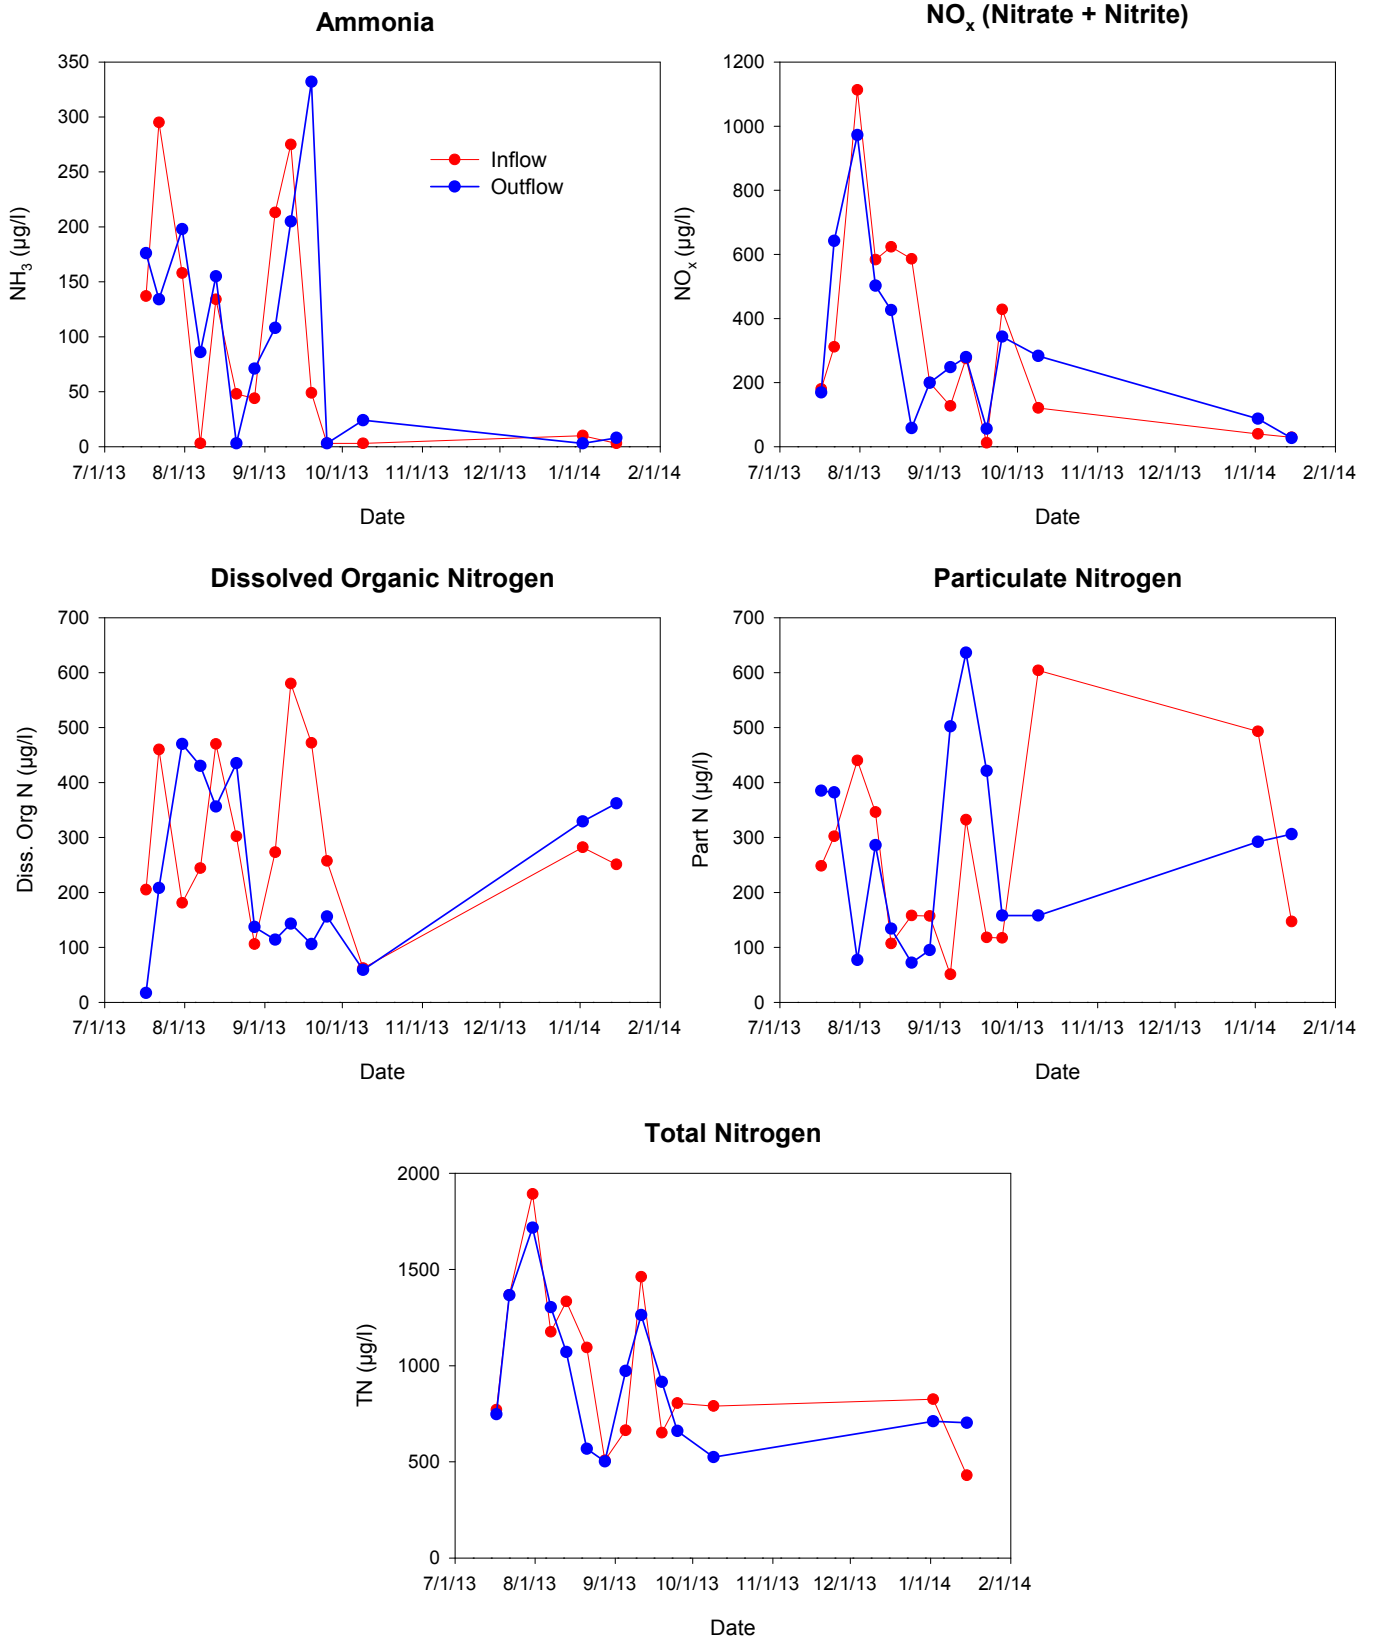
Figure 4-28. Comparison of Inflow and Outflow Concentrations of Nitrogen Species at the San Pablo EcoVault® Site.

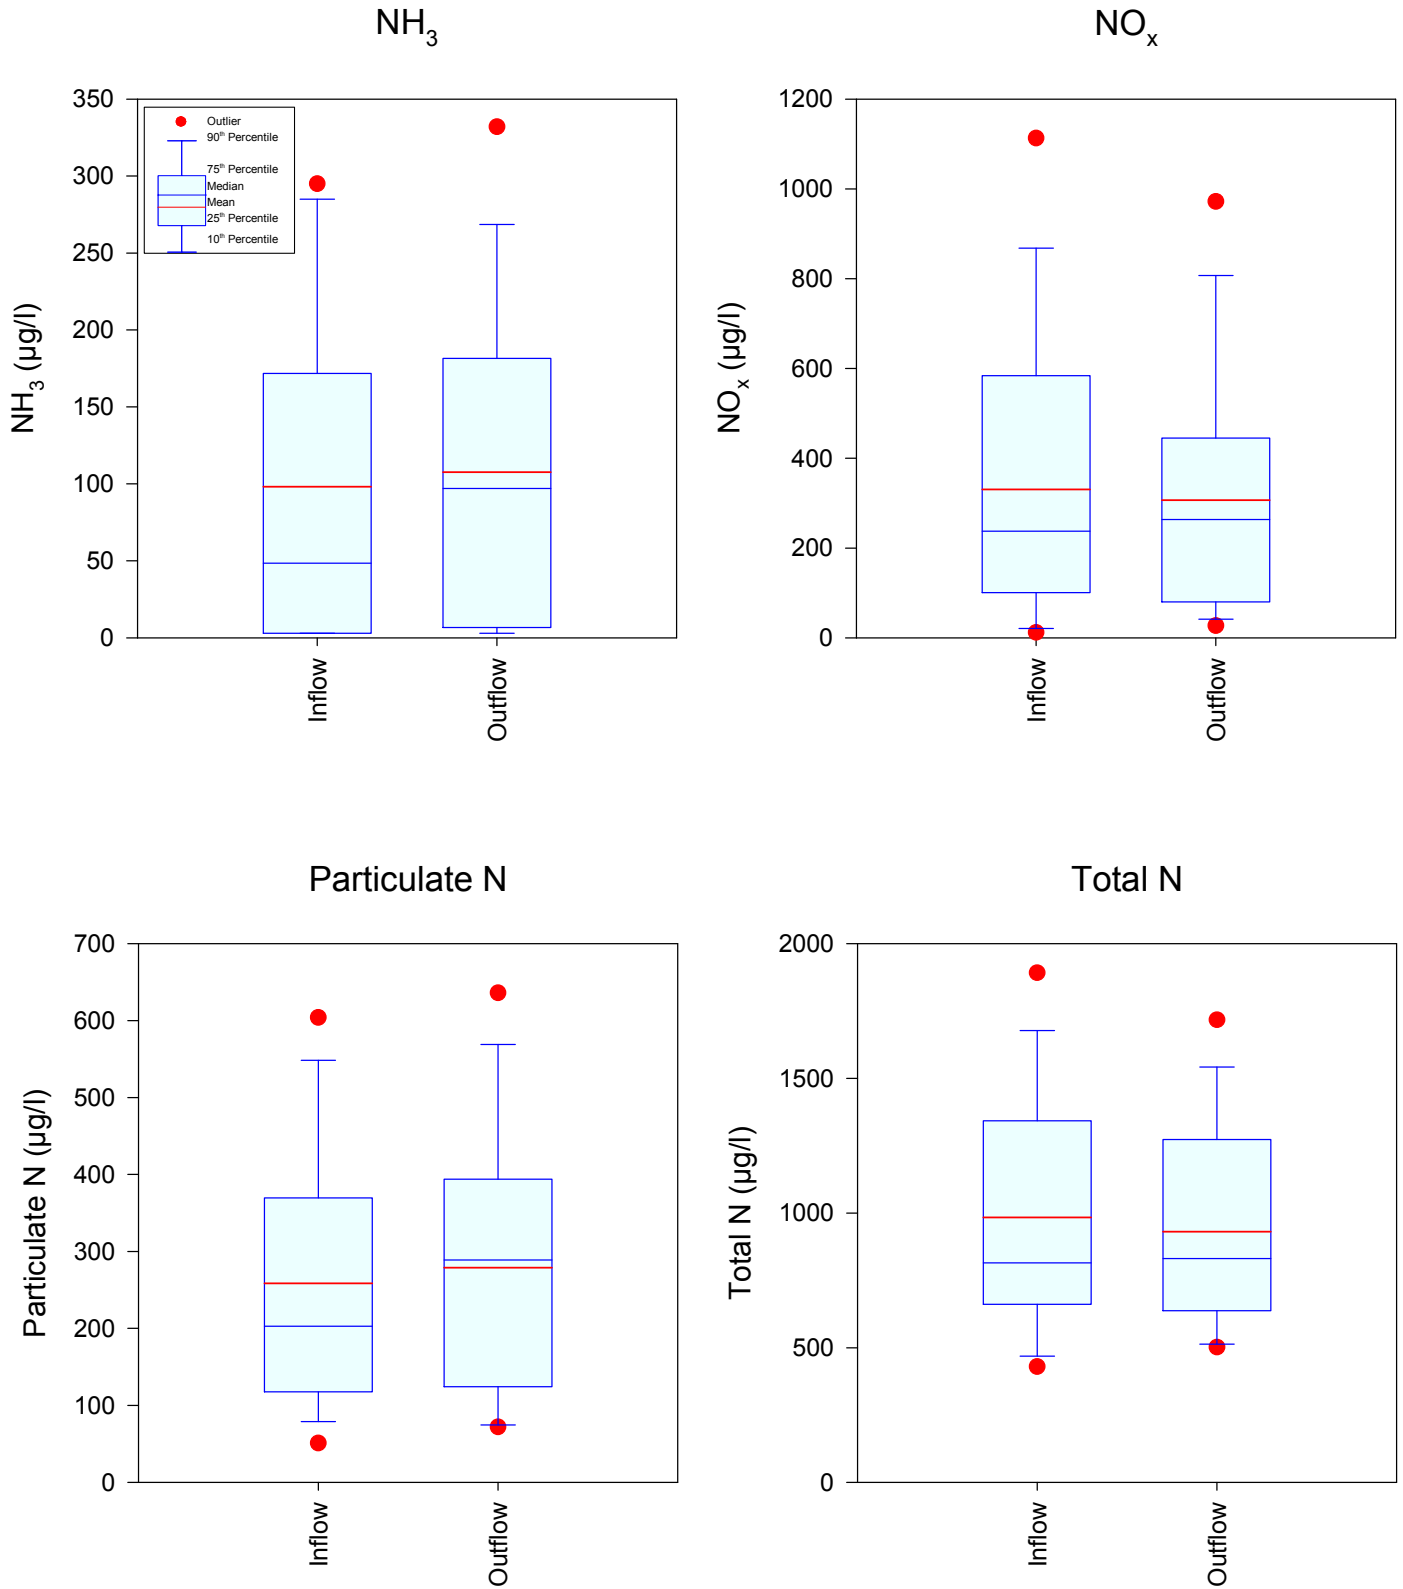
Figure 4-29. Statistical Comparison of Inflow and Outflow Concentrations of Nitrogen Species at the San Pablo EcoVault® Site.

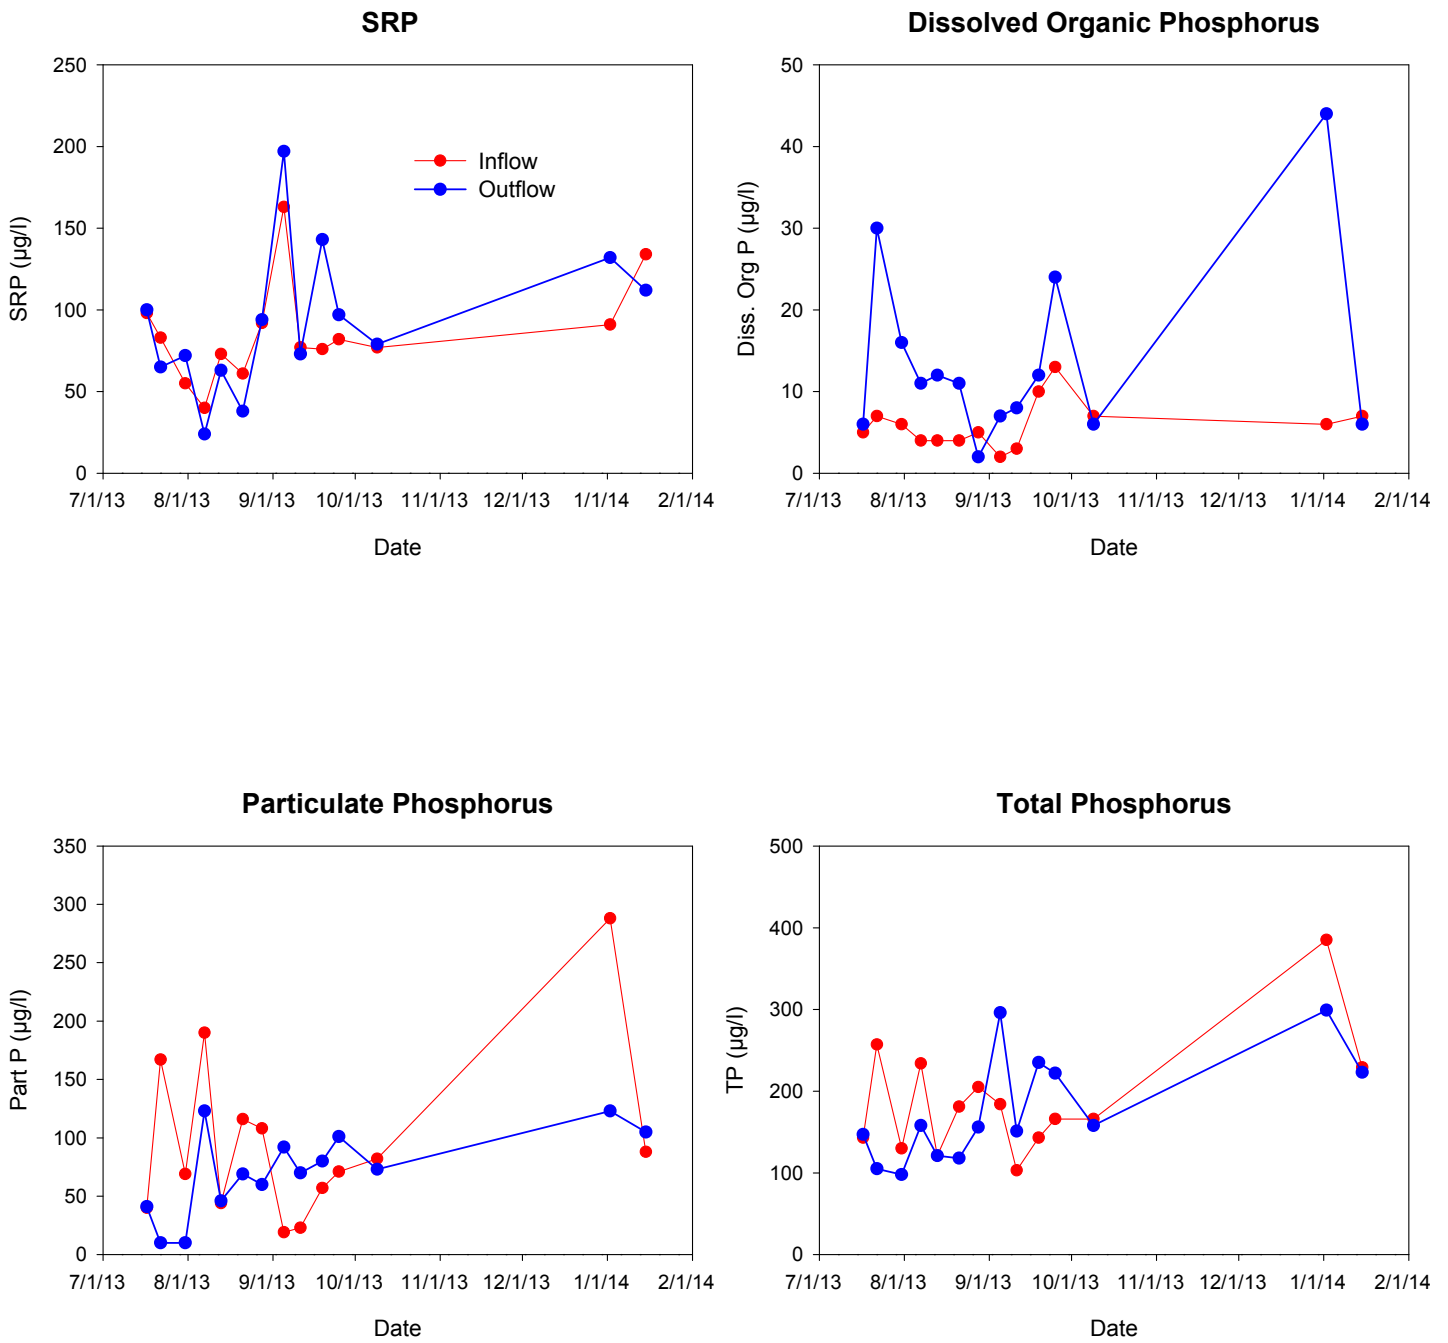
Figure 4-30. Comparison of Inflow and Outflow Concentrations of Phosphorus Species at the San Pablo EcoVault® Site.

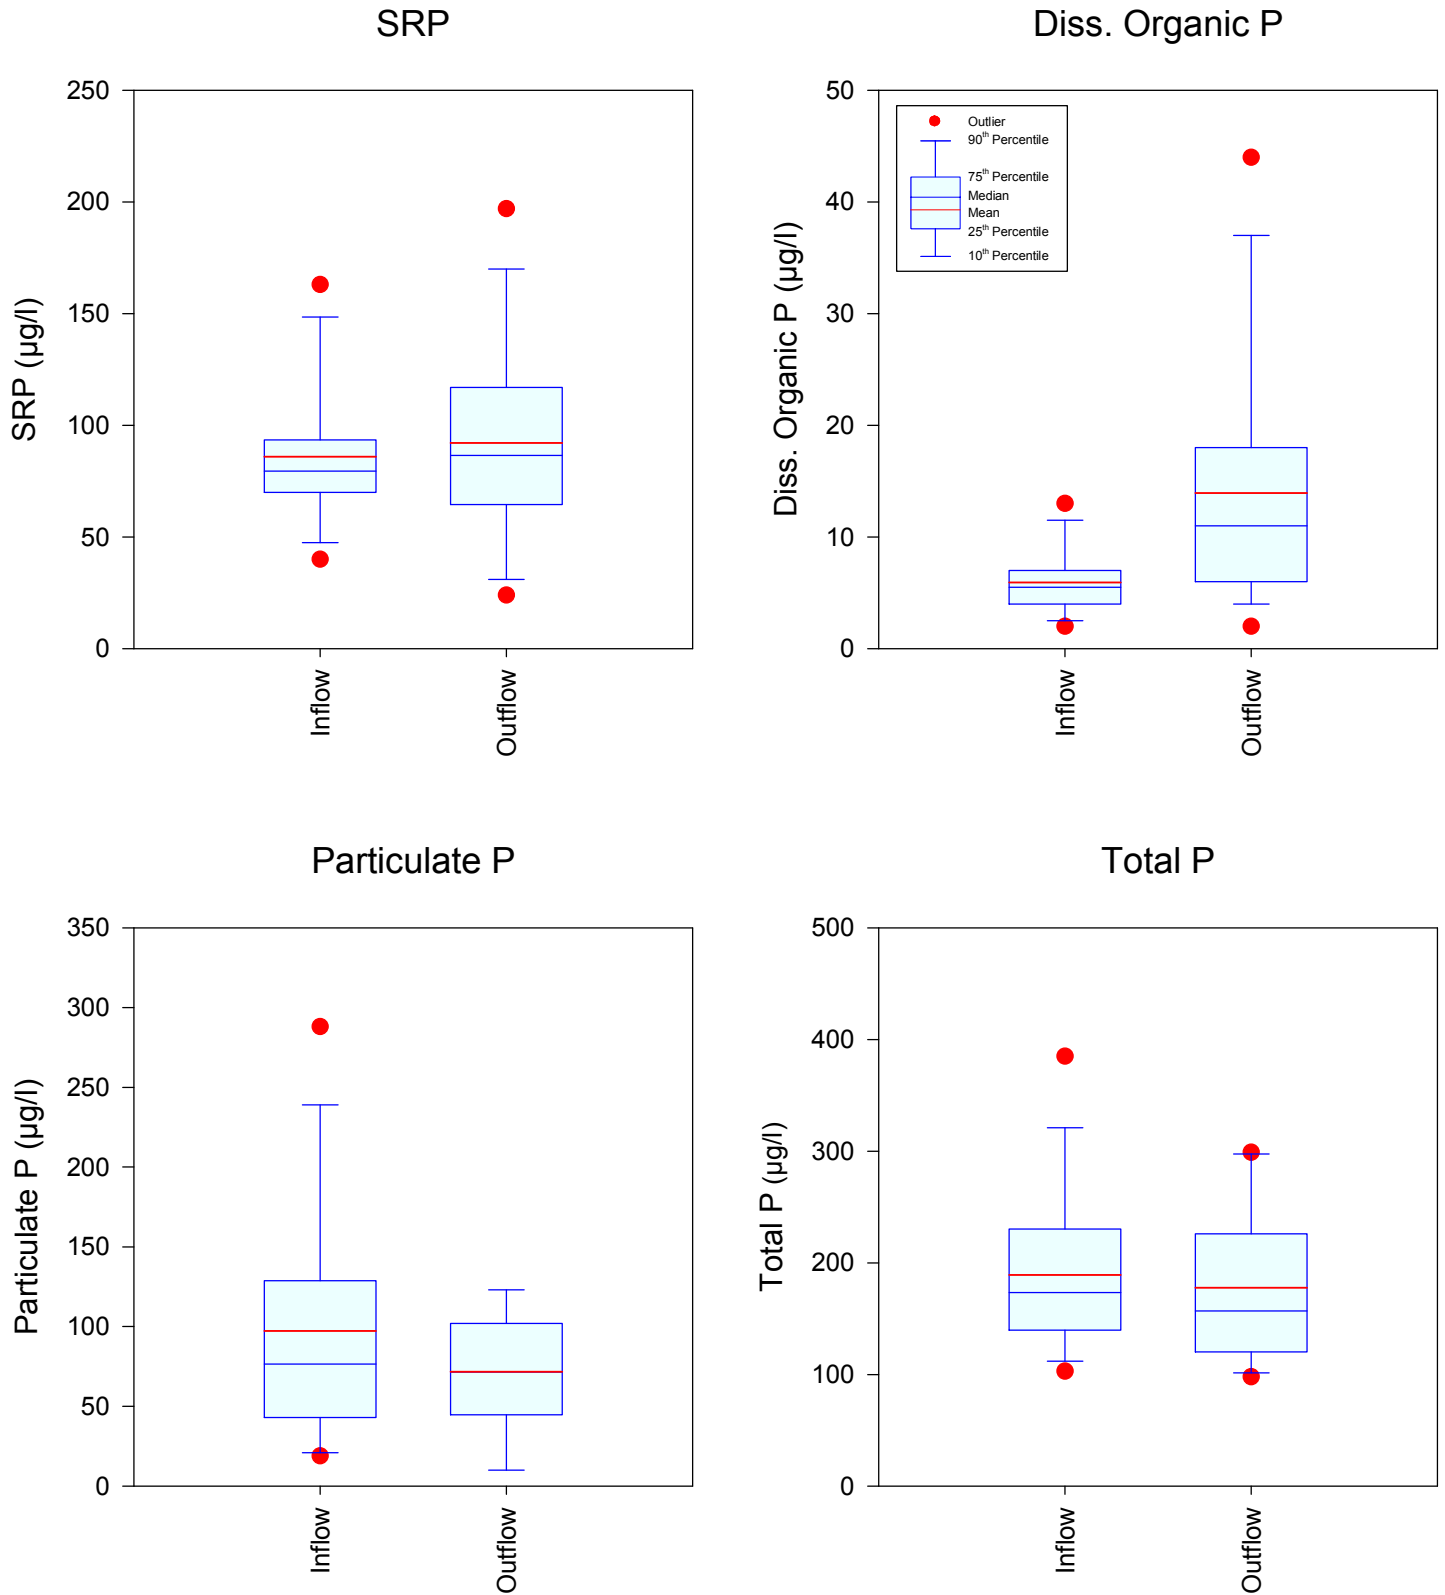
Figure 4-31. Statistical Comparison of Inflow and Outflow Concentrations of Phosphorus Species at the San Pablo EcoVault® Site.

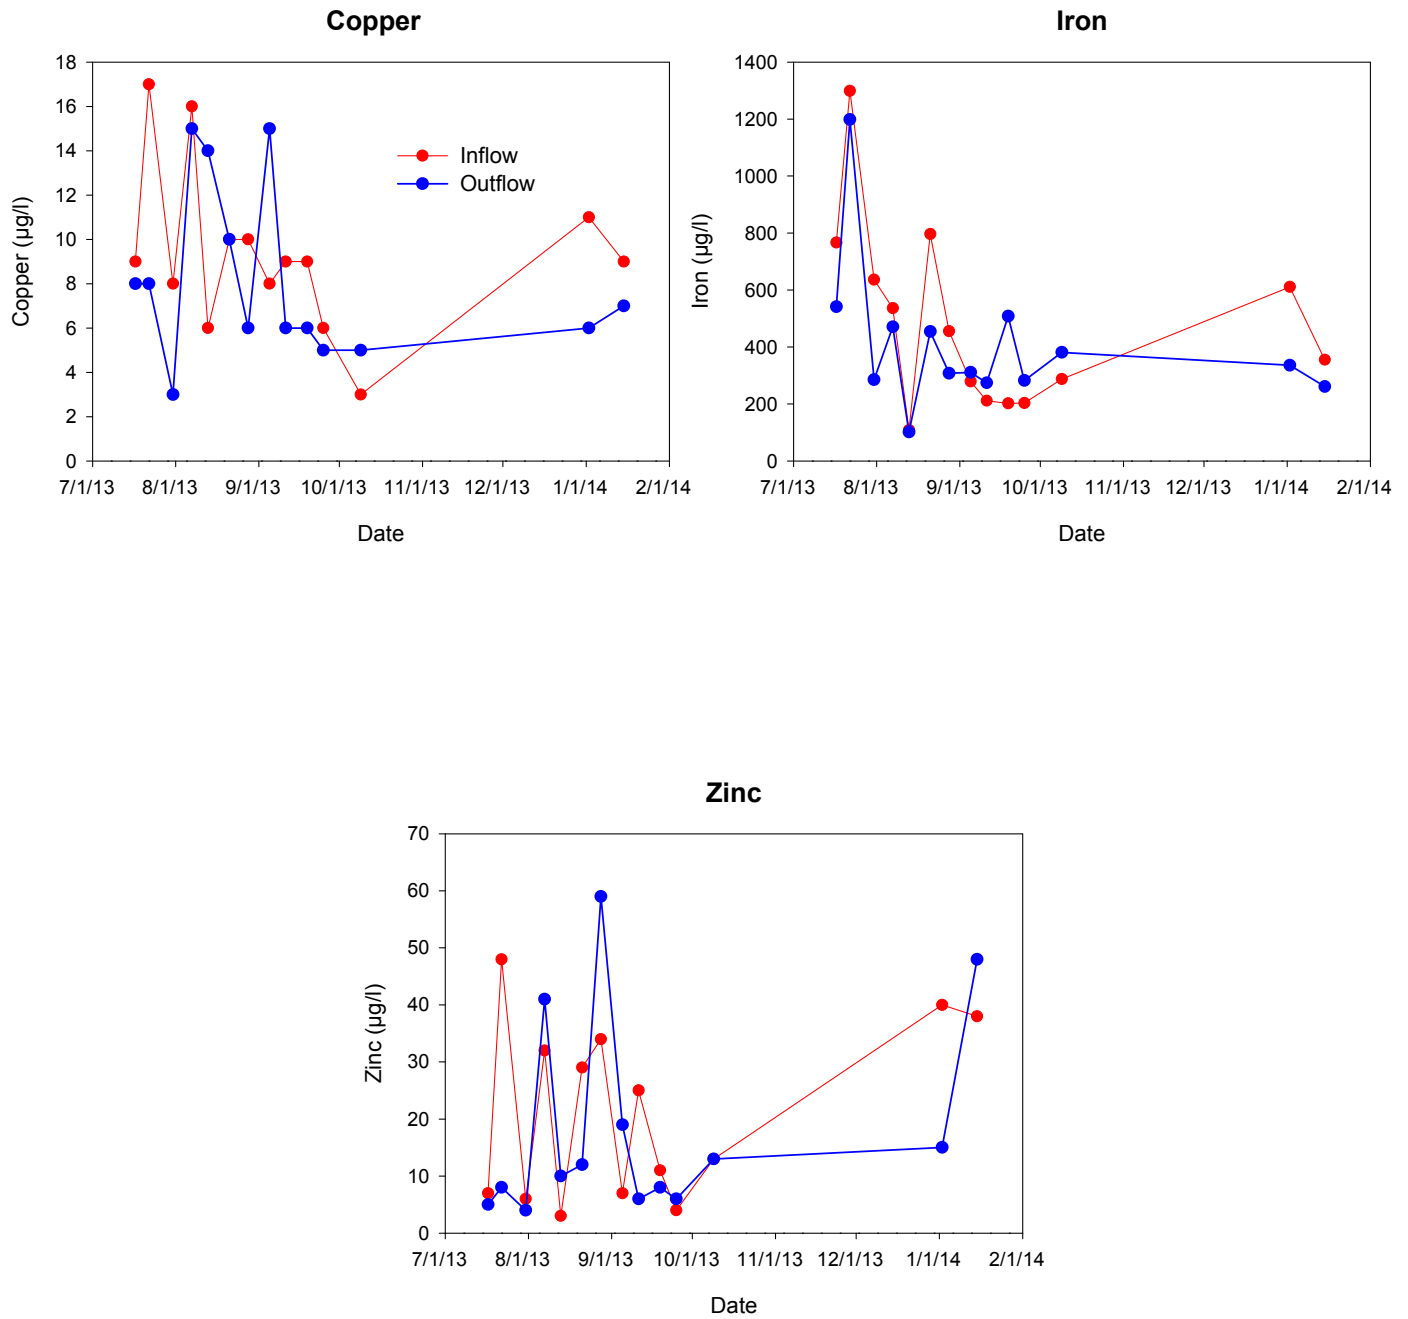
Figure 4-32. Comparison of Inflow Concentrations of Copper, Iron, and Zinc at the San Pablo EcoVault® Site.

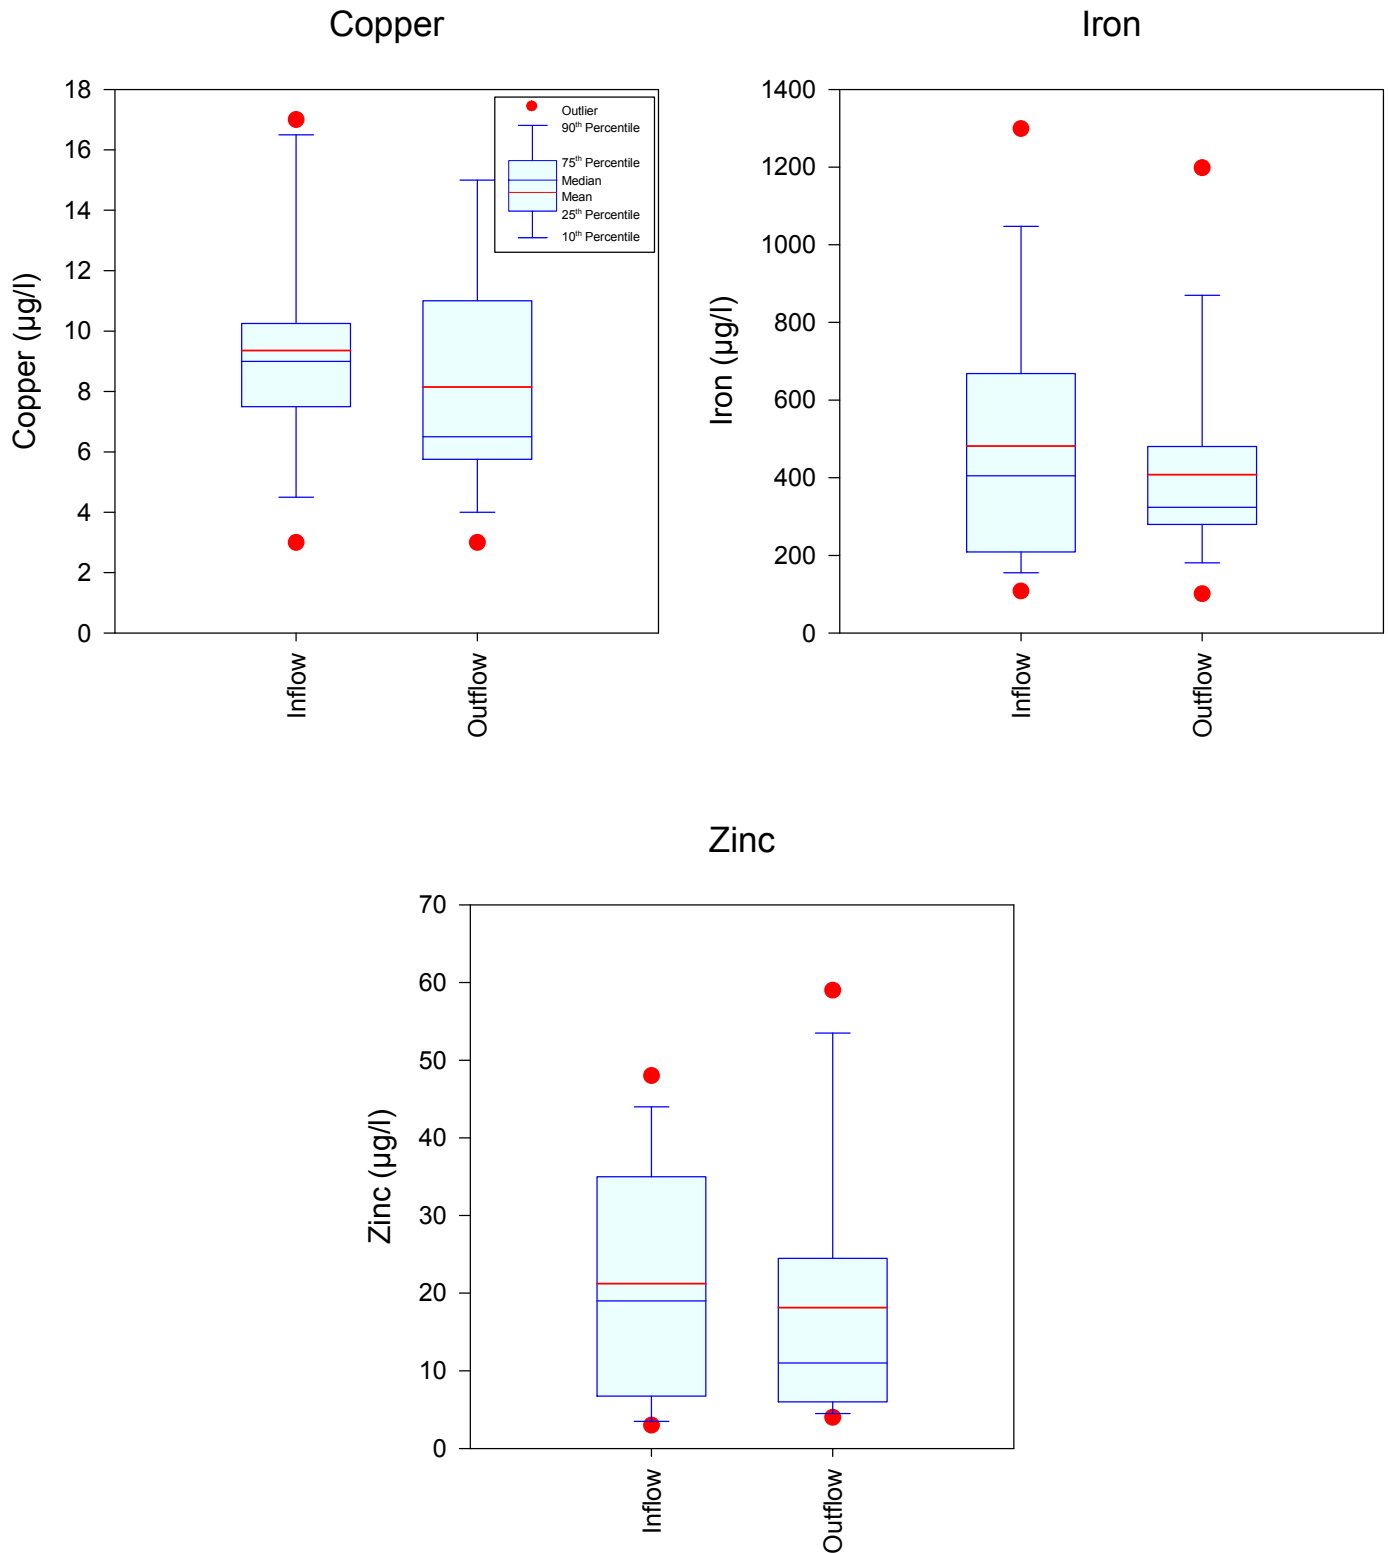
Figure 4-33. Statistical Comparison of Inflow and Outflow Concentrations of Copper, Iron, and Zinc at the Lake Hodge EcoVault® Site.
