Baffle Box with Media Filtration Installation,
Effectiveness Evaluation, and Associated Education for
the Lake Jesup Watershed

Contract S0497

Final Report

City of Casselberry

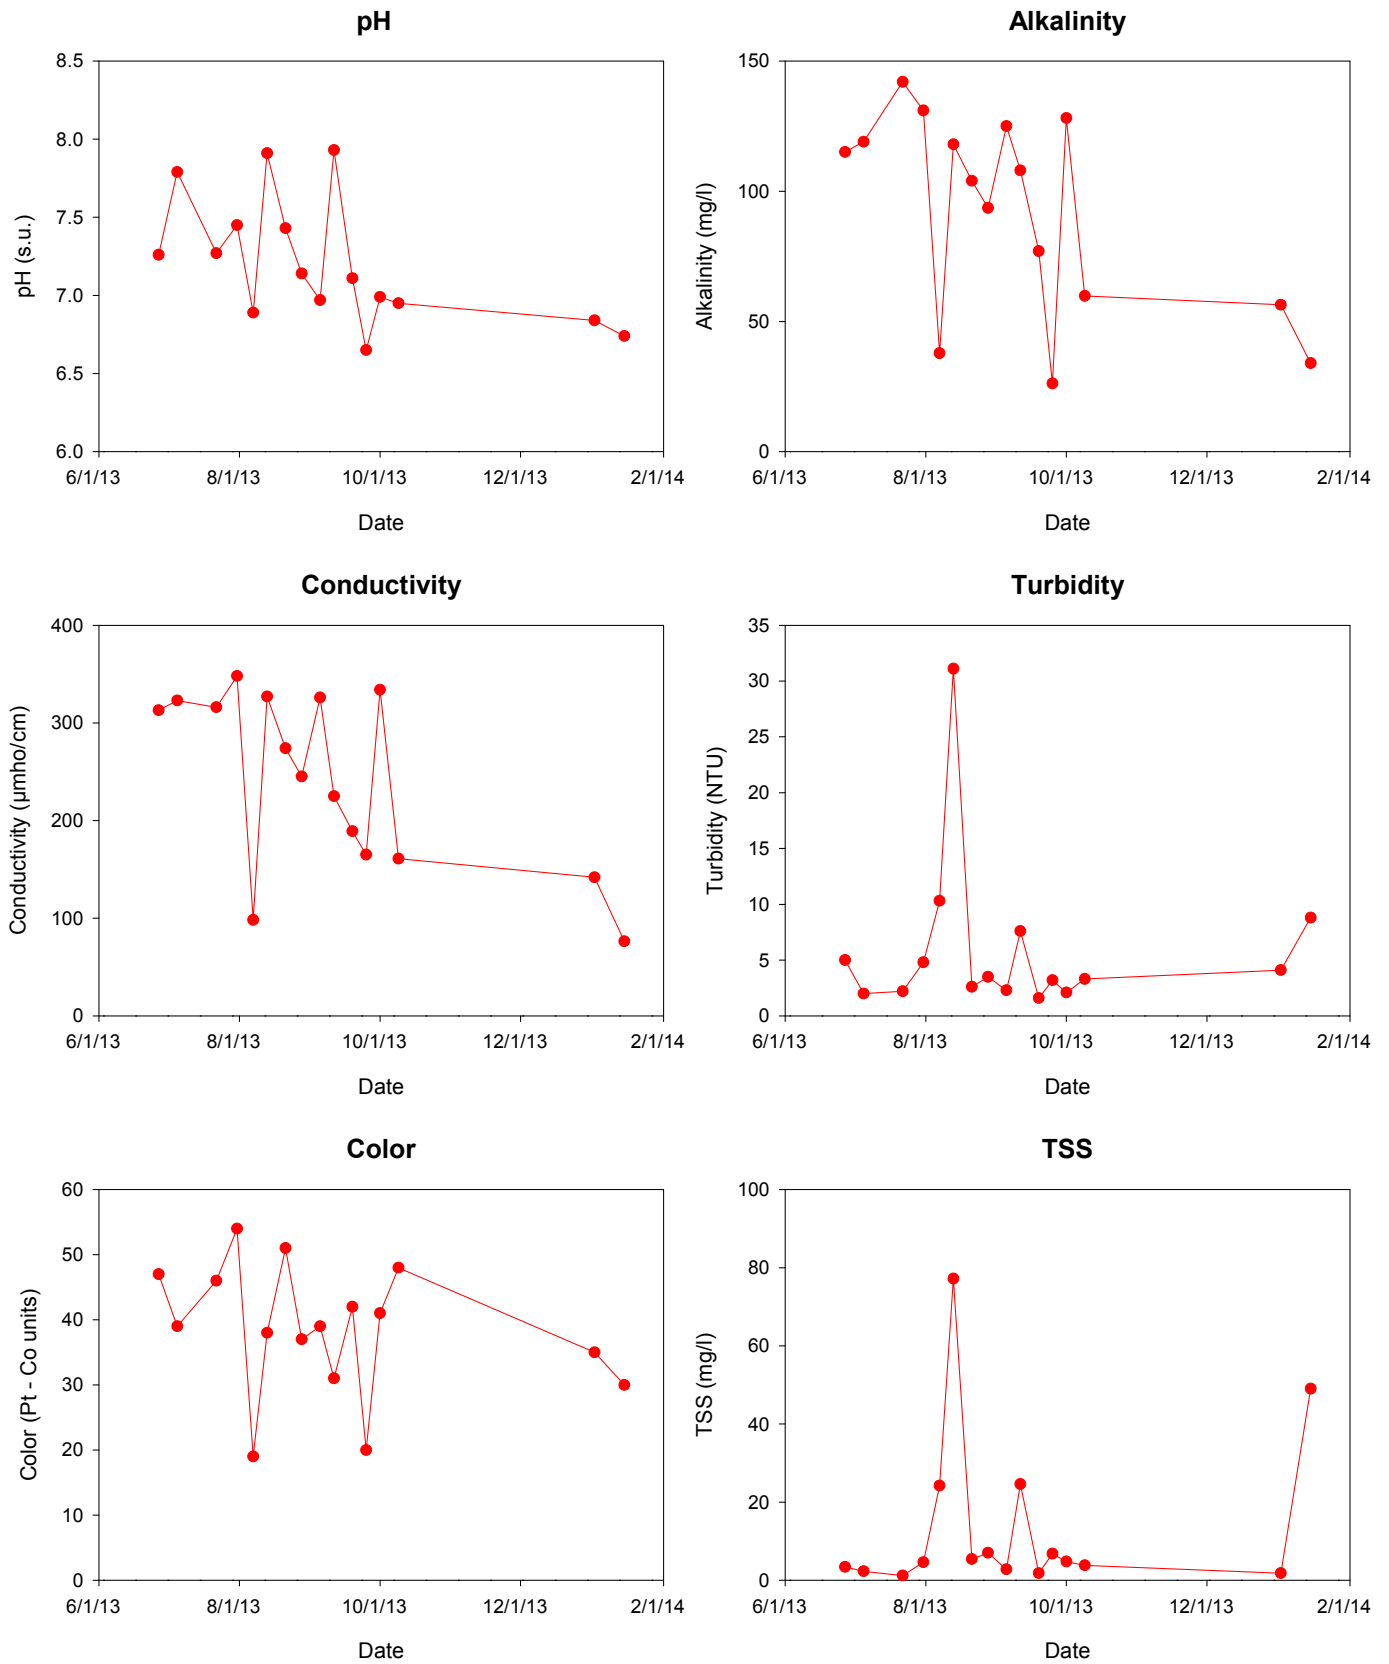
Figure 4-34. Characteristics of Outflow Concentrations of pH, Alkalinity, Conductivity, Turbidity, Color, and TSS at the San Pablo CDS Site.

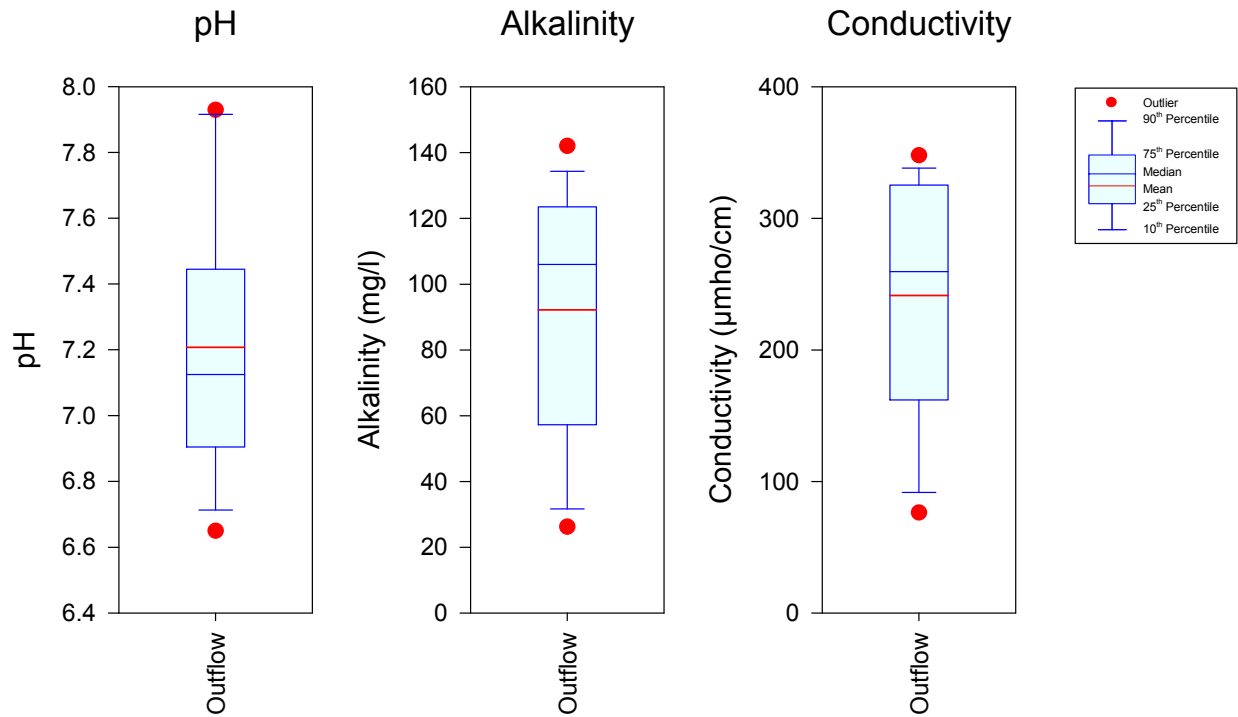
Figure 4-35. Statistical Summary of Outflow Concentrations of pH, Alkalinity, and Conductivity at the San Pablo CDS Site.

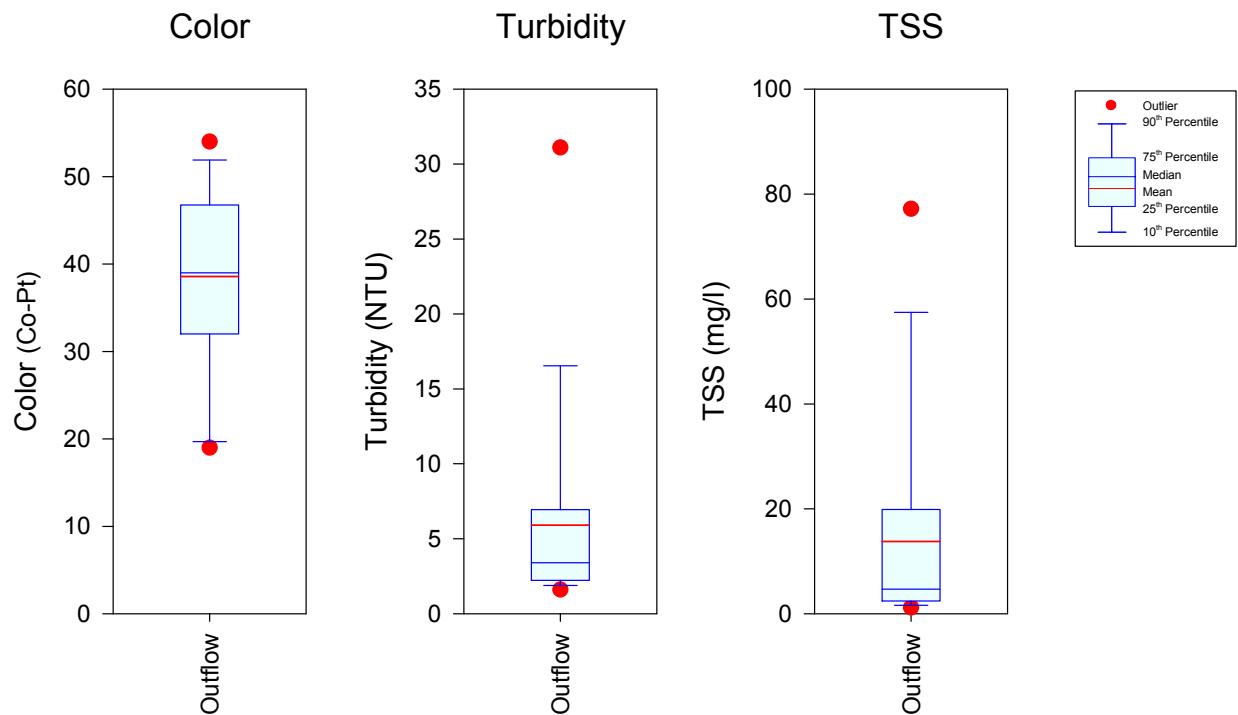
Figure 4-36. Statistical Summary of Outflow Concentrations of Color, Turbidity, and TSS at the San Pablo CDS Site.

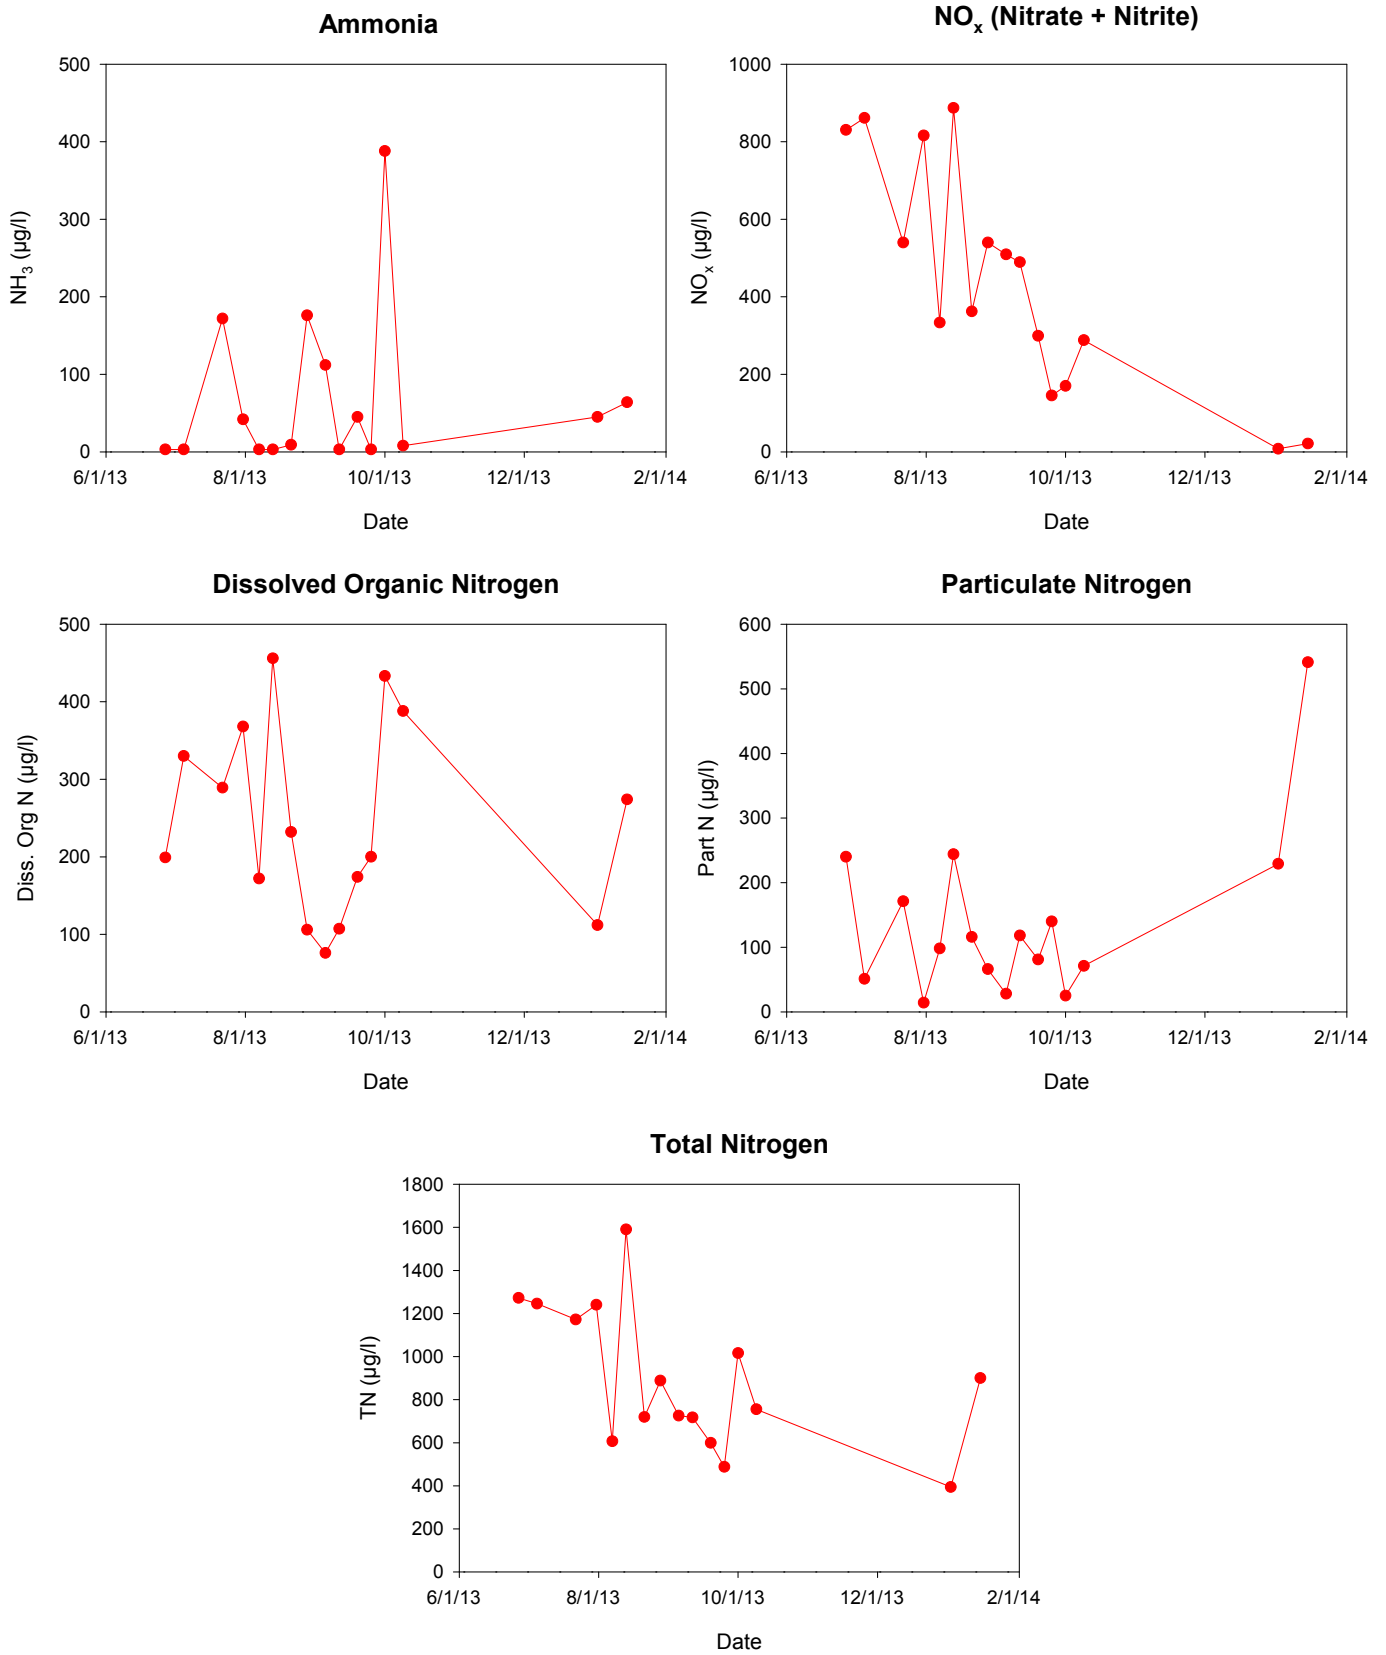
A graphical summary of measured outflow concentrations of nitrogen species at the San Pablo CDS site is given on Figure 4-37. In general, measured concentrations for each of the evaluated nitrogen species were highly variable during the field monitoring program. Measured concentrations of ammonia in the discharge ranged from < 5-388 $\mu\text{g/l}$, reflecting low to moderate elevations. A wide range of NO_x concentrations was measured in the discharge, with values ranging from 8-887 $\mu\text{g/l}$, reflecting low to elevated values.

Figure 4-37. Characteristics of Outflow Concentrations of Nitrogen Species at the San Pablo CDS Site.

Measured concentrations of dissolved organic nitrogen in the discharge ranged from 76-456 $\mu\text{g/l}$, reflecting low to moderate concentrations. Measured concentrations of particulate nitrogen were generally less than 250 $\mu\text{g/l}$, with the exception of a single outlier value, reflecting moderate concentrations for this parameter.

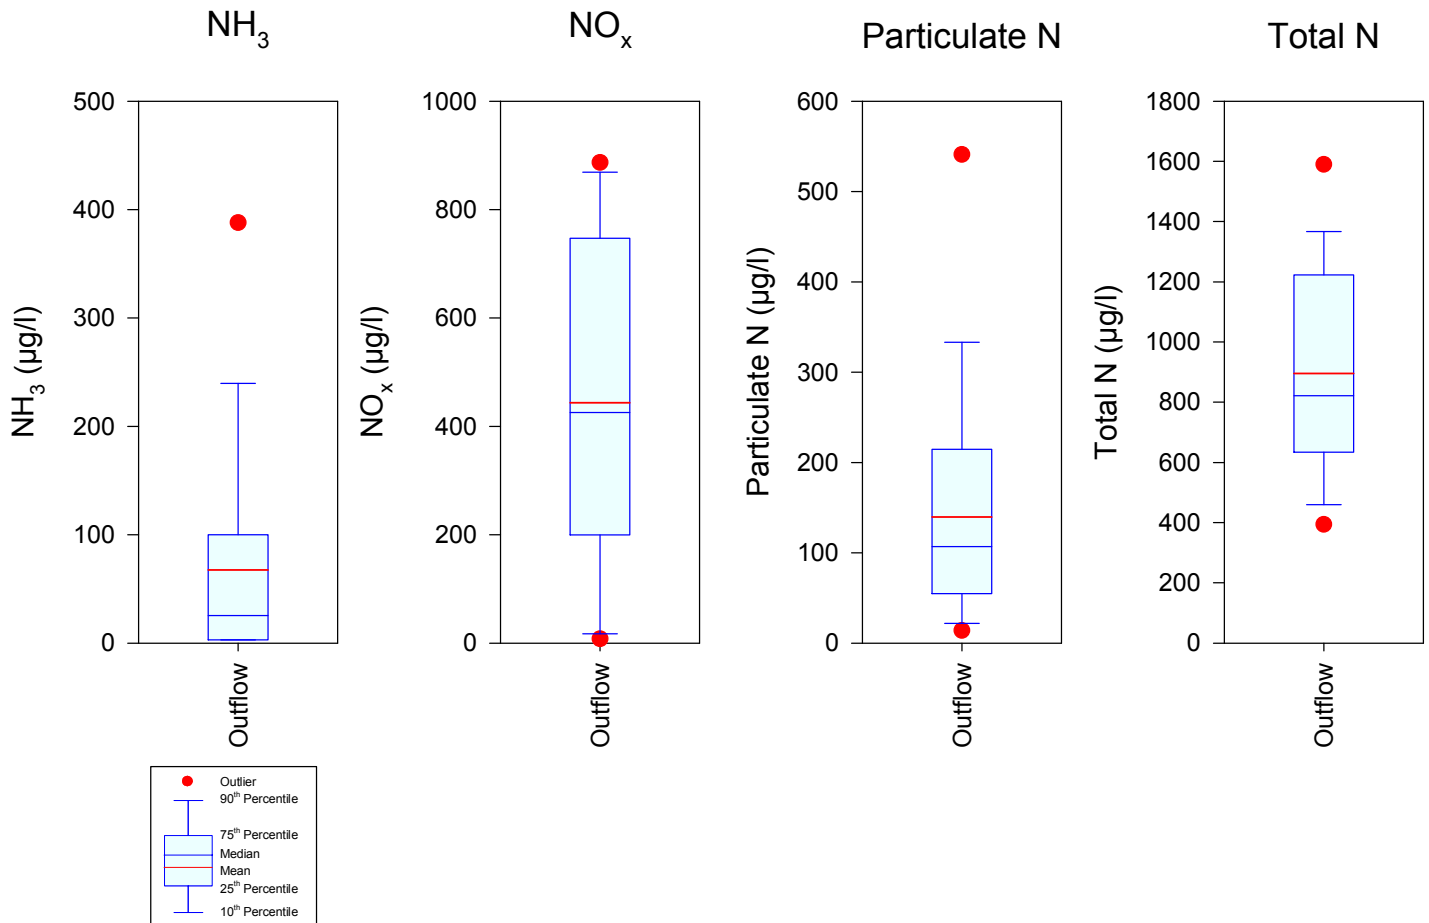
Figure 4-38. Statistical Summary of Outflow Concentrations of Nitrogen Species at the San Pablo CDS Site.

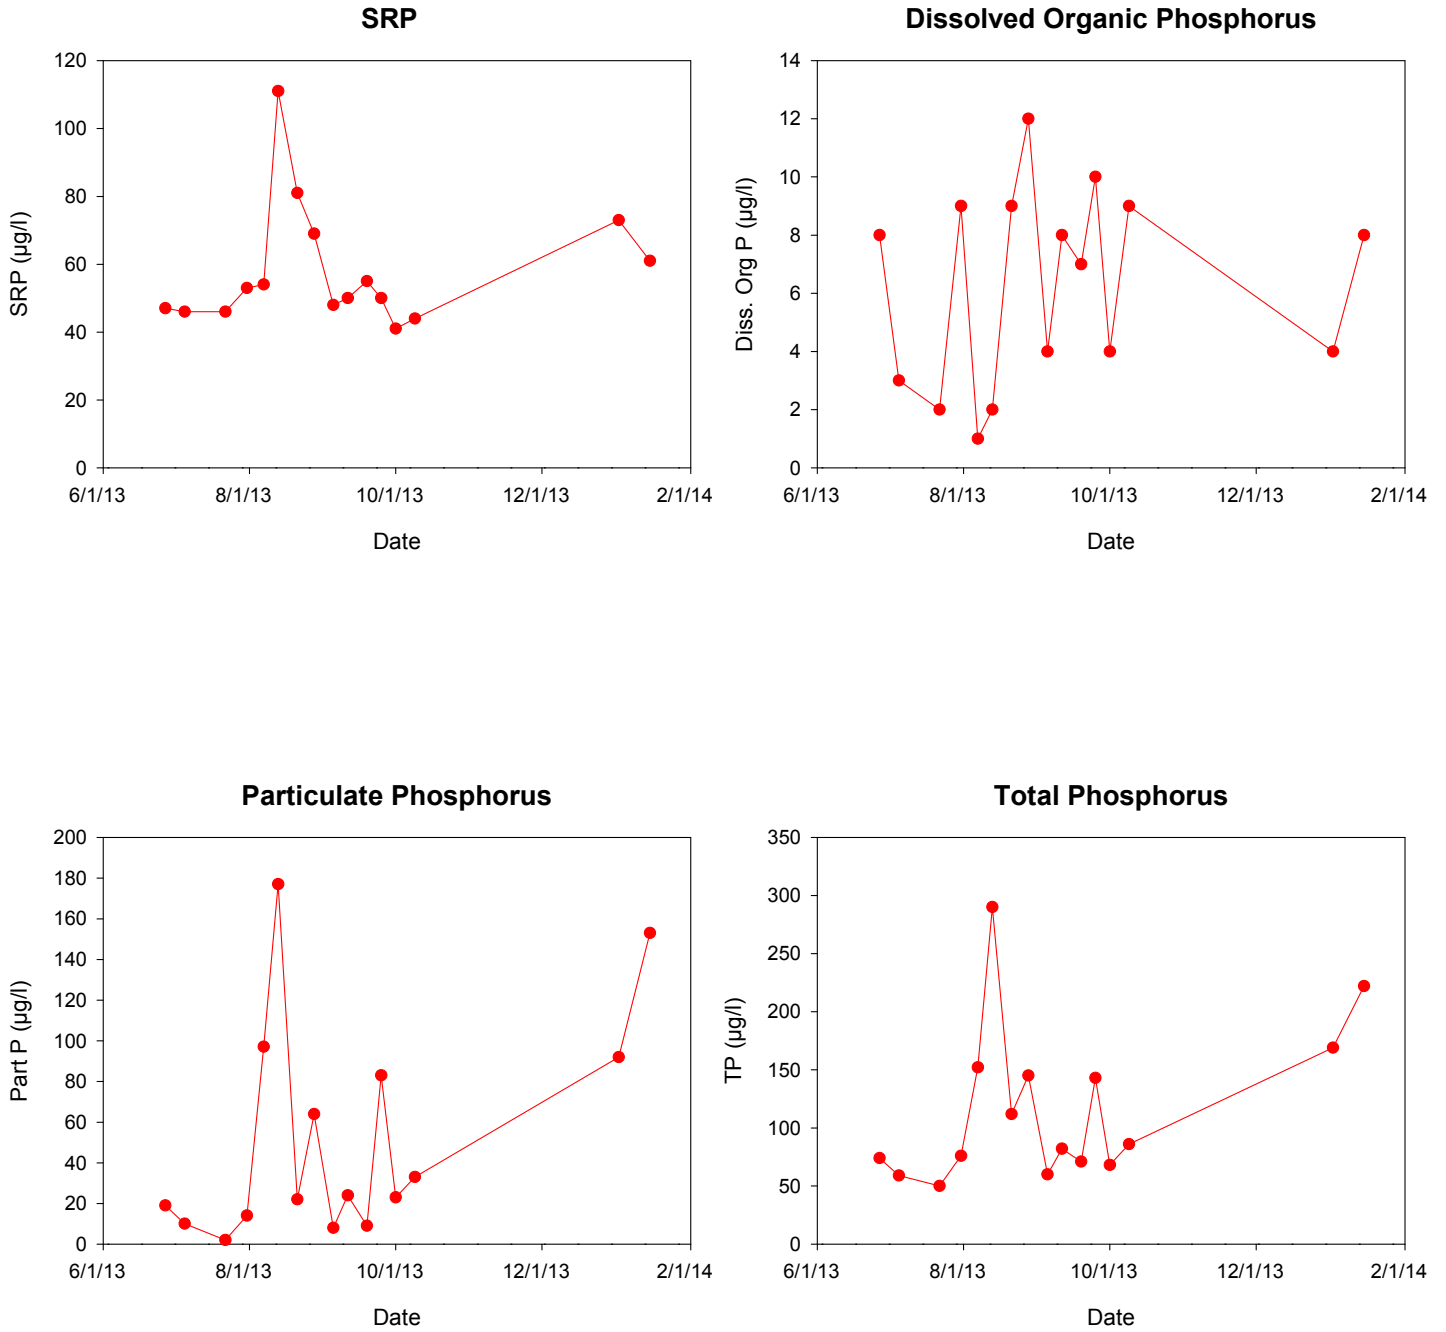
A comparison of measured discharge concentrations of phosphorus species at the San Pablo CDS site is given on Figure 4-39. Measured discharge concentrations of SRP were highly variable, ranging from 41-111 $\mu\text{g/l}$, reflecting values commonly observed in urban runoff. Measured discharge concentrations of dissolved organic phosphorus were also highly variable, but low in value. Particulate phosphorus concentrations were highly variable in the discharge, ranging from 2-177 $\mu\text{g/l}$, reflecting low to slightly elevated values. Overall, total phosphorus concentrations in the discharge range from 50-290 $\mu\text{g/l}$, with overall observed values somewhat less than commonly observed in urban runoff.

Figure 4-39. Characteristics of Outflow Concentrations of Phosphorus Species at the San Pablo CDS Site.

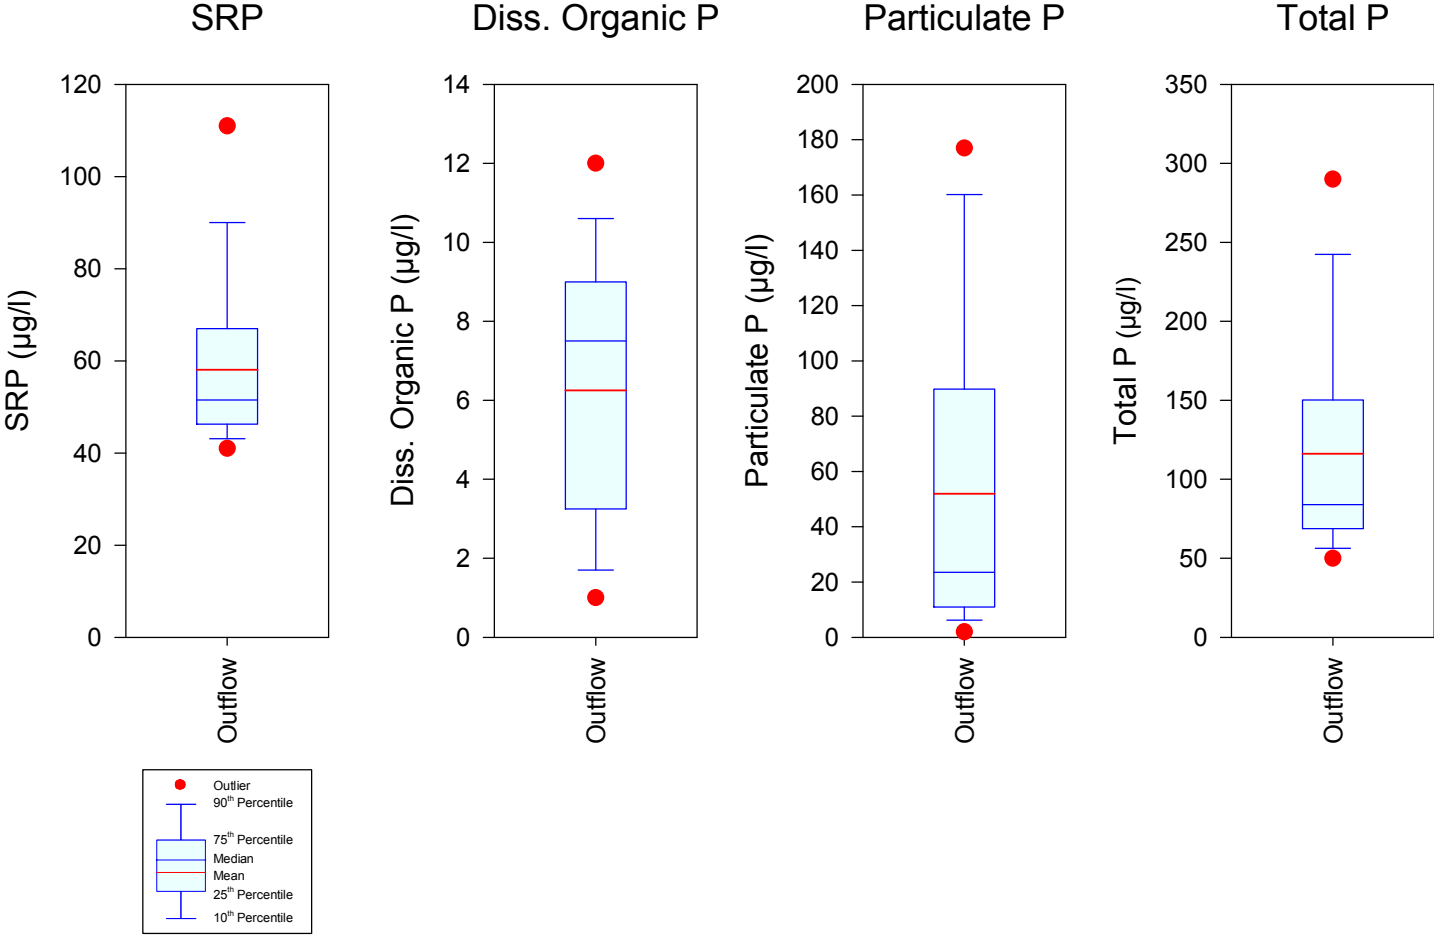
Figure 4-40. Statistical Summary of Outflow Concentrations of Phosphorus Species at the San Pablo CDS Site.

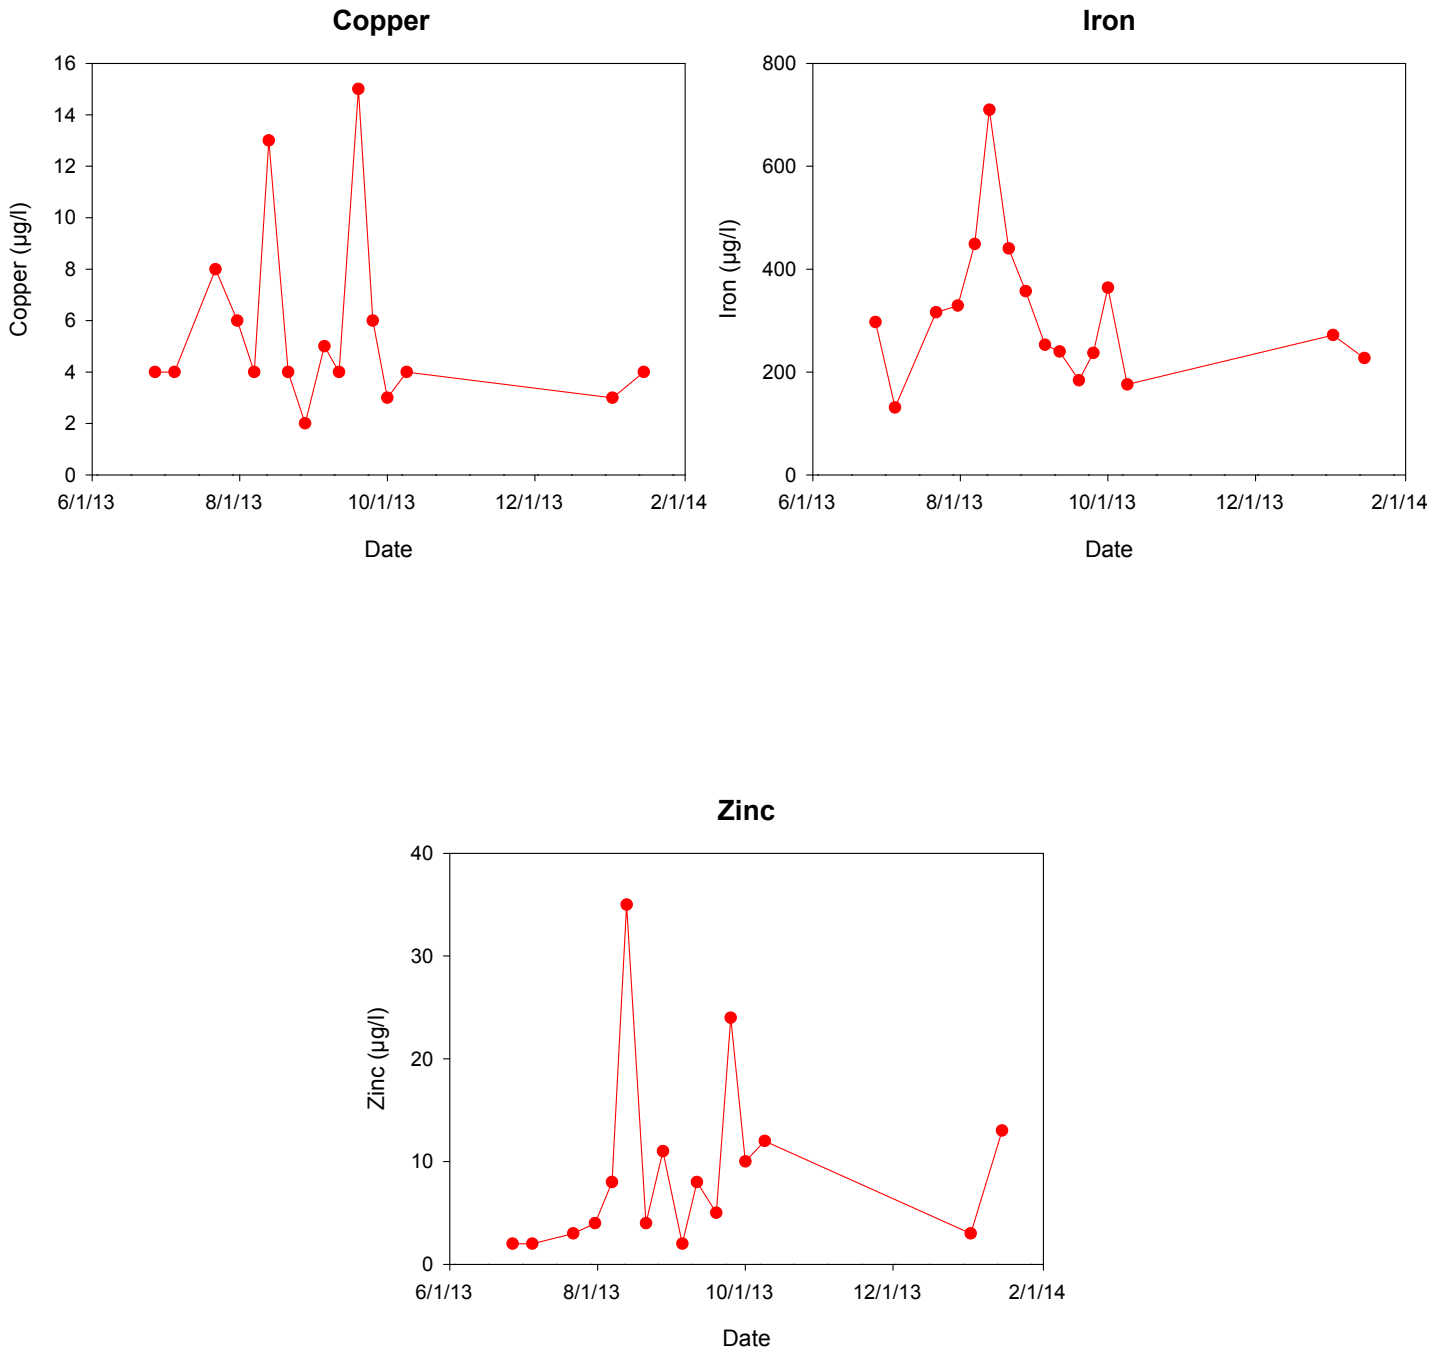
Figure 4-41. Characteristics of Outflow Concentrations of Copper, Iron, and Zinc at the San Pablo CDS Site.

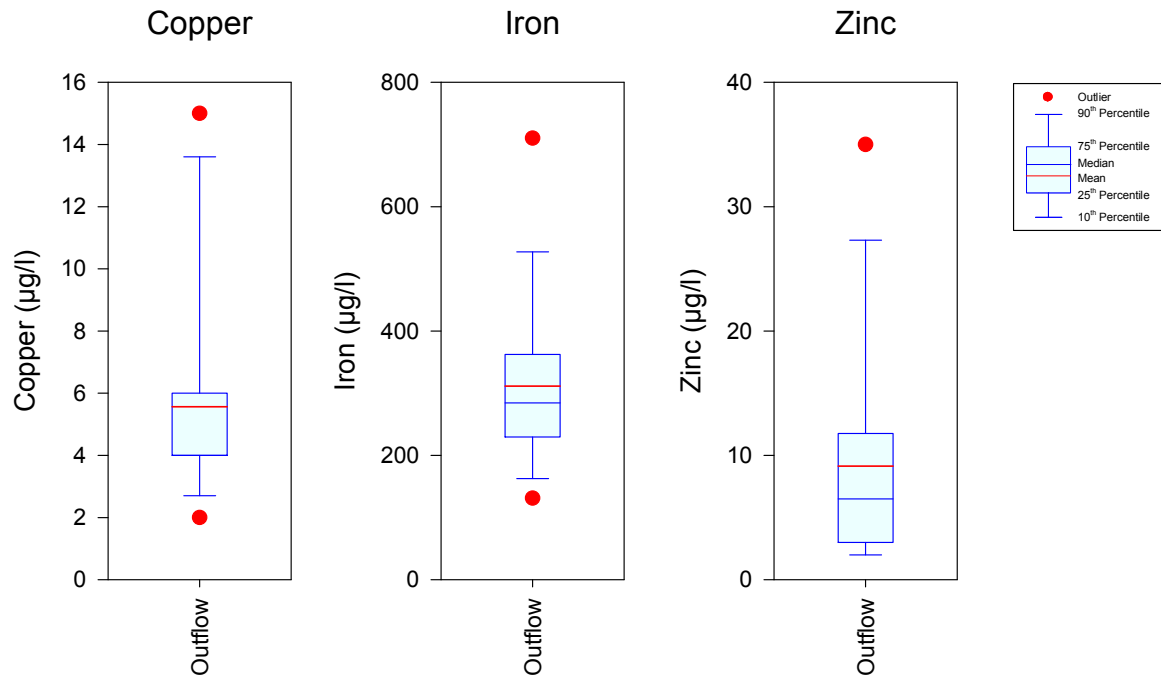
A statistical summary of measured concentrations of copper, iron, and zinc in the San Pablo CDS unit discharge is given on Figure 4-42. In general, the majority of the measured concentrations for copper, iron, and zinc occurred within a relatively narrow range of values, with outliers both above and below the range of typical values.

Figure 4-42. Statistical Summary of Outflow Concentrations of Copper, Iron, and Zinc at the San Pablo CDS Site.

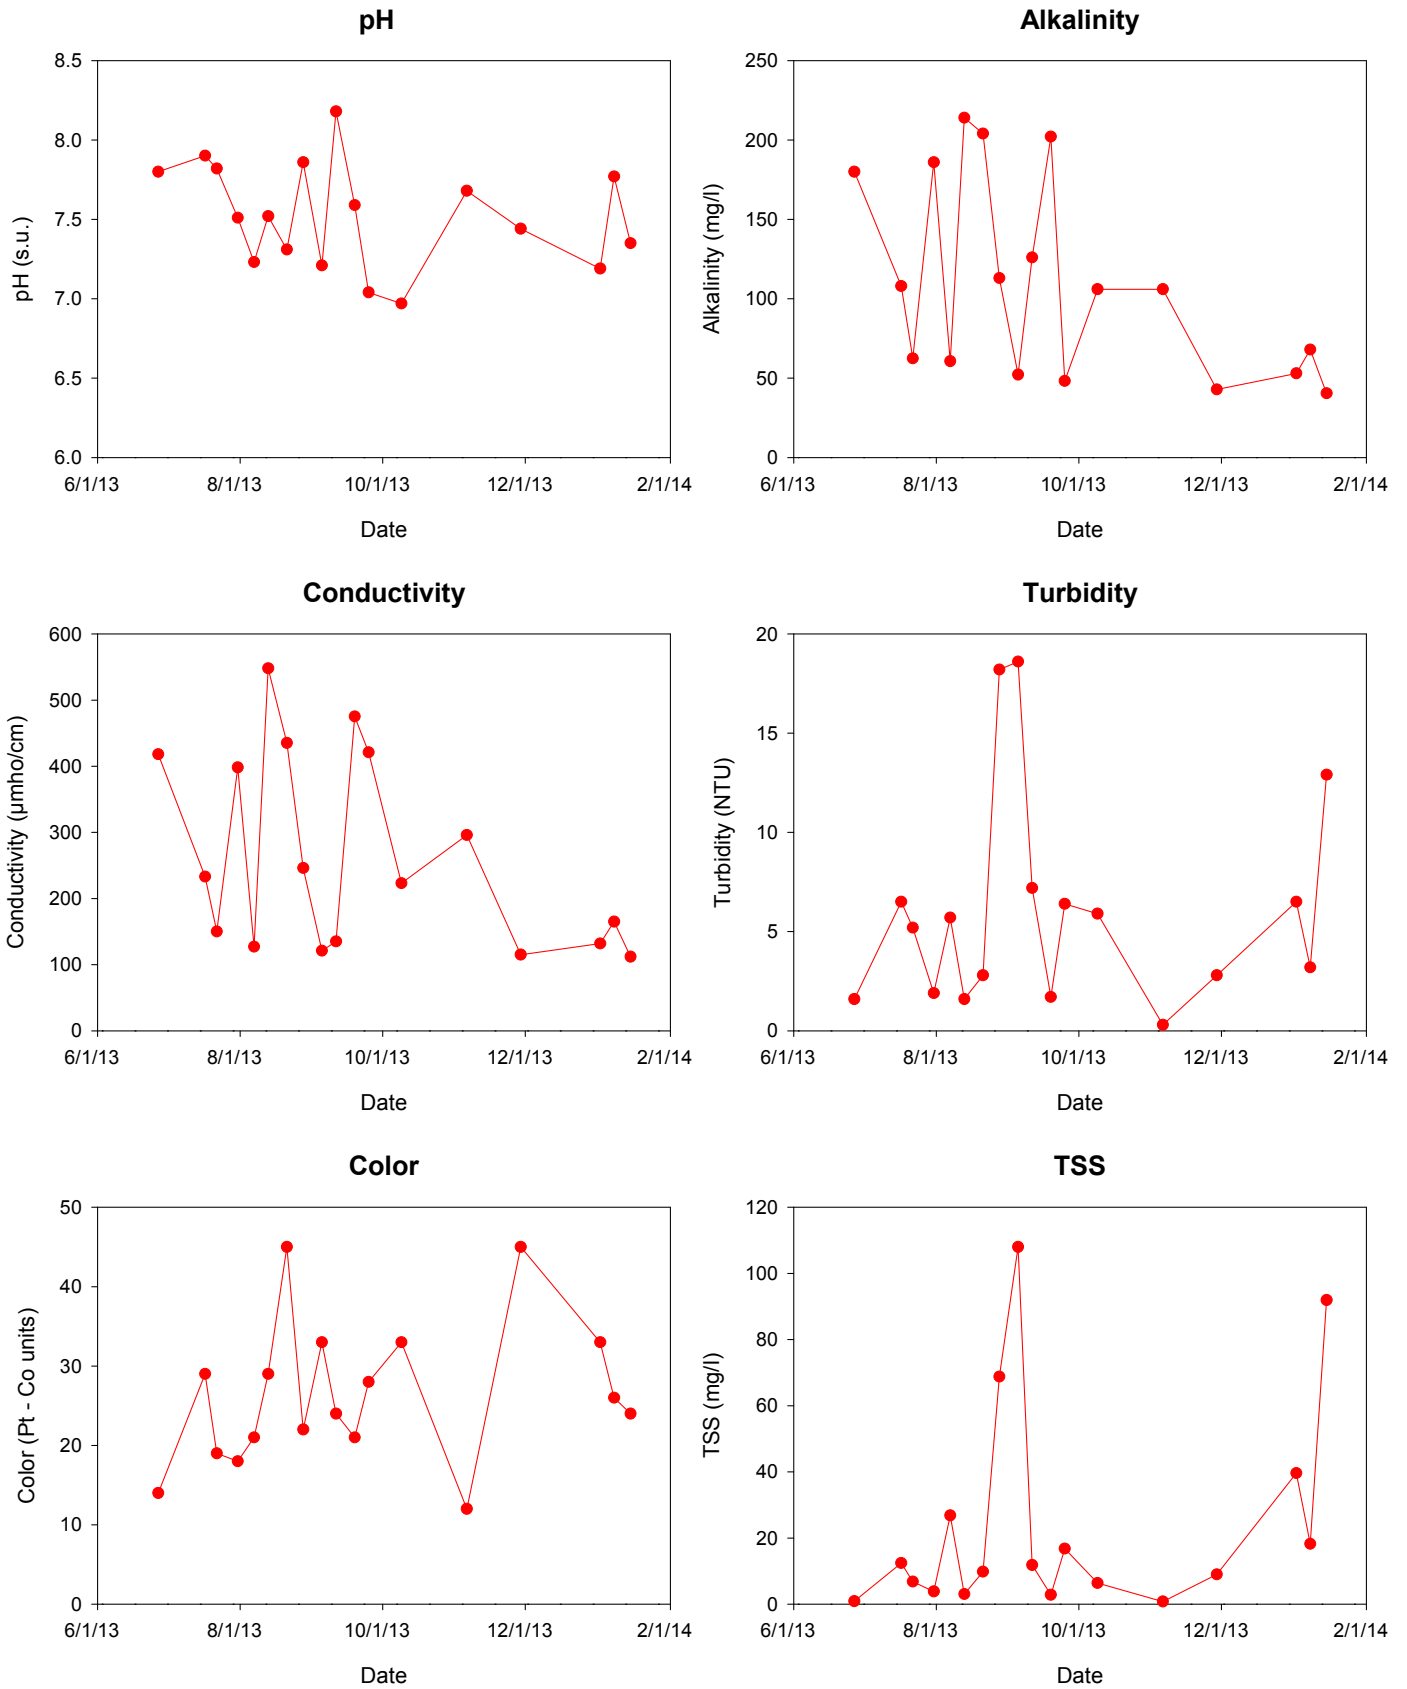
Figure 4-43. Characteristics of Outflow Concentrations of pH, Alkalinity, Conductivity, Turbidity, Color, and TSS at the Lake Concord Suntree Baffle Box Site.

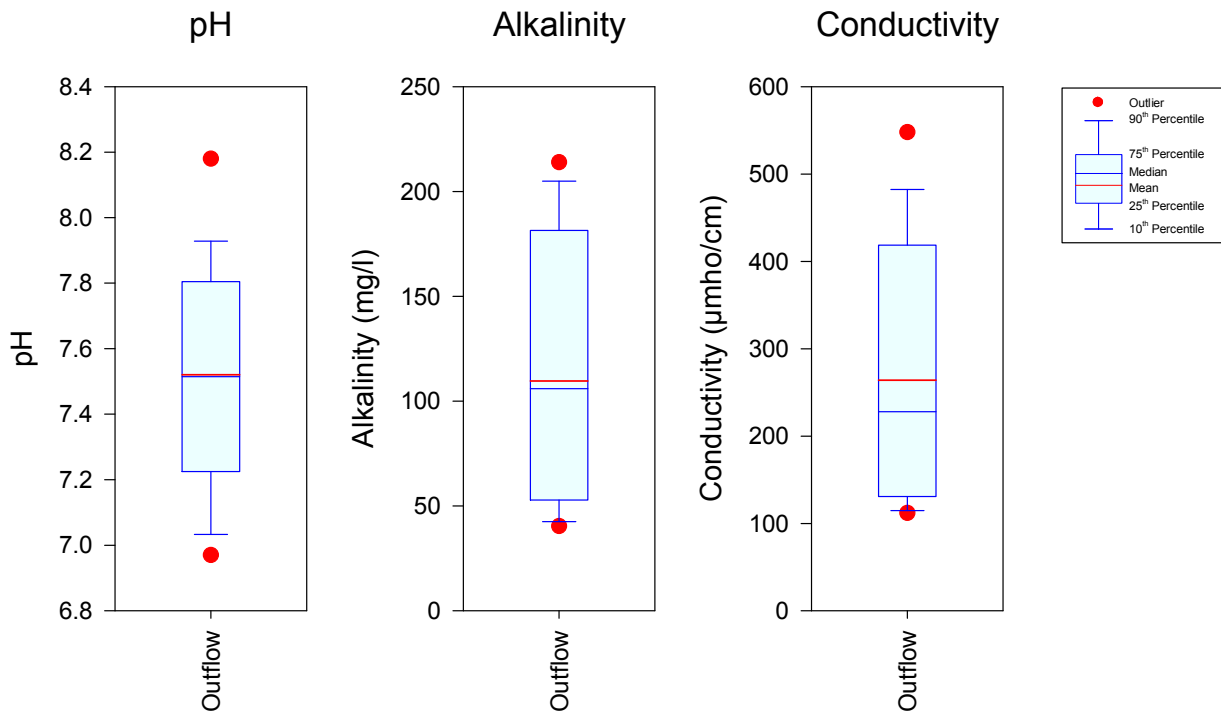
A statistical summary of outflow concentrations of pH, alkalinity, and conductivity at the Suntree baffle box site are given on Figure 4-44. The probability plots for alkalinity and conductivity appear to be very similar, suggesting that values for these parameters are affected by similar processes.

Figure 4-44. Statistical Summary of Outflow Concentrations of pH, Alkalinity, and Conductivity at the Lake Concord Suntime Baffle Box Site.

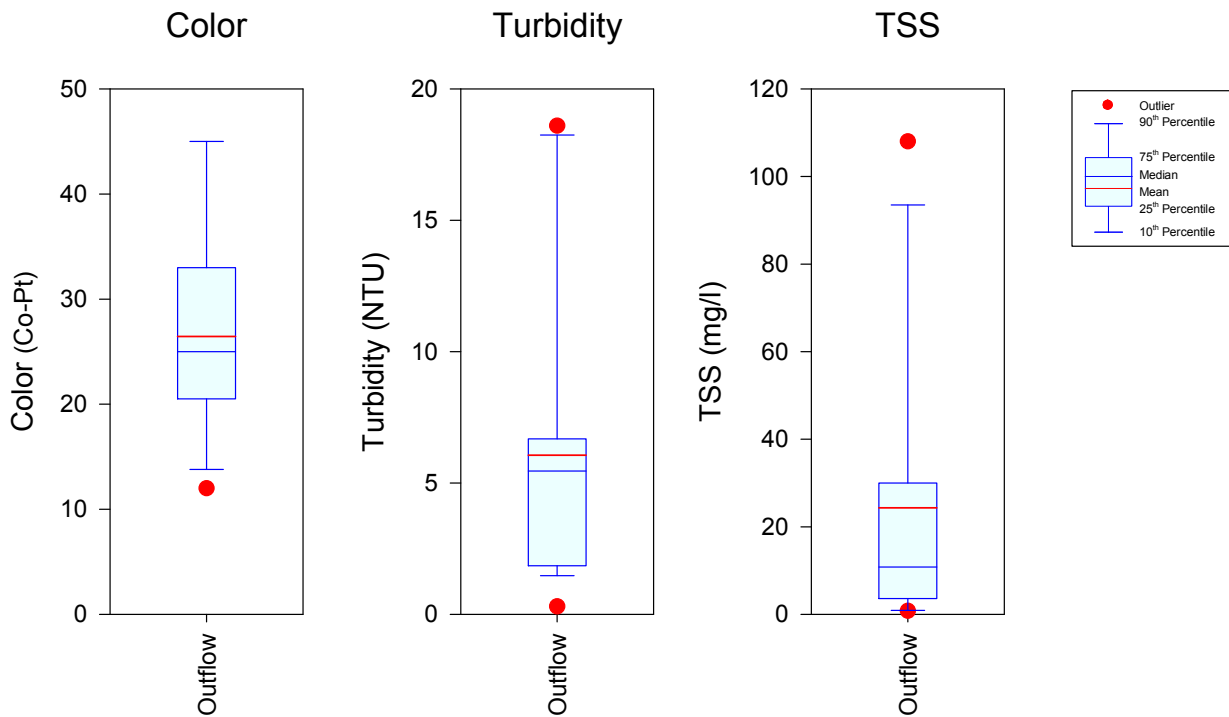
A statistical summary of discharge concentrations of color, turbidity, and TSS at the Suntree baffle box site are given on Figure 4-45. In general, a relatively low degree of variability was observed in measured concentrations for each of these parameters, with a few isolated outliers both above and below the typical range of values.

Figure 4-45. Statistical Summary of Outflow Concentrations of Color, Turbidity, and TSS at the Lake Concord Suntime Baffle Box Site.

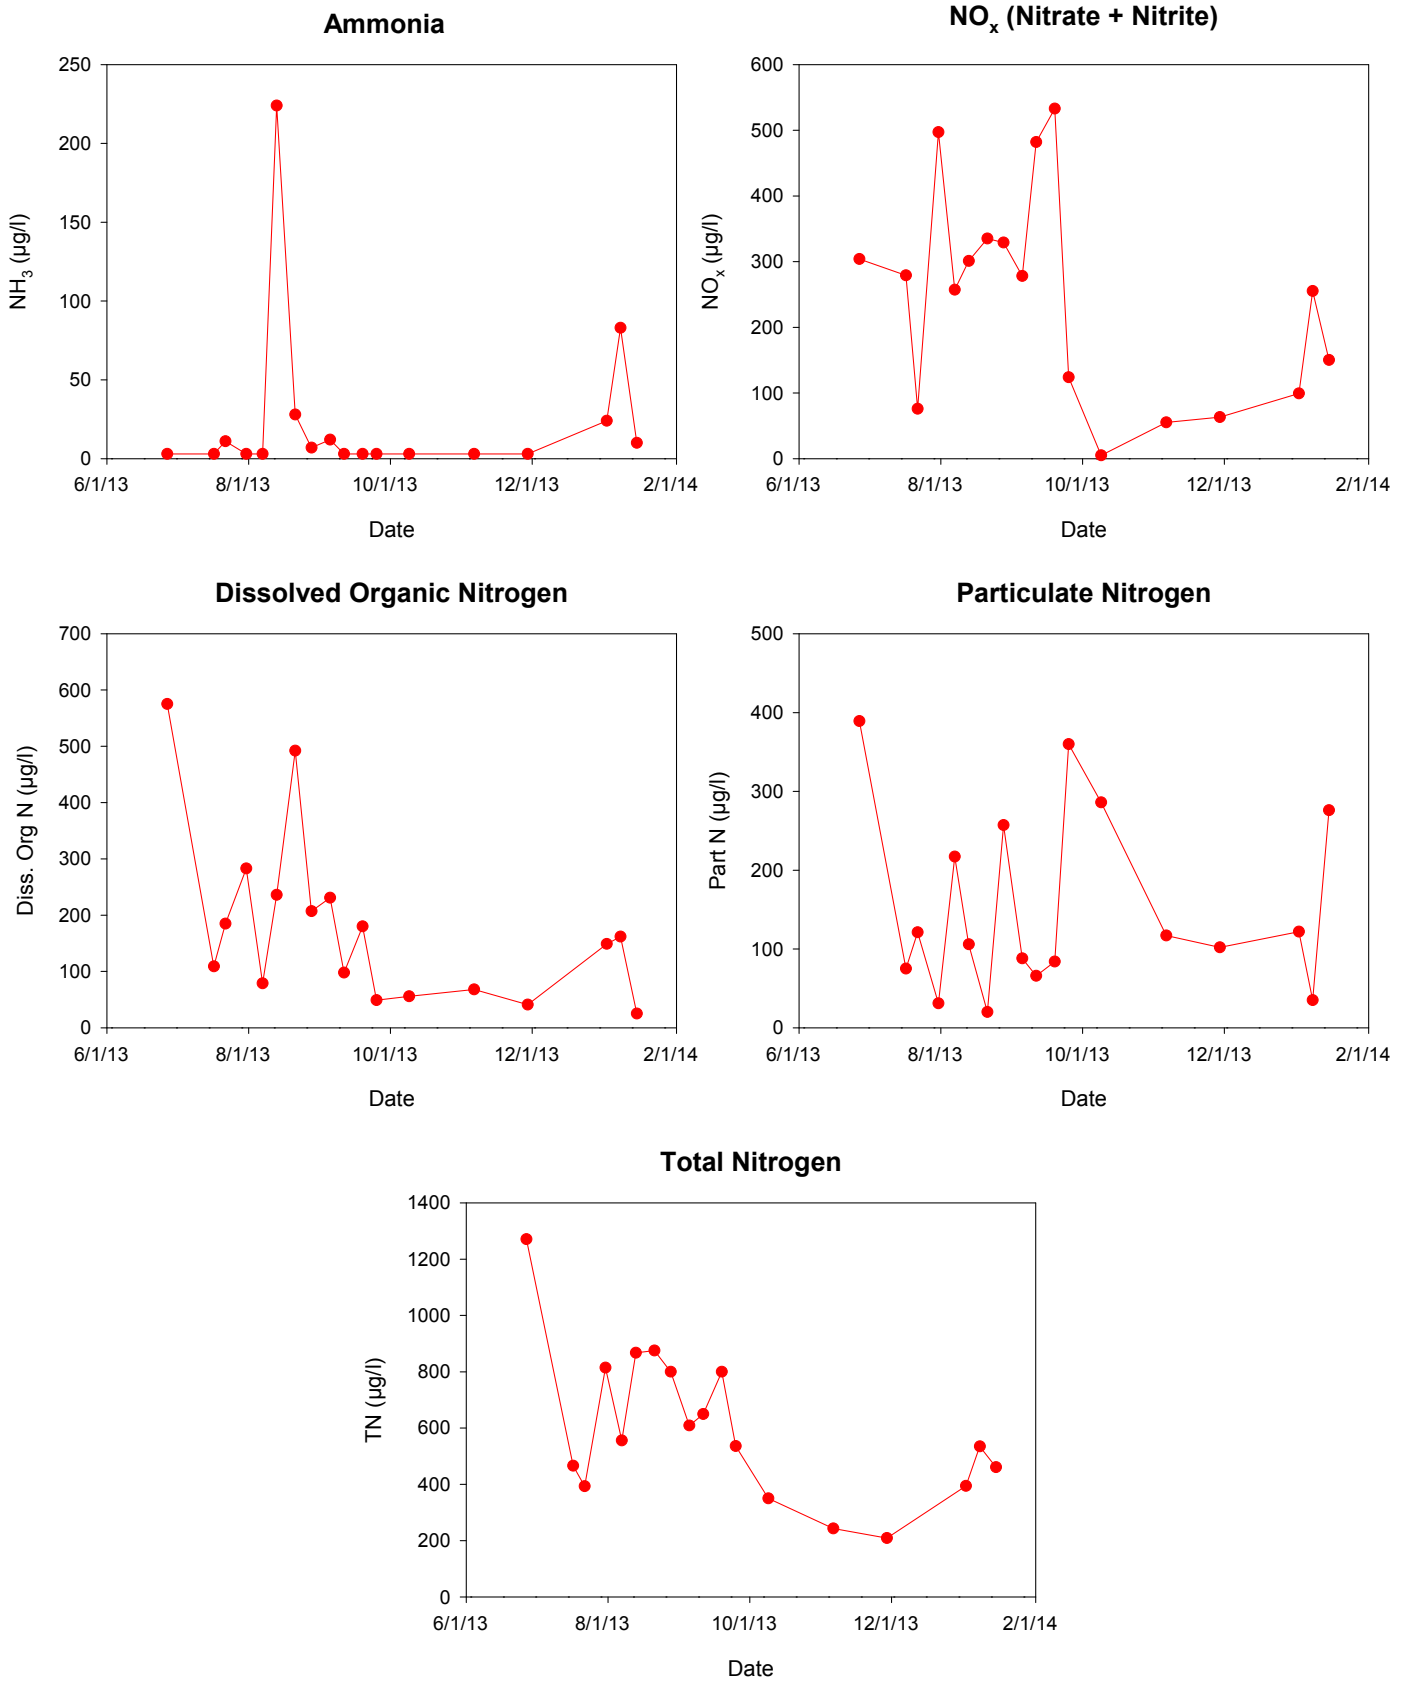
A graphical summary of measured outflow concentrations for nitrogen species at the Lake Concord Suntree baffle box site is given on Figure 4-46. Measured concentrations for ammonia were generally low in value, with the exception of several isolated peak values, with one extending as high as 224 $\mu\text{g/l}$. However, overall, measured concentrations of ammonia in the discharge were relatively low in value.

Figure 4-46. Characteristics of Outflow Concentrations of Nitrogen Species at the Lake Concord Suntree Baffle Box Site.

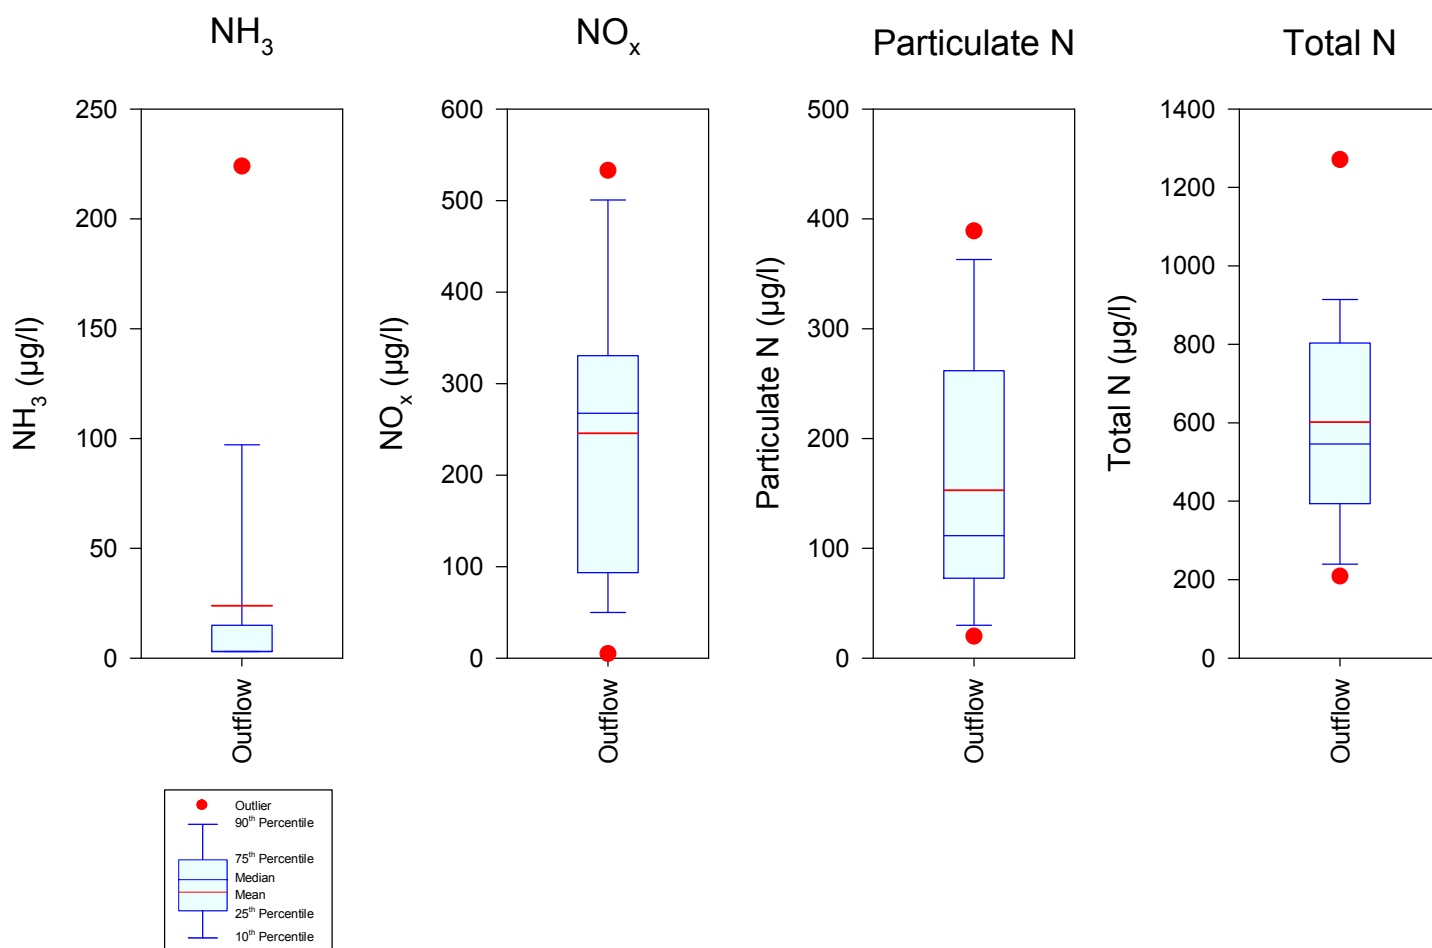
Figure 4-47. Statistical Summary of Outflow Concentrations of Nitrogen Species at the Lake Concord Suntime Baffle Box Site.
