Baffle Box with Media Filtration Installation,
Effectiveness Evaluation, and Associated Education for
the Lake Jesup Watershed

Contract S0497

Final Report

City of Casselberry

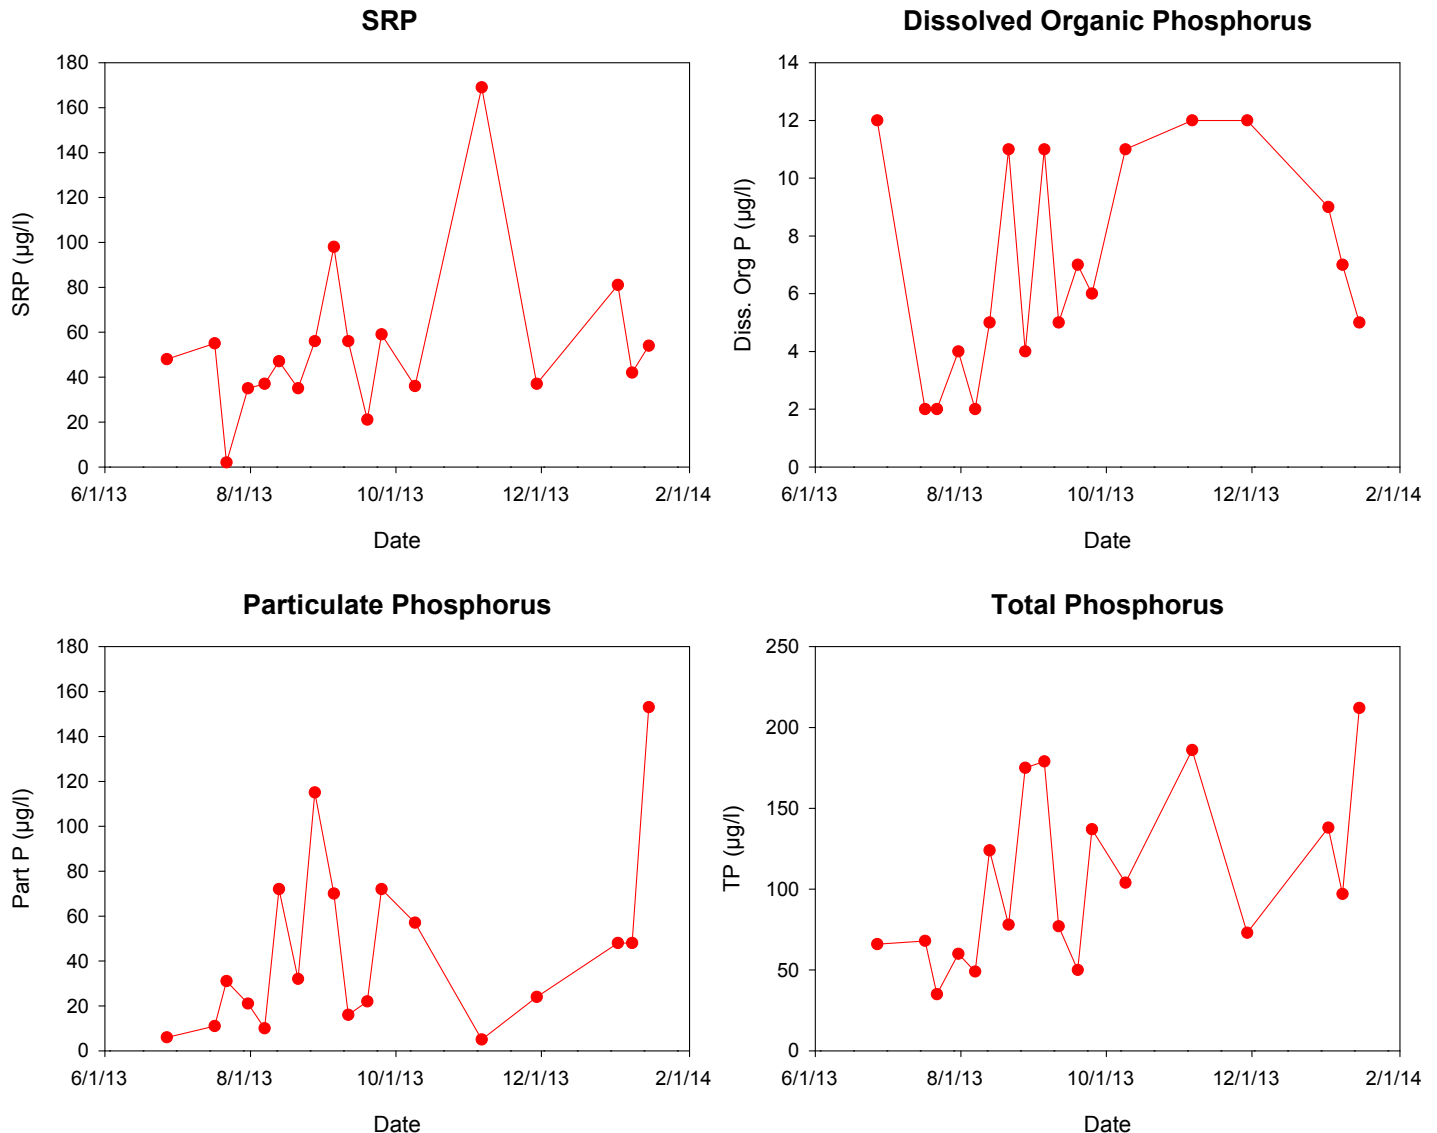
Figure 4-48. Characteristics of Outflow Concentrations of Phosphorus Species at the Lake Concord Suntree Baffle Box Site.

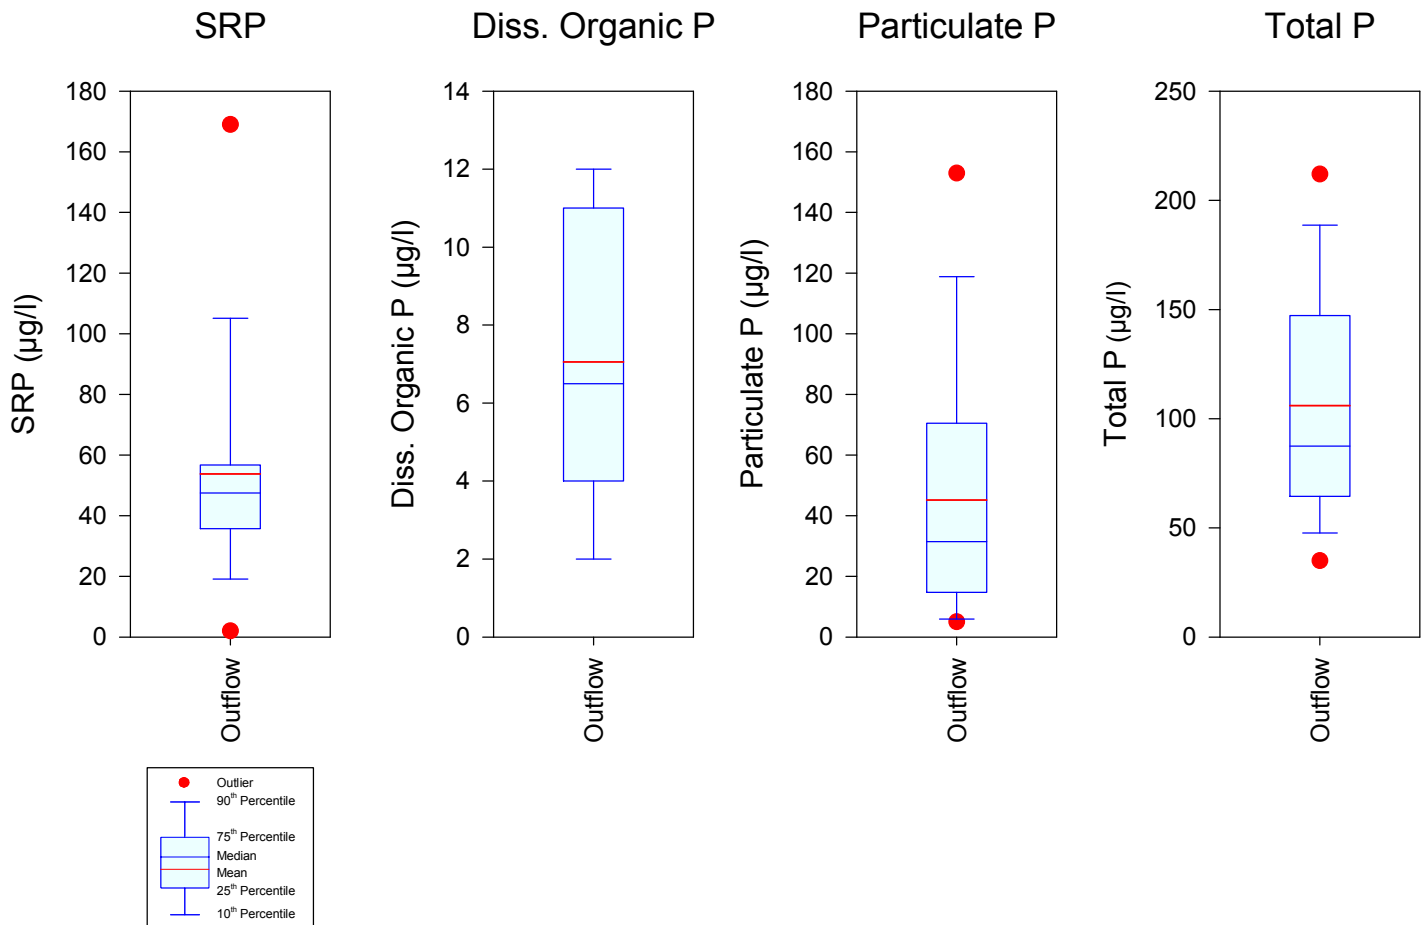
Figure 4-49. Statistical Summary of Outflow Concentrations of Phosphorus Species at the Lake Concord Suntree Baffle Box Site.

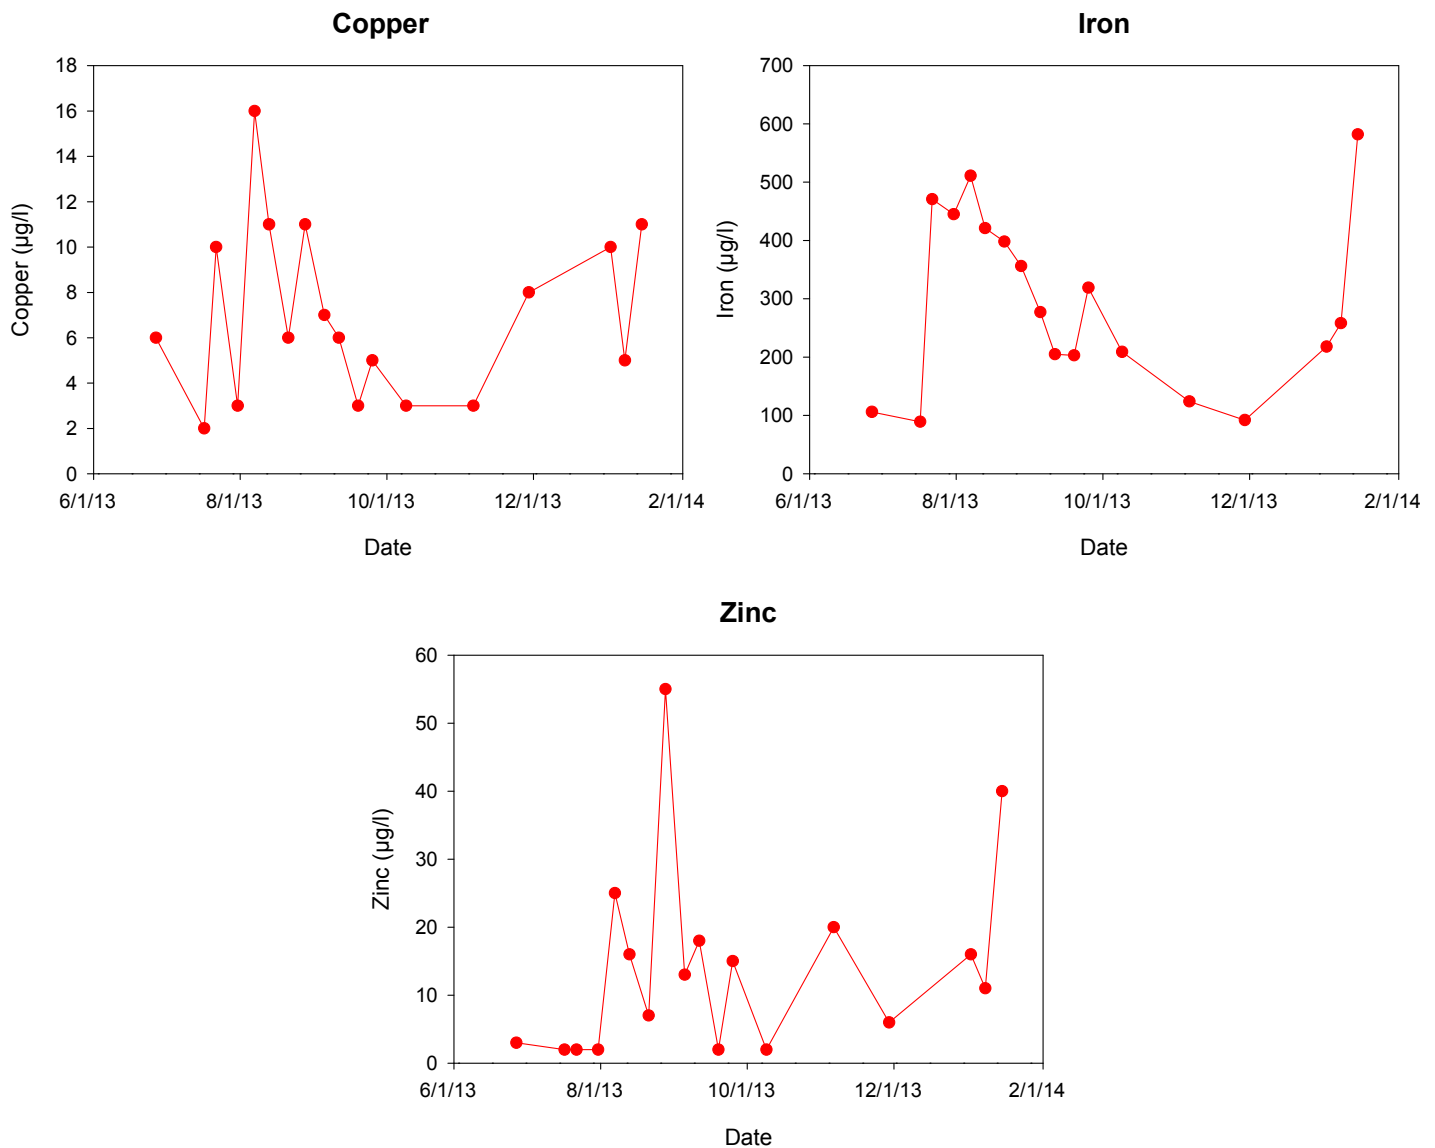
A graphical summary of measured concentrations of copper, iron, and zinc in discharges from the Lake Concord Suntree baffle box unit is given on Figure 4-50. Measured concentrations for copper, iron, and zinc exhibited a high degree of variability during the field monitoring program. Measured copper concentrations in the discharges ranged from 2-16 $\mu\text{g/l}$, reflecting low to moderate values. Measured concentrations of iron in the discharge ranged from 89-582 $\mu\text{g/l}$, also reflecting low to moderate concentrations. Measured concentrations for zinc ranged from 2-55 $\mu\text{g/l}$, reflecting low to moderate concentrations. A statistical summary of measured concentrations for copper, iron, and zinc in the Suntree baffle box discharges is given on Figure 4-51.

Figure 4-50. Characteristics of Outflow Concentrations of Copper, Iron, and Zinc at the Lake Concord Suntree Baffle Box Site.

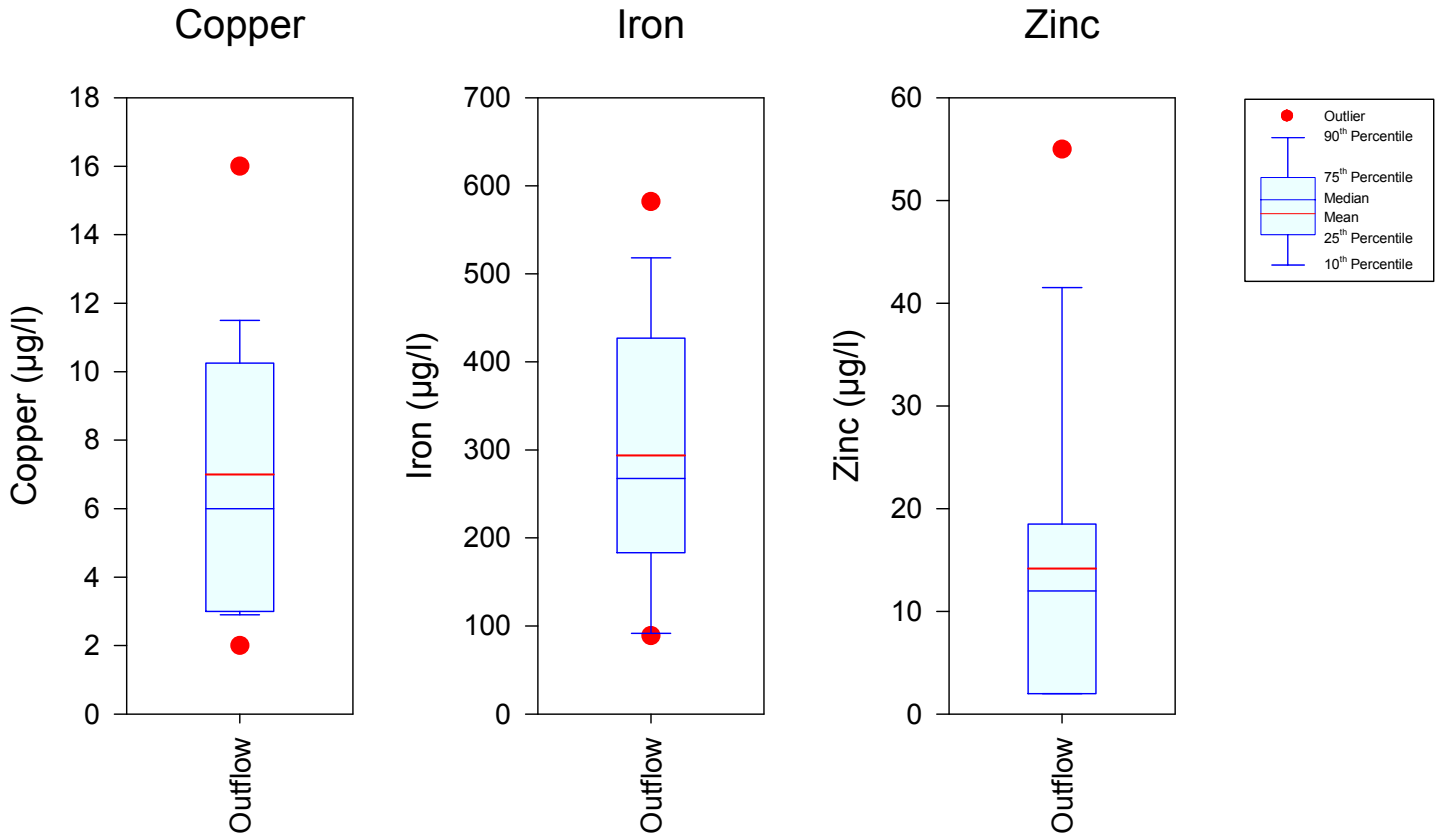
Figure 4-51. Statistical Summary of Outflow Concentrations of Copper, Iron, and Zinc at the Lake Concord Suntime Baffle Box Site.

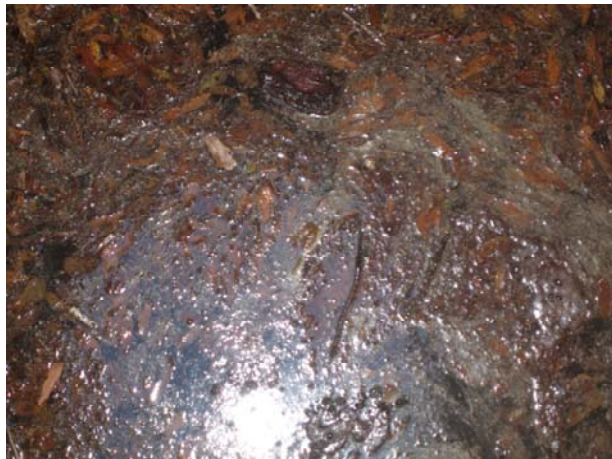
a. Floating leaves between storm events

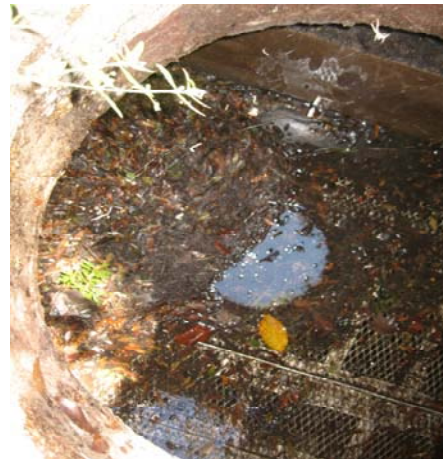
b. Standing water above screen

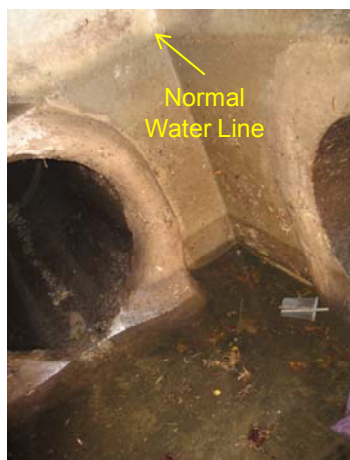
c. Typical water elevation in unit

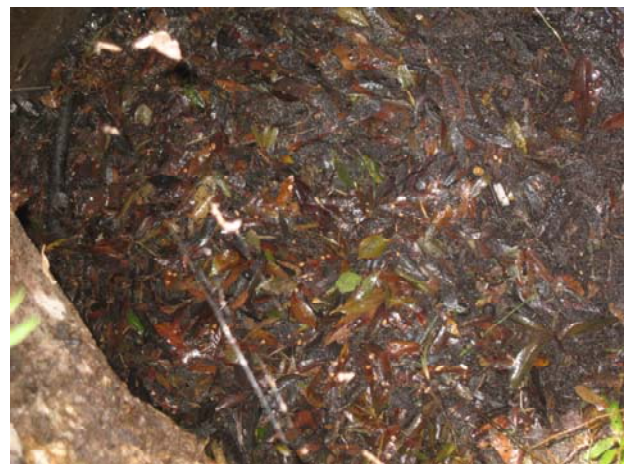
d. Floating leaves and vegetation debris

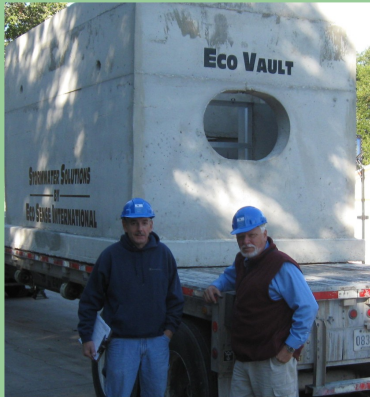
A.1: ESI EcoVault® Baffle Box

The **ESI EcoVault®** is a precast concrete stormwater treatment structure that removes:

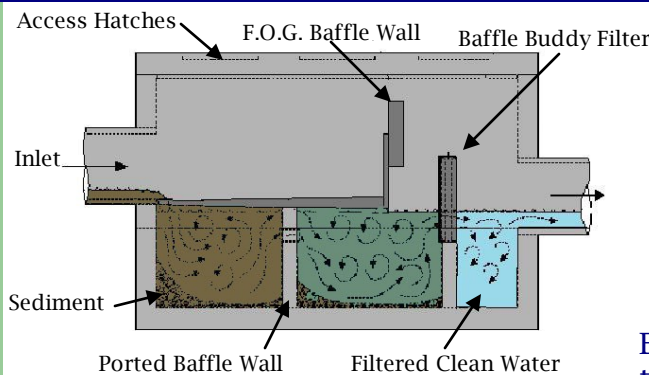
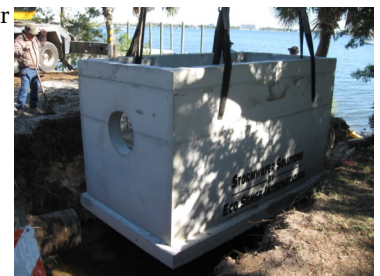
Multi-piece construction to minimize lifting and freight.

Baffle Buddy Cassette Filter becomes the final internal weir wall.

Debris screens are made of aluminum or Stainless Steel.

ESI MZ Filter medium is superior to traditional clay materials because it is rigid and stable, even in aqueous conditions.

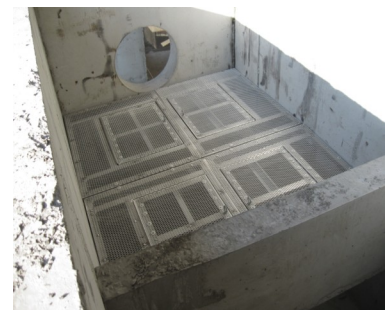
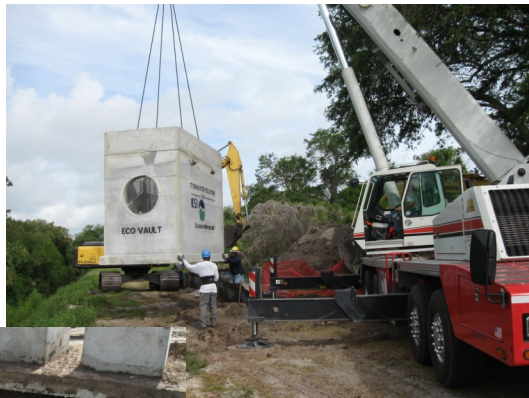
EcoVault® treats the continuous flow while debris screens span the entire box, creating extensive storage volume.

Technology is based on slowing the flow's velocity to facilitate settling.

Baffles impede forward movement of settling particles.

Debris screens raise trash and leaves out of the water to greatly reduce decomposition.

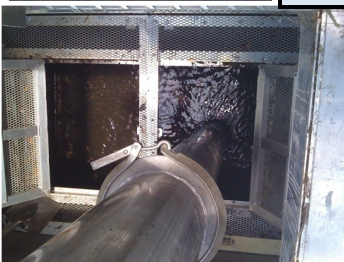
Servicing the EcoVault® is easy with the accessible hatches and requires a vacuum truck.

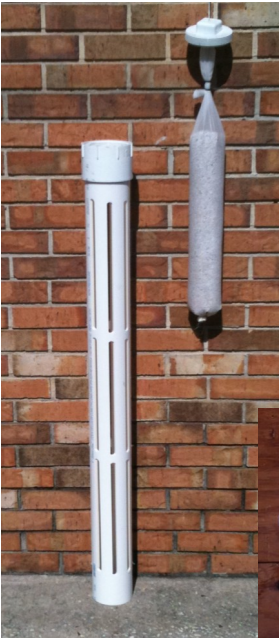
Vault-Ox® infusion module.
Vault-Ox® can be inexpensively retro-fitted into any storm water structure or retention pond

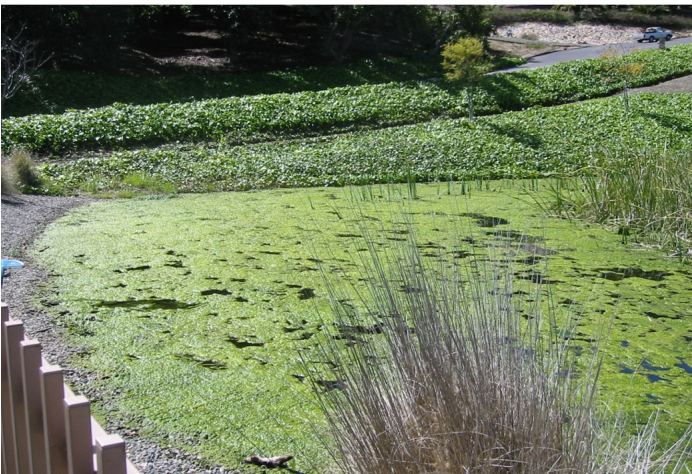
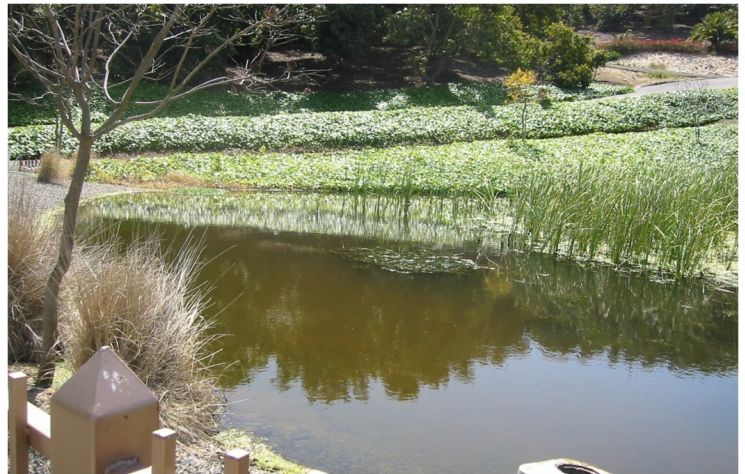
Retention Pond before treatment ↓

Retention Pond – 6 Weeks Later
2lb/acre.ft CaO₂ + Enzymes ↓

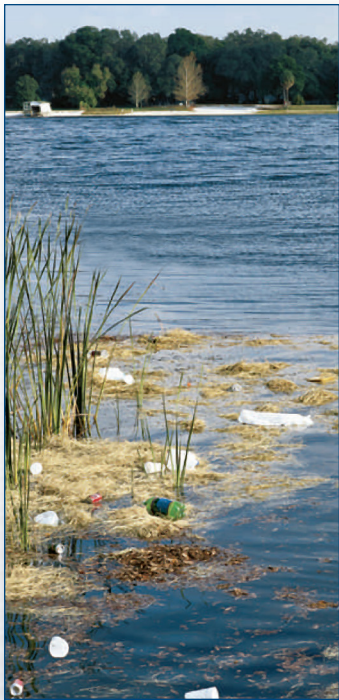
Before CDS®

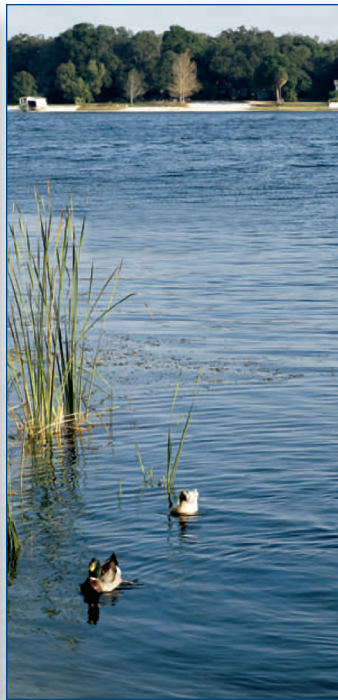
After CDS®

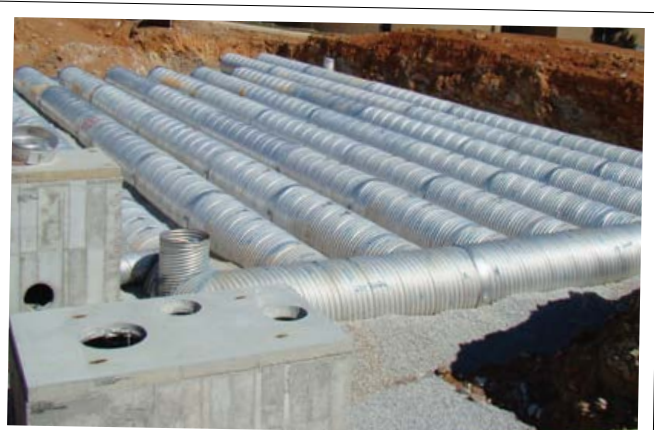
A Vortechs protects detention system from sediment build-up and reduces maintenance

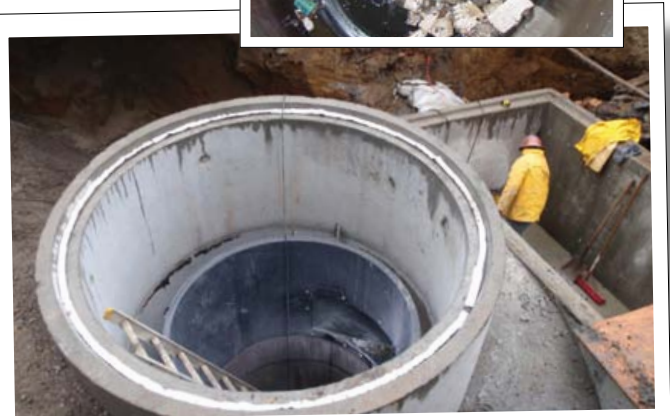
CDS unit installed to remove trash before entering Lake Meritt in Oakland, CA

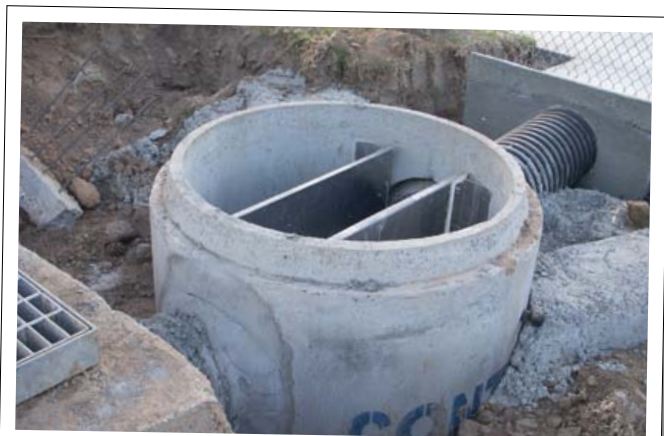
VortSentry HS is an effective option where space is limited

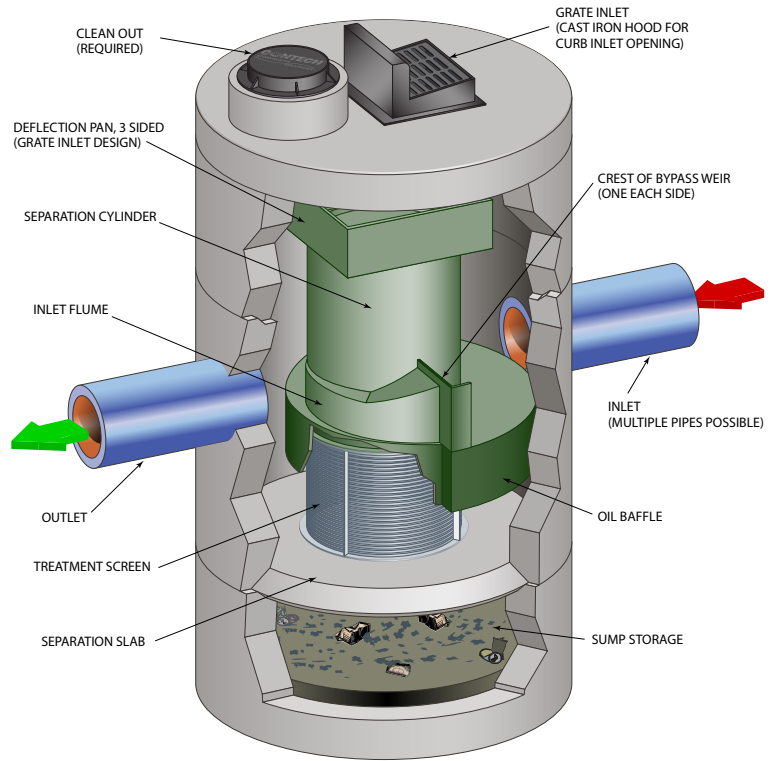
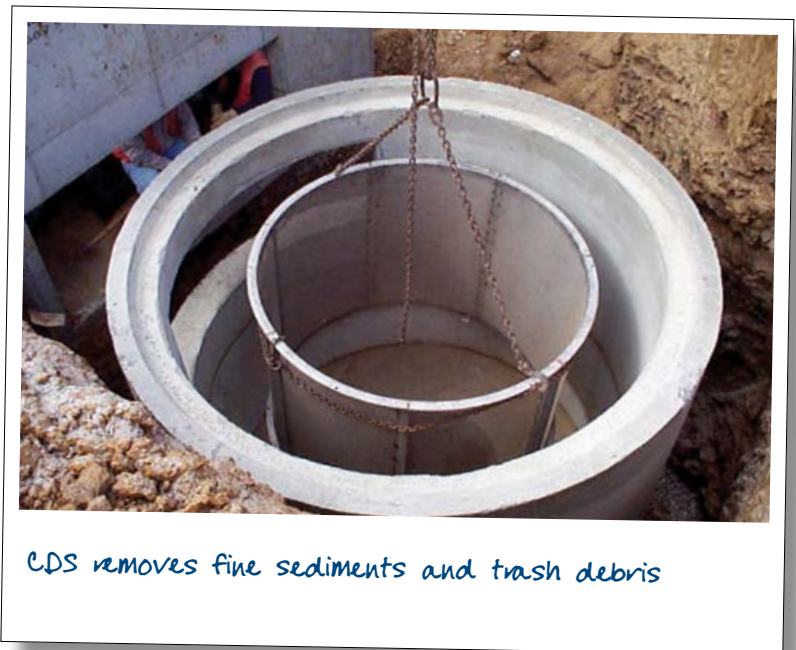
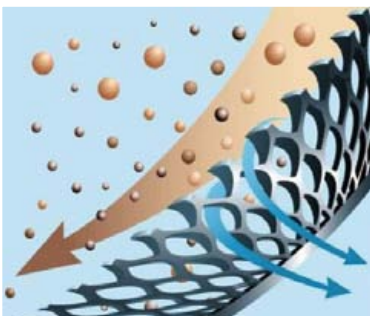
The CDS is a swirl concentrator hybrid technology that provides continuous deflective separation – a combination of swirl concentration and patented indirect screening – into a uniquely capable product. It effectively screens, separates and traps debris, sediment and oil from stormwater runoff and is an ideal system to meet trash Total Maximum Daily Load (TMDL) requirements.

Continuous deflective separation — water velocities within the swirl chamber continually shear debris off the screen to keep it clean

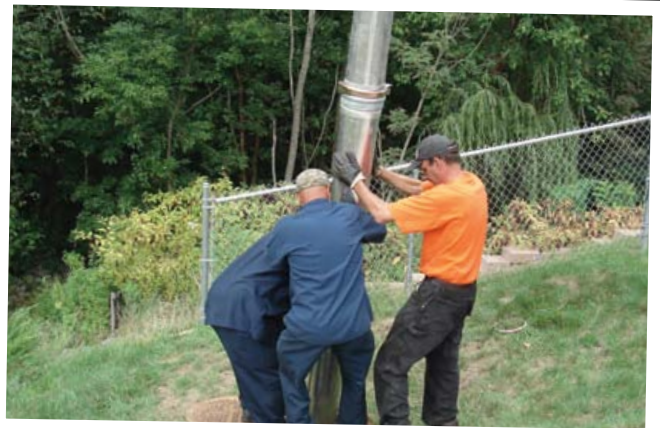
A vacuum truck excavates pollutants from the systems

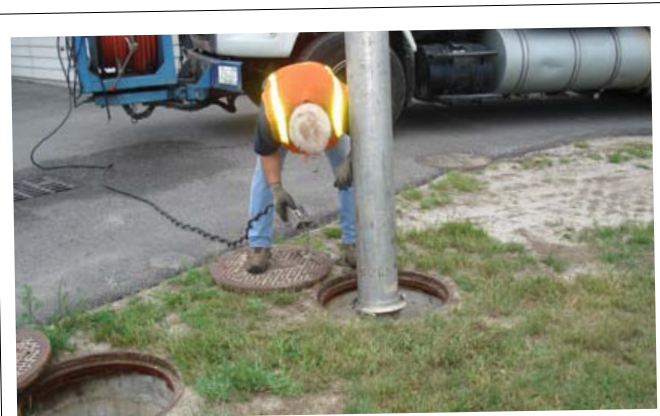
A CDS unit can be easily cleaned out in less than 30 minutes

The recommended cleanout of solids within the CDS unit's sump should occur at 75% of the sump capacity. Access to the CDS unit is typically achieved through two manhole access covers – one allows inspection and cleanout of the separation chamber and sump, and another allows inspection and cleanout of sediment captured and retained behind the screen. A vacuum truck is recommended for cleanout of the CDS unit and can be easily accomplished in less than 30 minutes for most installations.

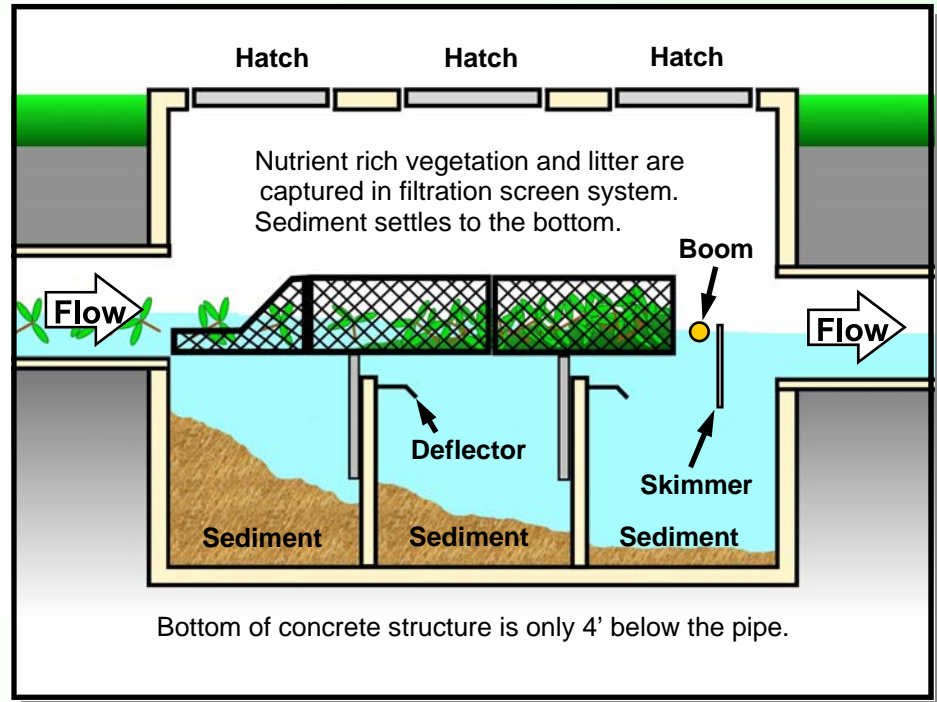
Turbulence deflectors prevent captured sediment from re-suspending.

Hydrocarbons collect in front of skimmer and are absorbed by Storm Boom.

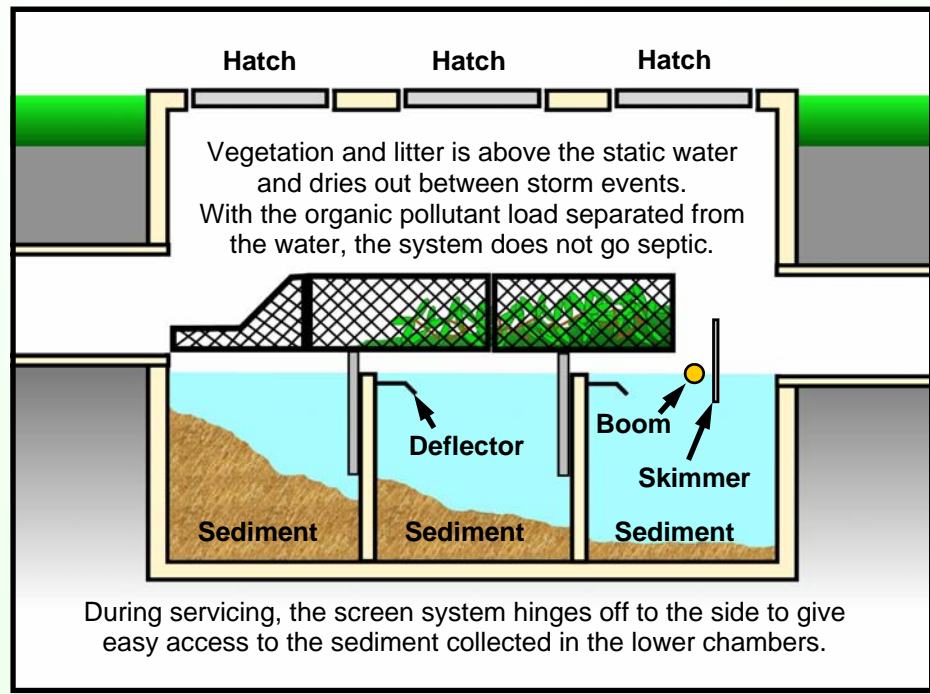
Separating organic matter from the static water prevents bacterial buildup.

After The Storm Event

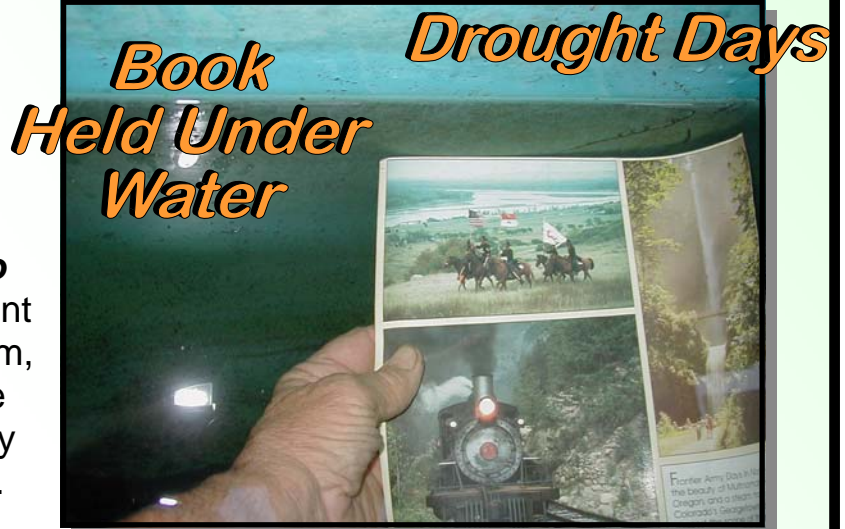
To the right is a photo of the back page of a road atlas being held 10" underwater in a *Nutrient Separating Baffle Box*.

After a couple of months with no rain, the water still has no smell and is clear. The sediment can be clearly seen on the bottom, and small fish and critters have established a happy and healthy ecosystem within the structure.

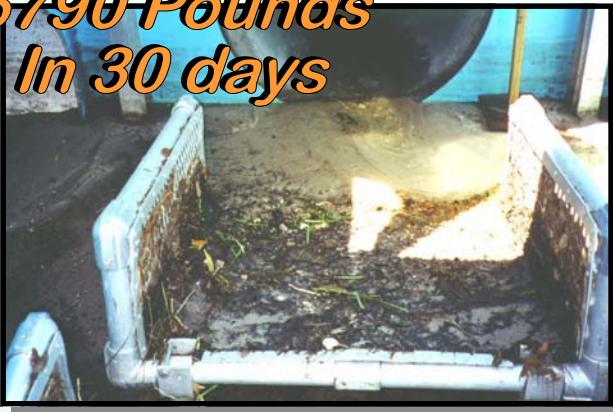
5790 Pounds In 30 days

To the left is a view of 5790 pounds of sediment collected in a *Nutrient Separating Baffle Box* just 30 days after installation.

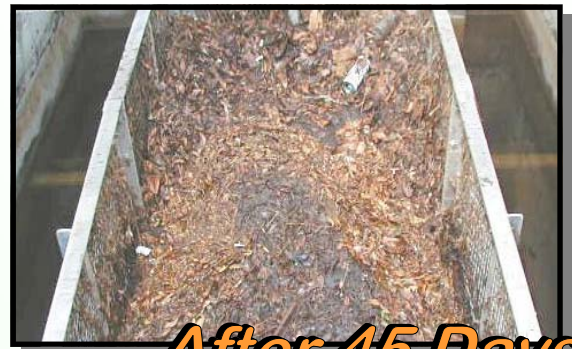
After 45 Days

To the right is a view of foliage and litter collected within the screen system of a *Nutrient Separating Baffle Box*.

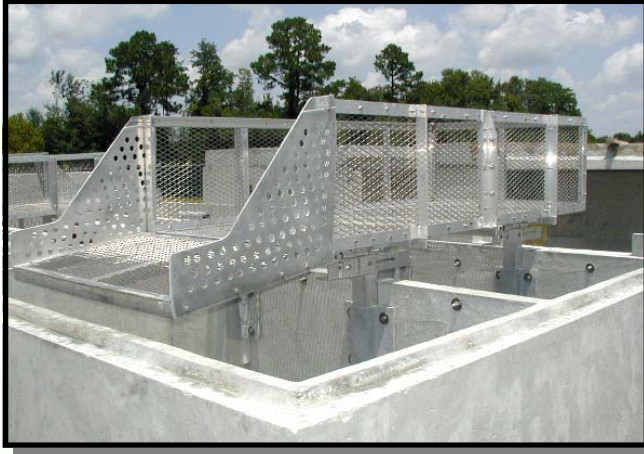
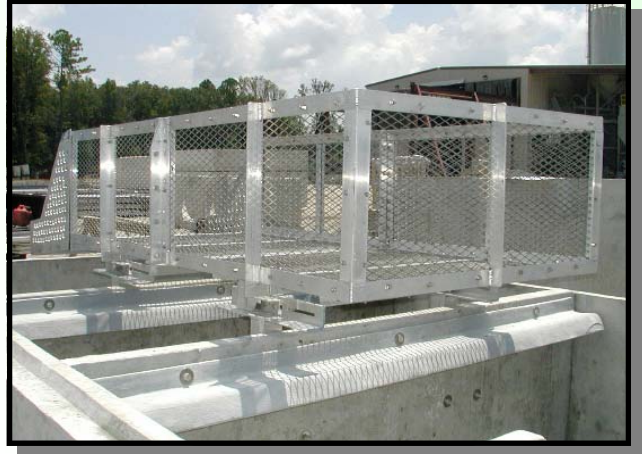
Turbulence deflectors are attached to the tops of the baffles with stainless steel bolts. Several bolts per deflector are required.

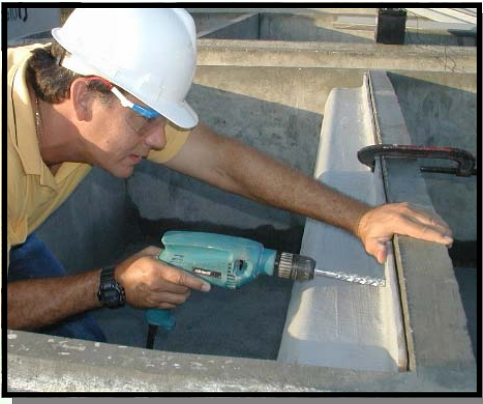
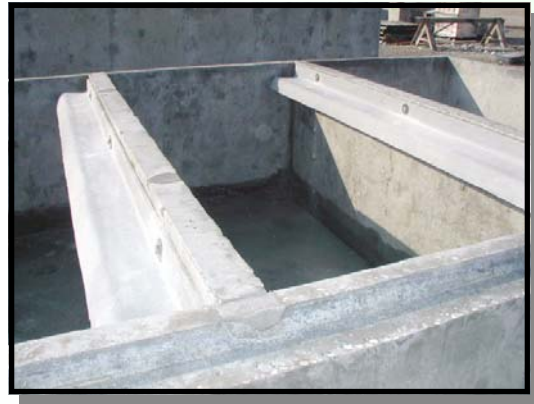
Four brackets, held in place with 4 stainless steel bolts each, secure the screen system to the baffles. The screen system includes a wide range of positional adjustment.

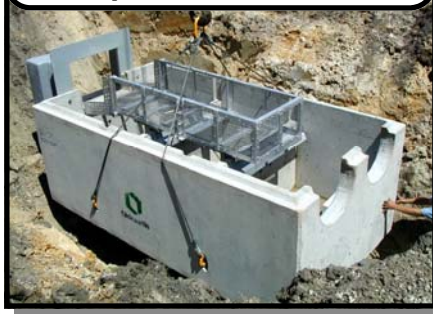
Step 1: Set lower half

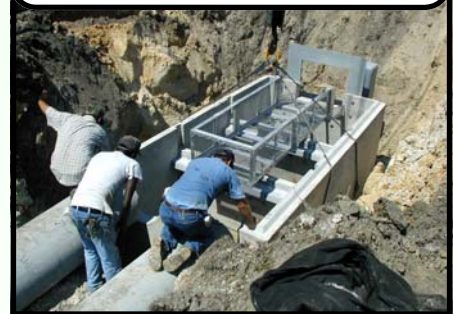
Step 2: Hook up pipes

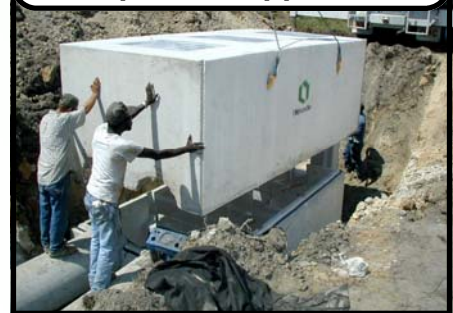
Step 4: Set upper half

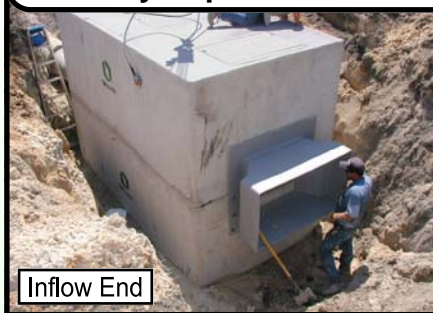
Ready to position inflow pipe and seal pipes with grout

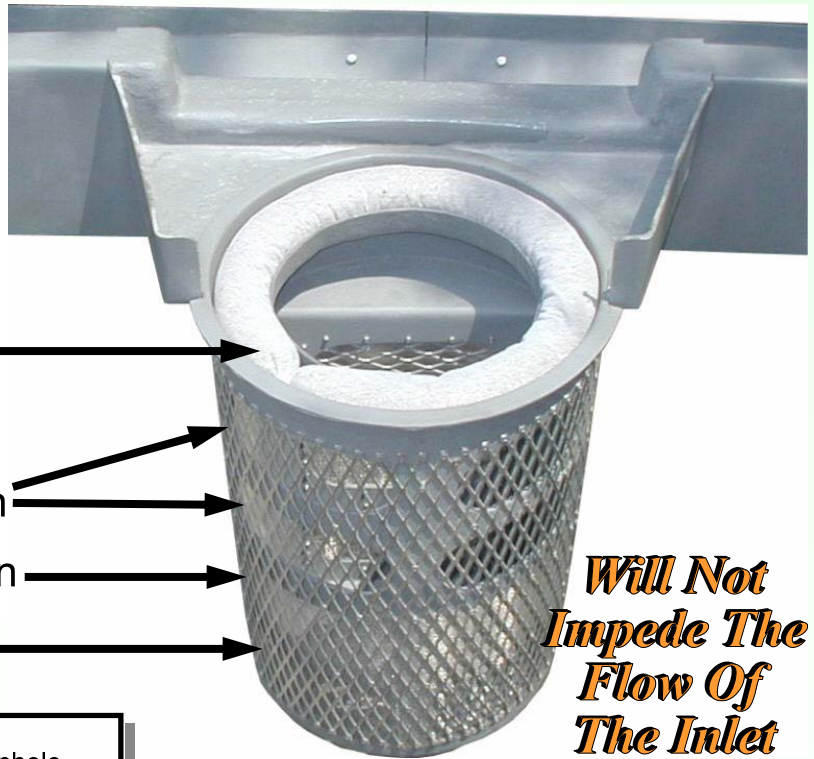
Multi-Stage Filtration
Screens of Different
Sieve Sizes
Optimize Filtration
And Water Flow

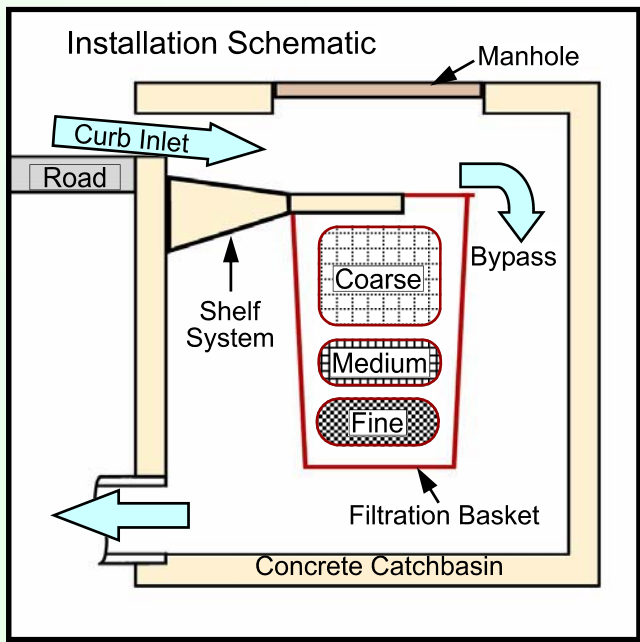
For use in inlets where the only access is through a manhole.

A shelf system directs water flow into the filtration basket and positions the basket directly under the manhole for easy access. If necessary, the water flow can bypass the entire filtration system simply by flowing past the filter and into the catchbasin.

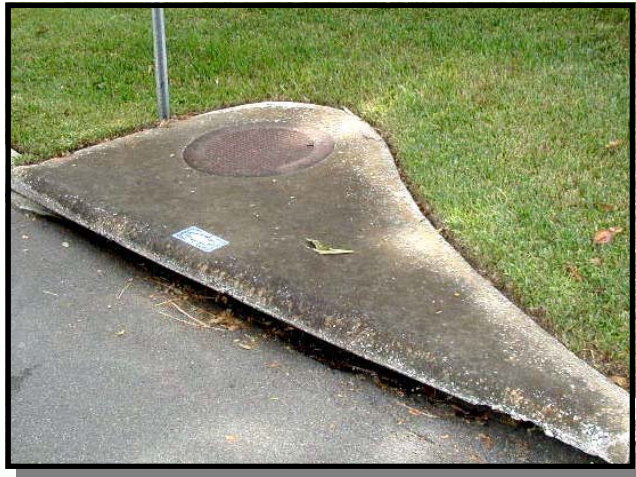
Above: View of the curb inlet showing that the only access is through a manhole.

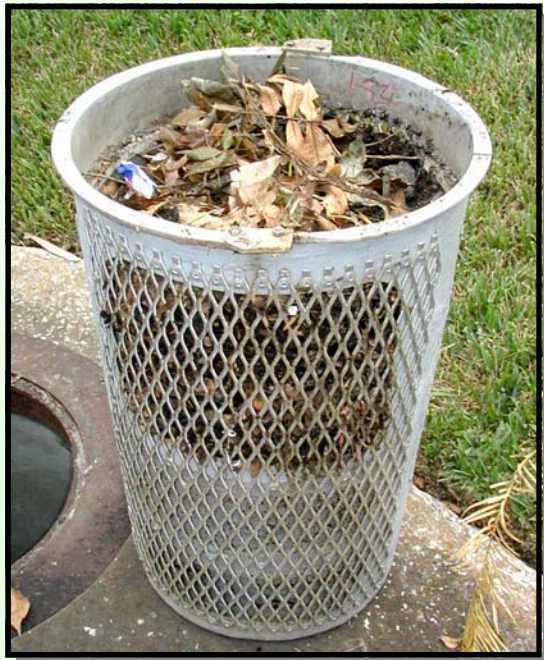
Right: View of full **High Capacity Curb Inlet Basket** immediately after the manhole lid was removed.

Left: The **Curb Inlet Basket** has been removed and can be easily emptied by hand without the need of a vacuum truck.

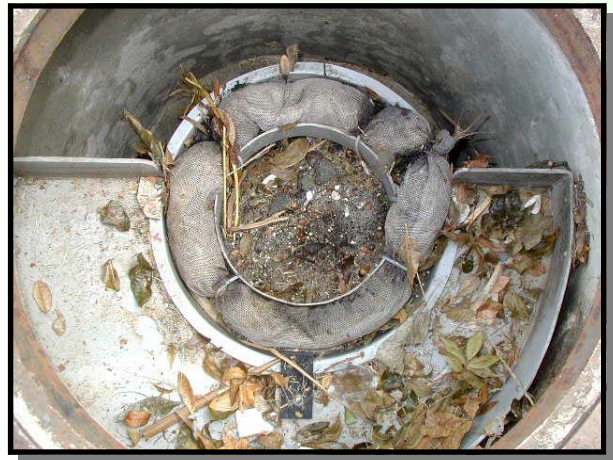
High Capacity Curb Inlet Basket

A total of **200.5 pounds** of debris was removed having a volume of **123 quarts**. The foliage weighed **140.4 pounds** and the sediment weighed **56.2 pounds**. A large quantity of palm nuts was captured by this unit.

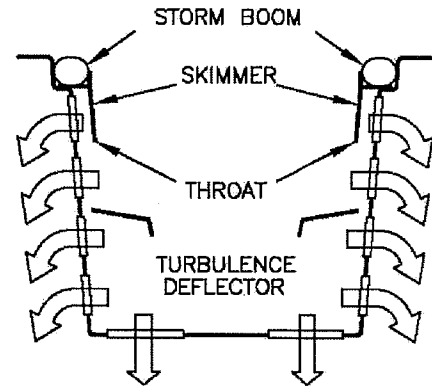
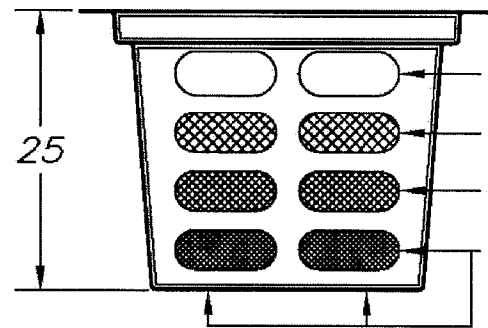
SIDE VIEW

BOX MANUFACTURED FROM MARINE GRADE FIBERGLASS & GEL COATED FOR UV PROTECTION

ALL FILTER SCREENS ARE STAINLESS STEEL

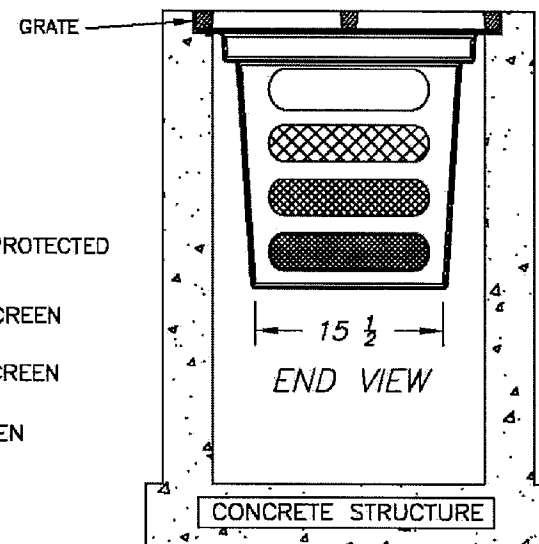
REMOVE GRATE
INSERT GISB
REINSTALL GRATE

ENVIRO-SAFE HIGH CAPACITY ROUND GRATE INLET SKIMMER BOX SYSTEM FOR USE UNDER MANHOLES
ROUND GISB FOR MOUNTING UNDER MANHOLE

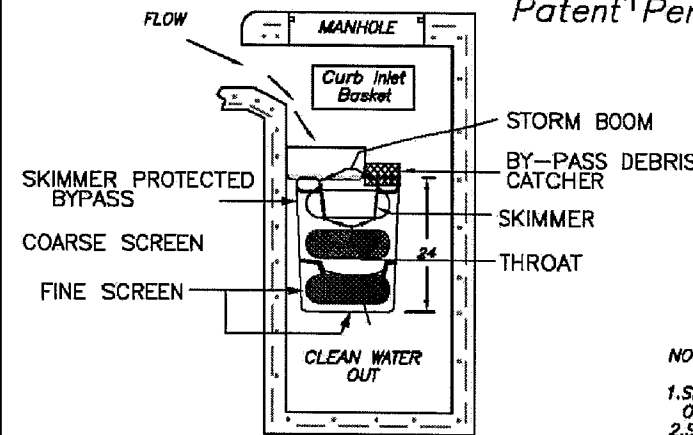
FIGURE 3
DETAIL OF PROCESS

REMOVABLE BASKET CATCHES EVERYTHING AND MAY BE REMOVED THROUGH MANHOLE WITHOUT ENTRY.

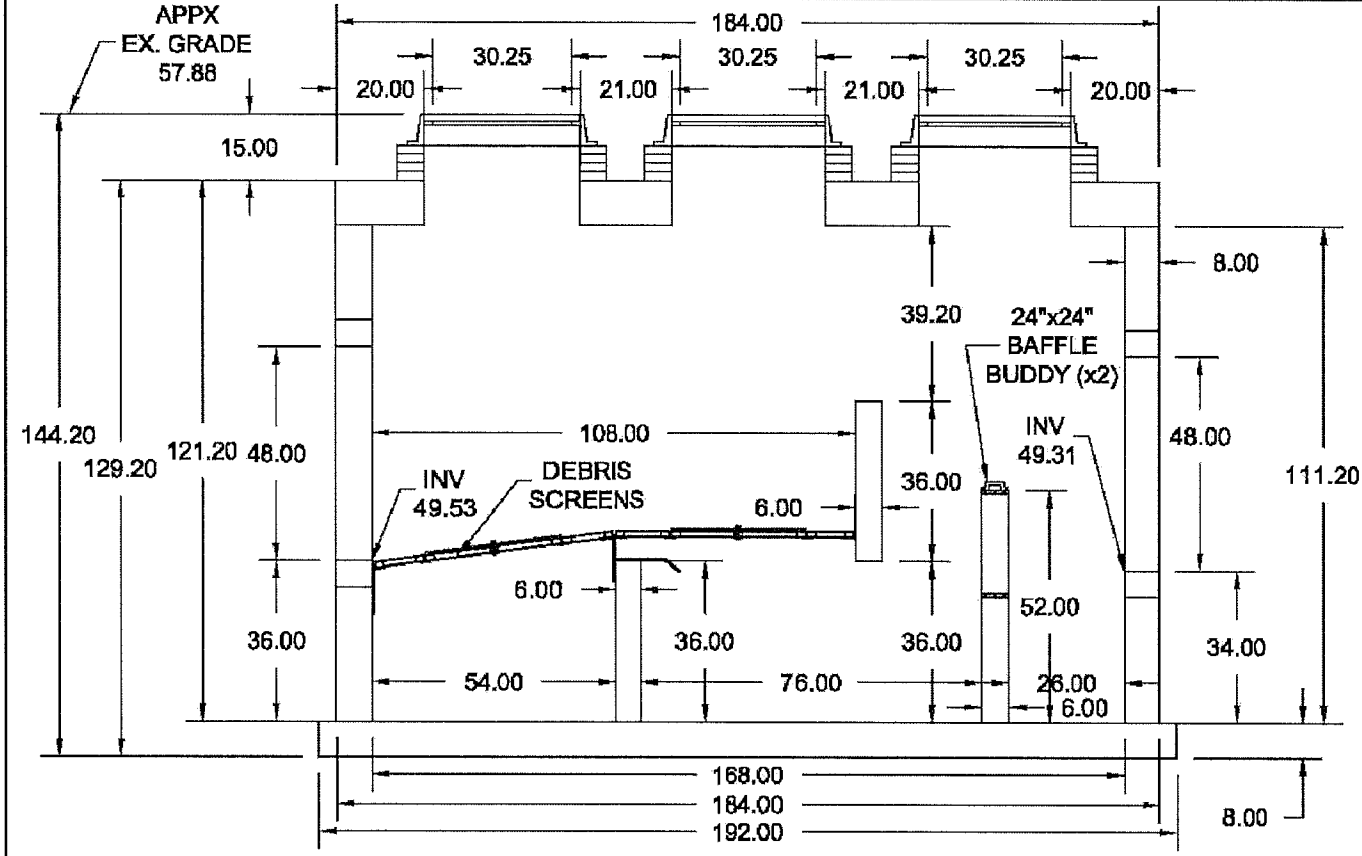
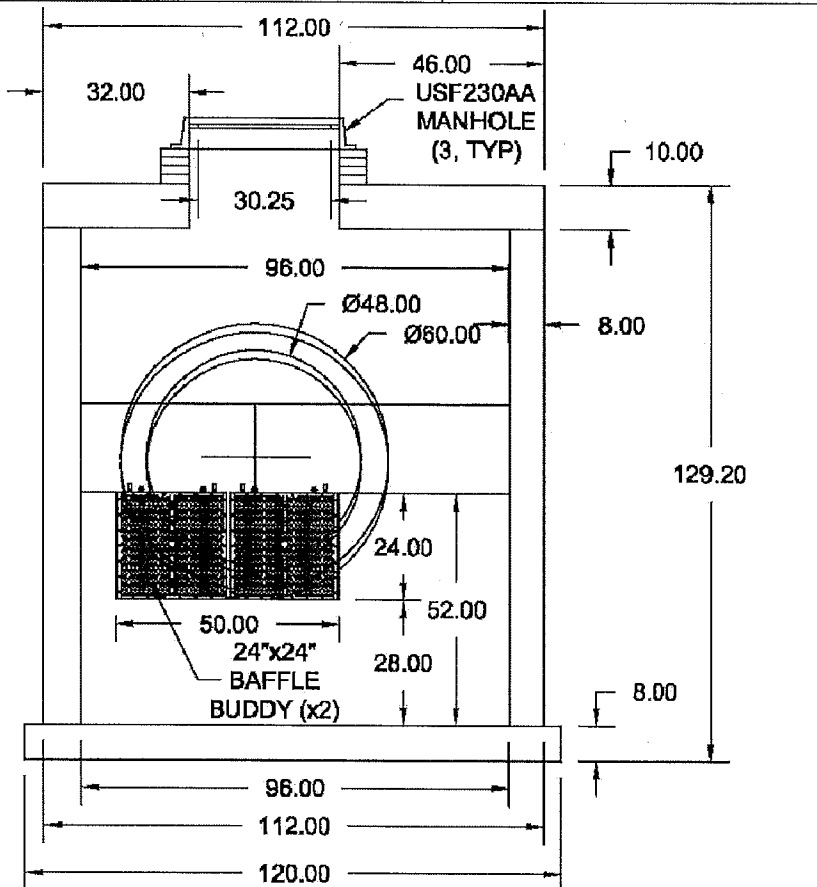
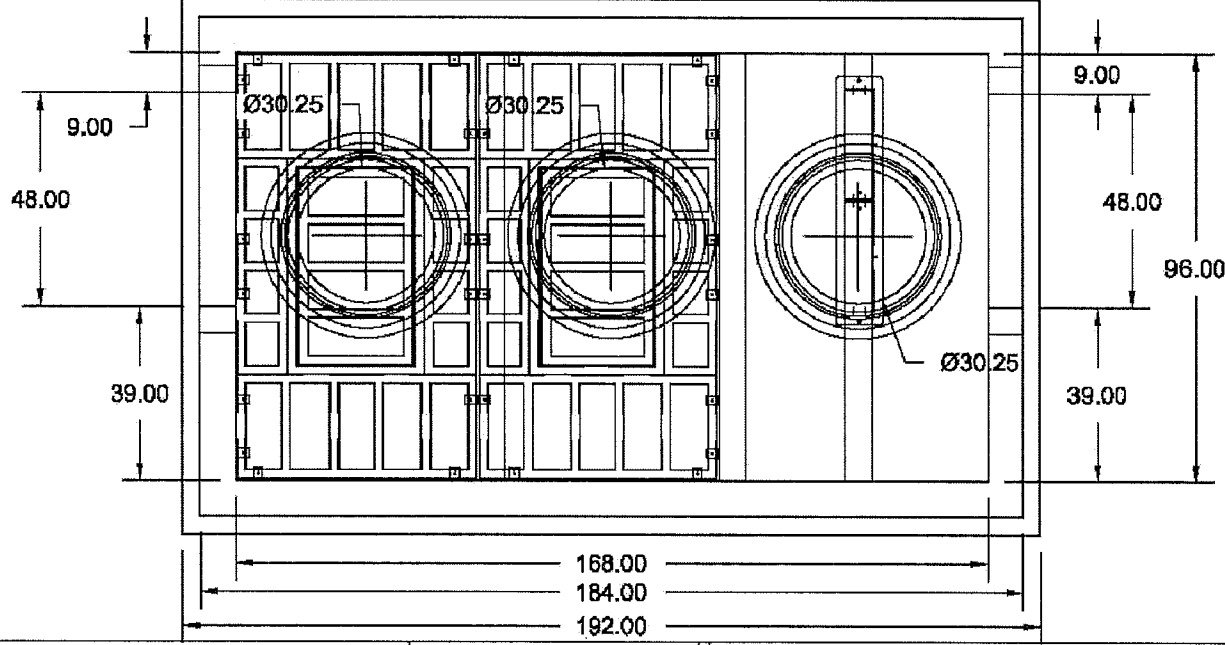
C14A

JOB: CASSELBERRY (8x14) **DESCRIPTION: STORMWATER QUALITY VAULT, PRECAST CONCRETE** **PART# VAULT 4a**

- NOTES:**
- (1) ALL VAULT PARTS TO HAVE H-20 LOAD RATING
 - (2) ALL DIMENSIONS ARE IN INCHES
