Baffle Box with Media Filtration Installation,
Effectiveness Evaluation, and Associated Education for
the Lake Jesup Watershed

Contract S0497

Final Report

City of Casselberry

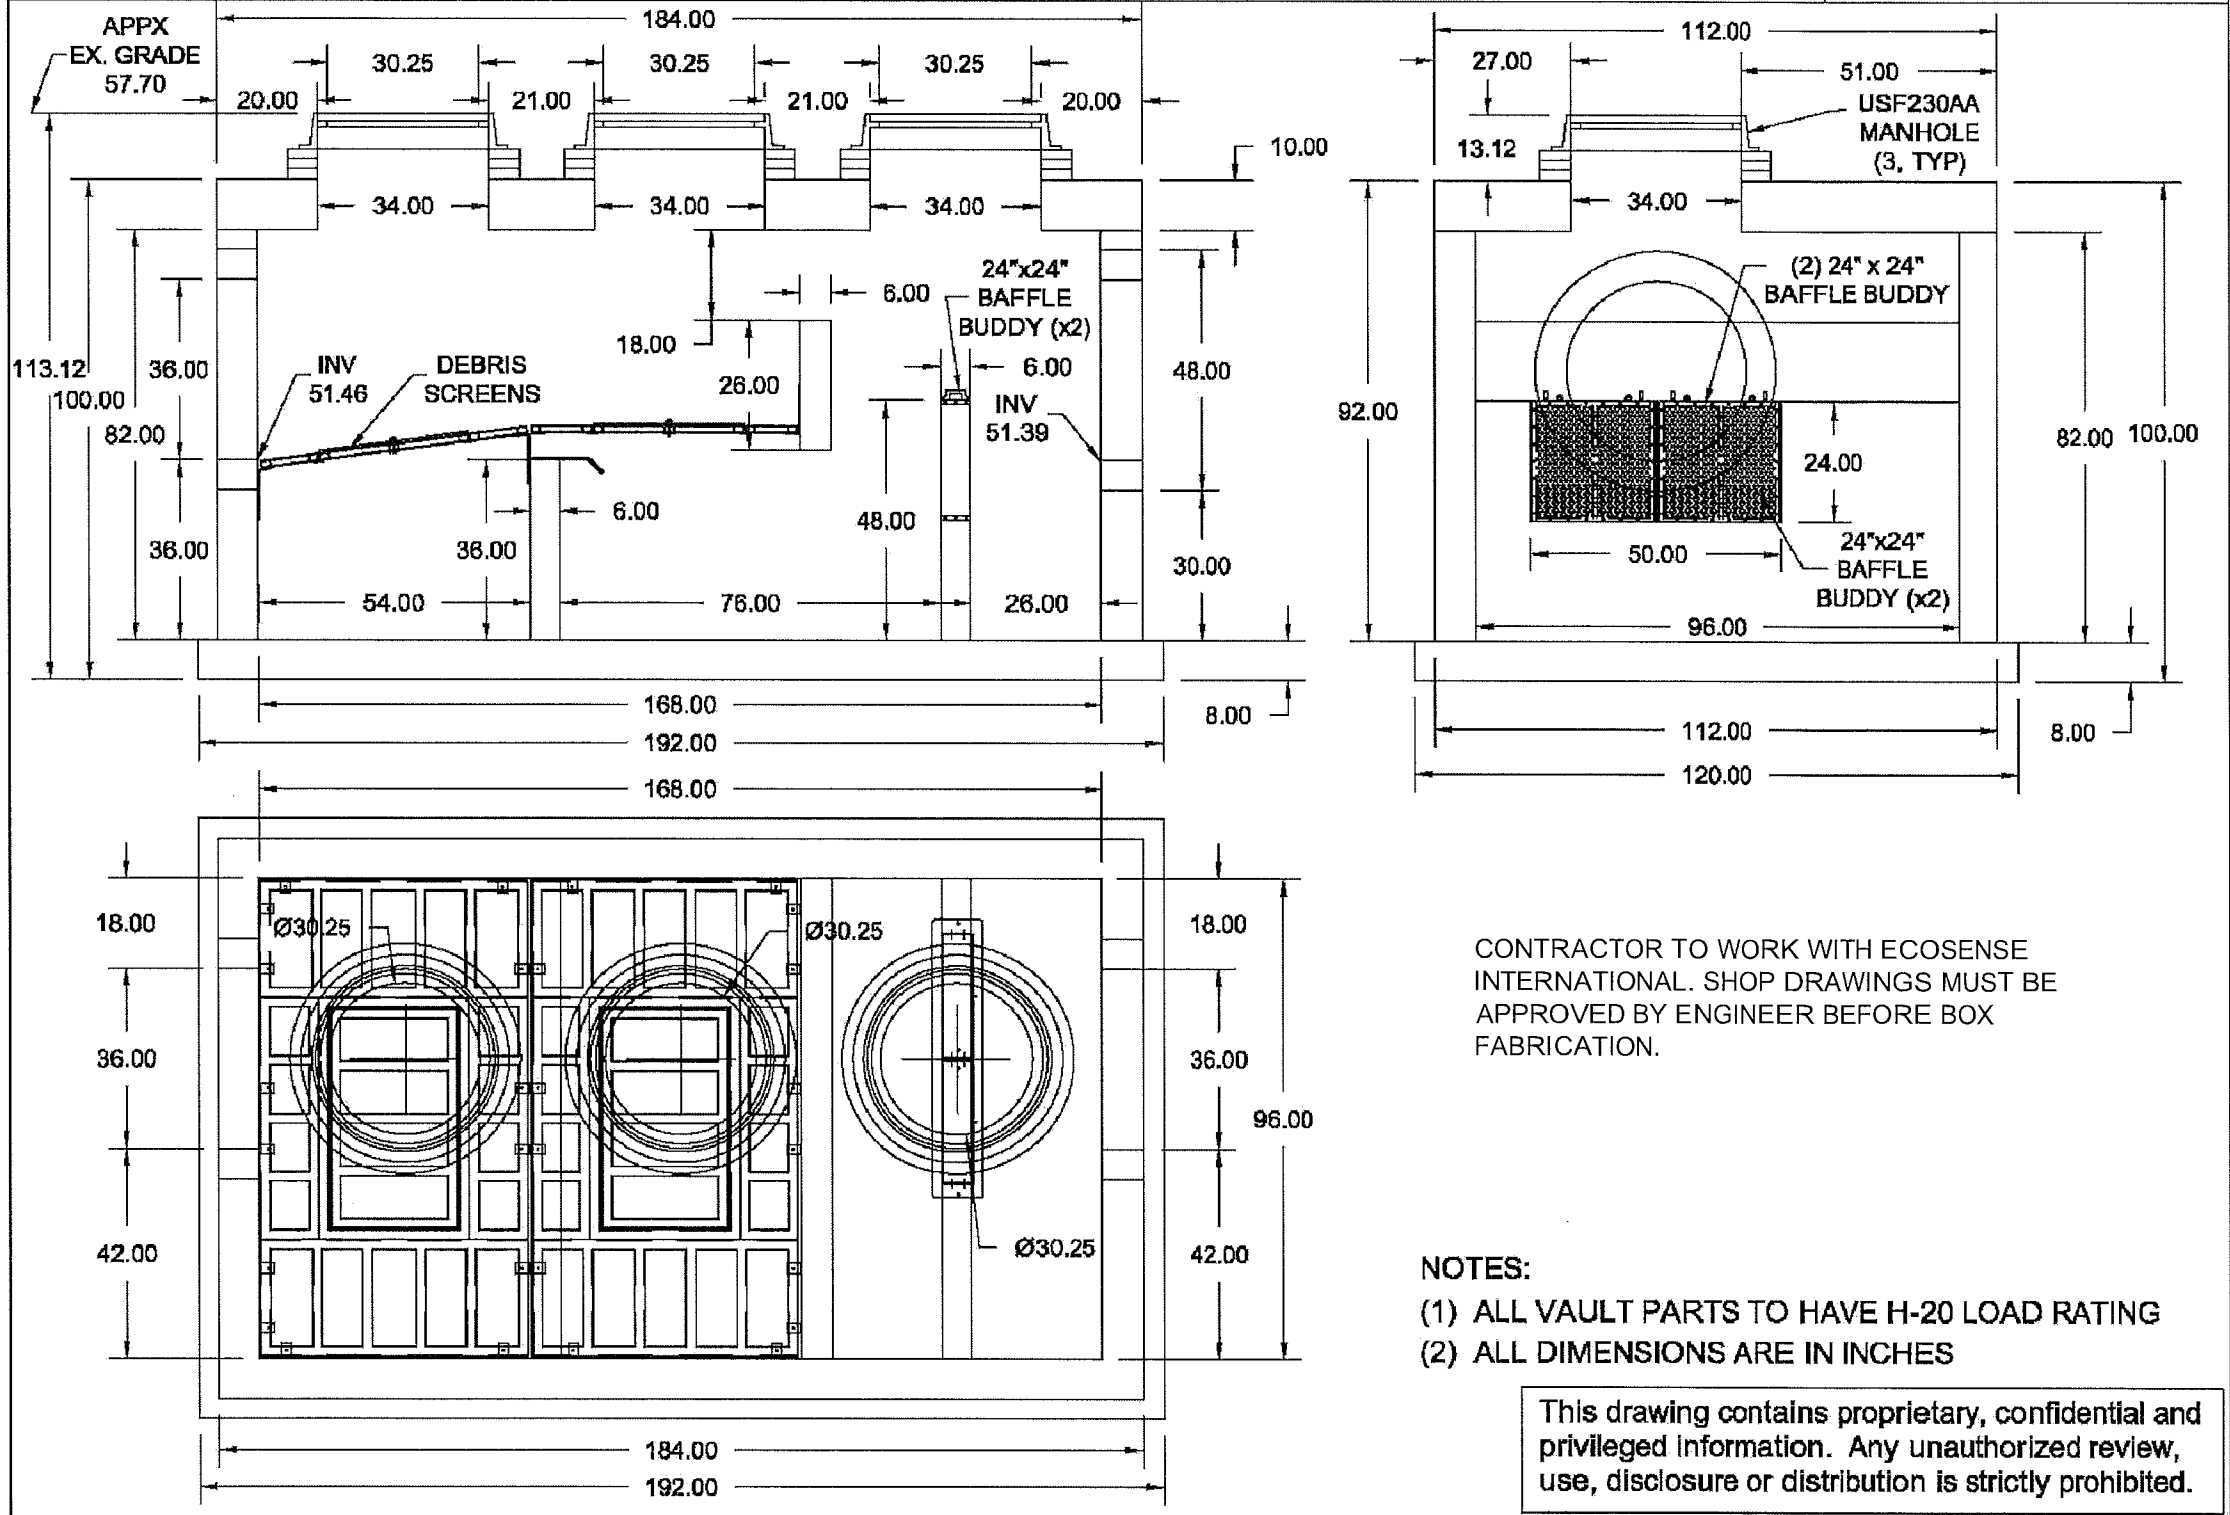
JOB: CASSELBERRY (8x14) **DESCRIPTION: STORMWATER QUALITY VAULT, PRECAST CONCRETE** **PART# VAULT 4c**

- NOTES:**
- (1) ALL VAULT PARTS TO HAVE H-20 LOAD RATING
 - (2) ALL DIMENSIONS ARE IN INCHES
